**BMW 1 HATCH: 1LDZ852**

**Limited Technical Inspection**

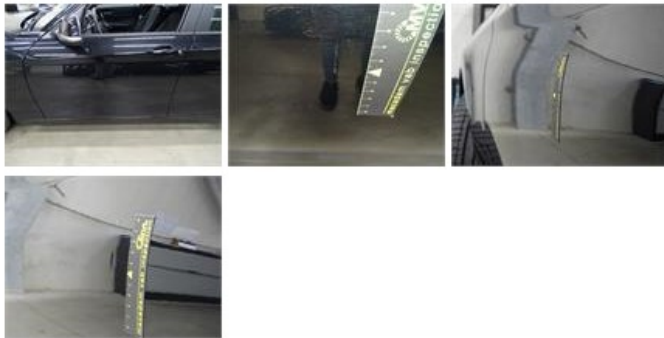
Door F L, Dent(s) and scratch(es), LI - Repair and paint (complete)

318,35

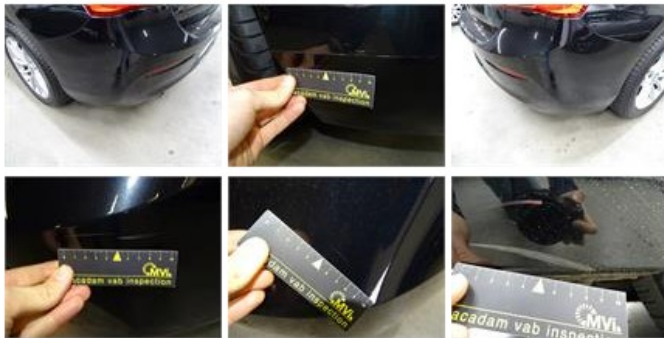
Bumper R, Scratch(es), LI - Repair and paint (complete)

211,80

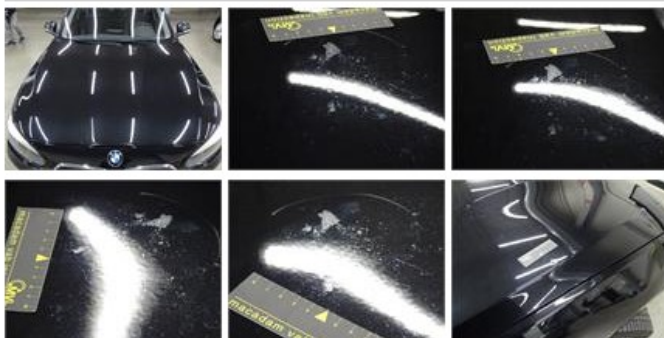
Bonnet, Chemical polution, LI - Repair and paint (complete)

290,08
