**MERCEDES CLA SHOOTING BRAKE: 1KVB714**

**Limited Technical Inspection**

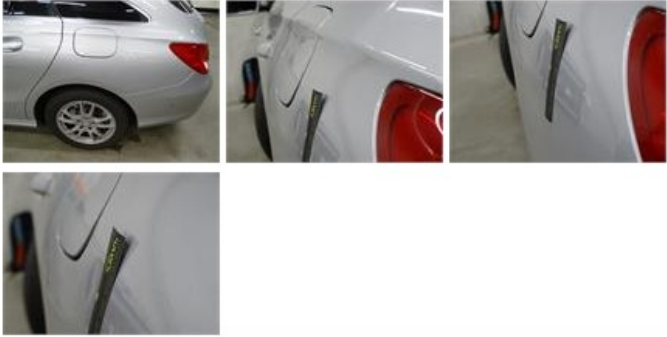
<i>No pictures to display</i>	
Bumper R, Scratch(es), Acceptable	0,00
<i>No pictures to display</i>	
Alloy rim F L, Scratch(es), Acceptable	0,00
<i>No pictures to display</i>	
Door R L, Scratch(es), Acceptable	0,00
<i>No pictures to display</i>	
Bumper F, Chemical polution, 67 - Polish	0,00
<i>No pictures to display</i>	
Wing R L, Dent(s), PDR - Paintless dent repair	63,00
