**MERCEDES CLA: 1JVV719**

**Limited Technical Inspection**

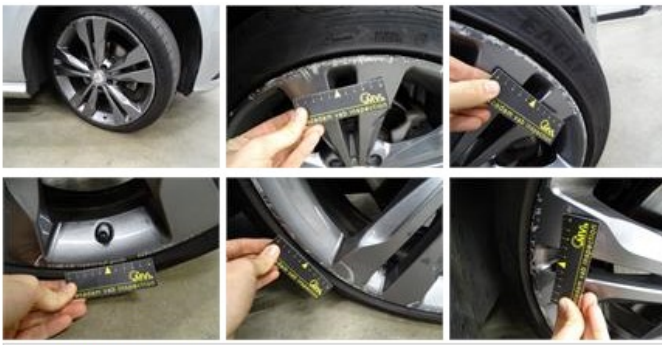
<b>Total cost ex VAT</b>	<b>1017,60</b>
<b>Alloy rim F R, Scratch(es), LI - Repair and paint (complete)</b>	<b>95,00</b>

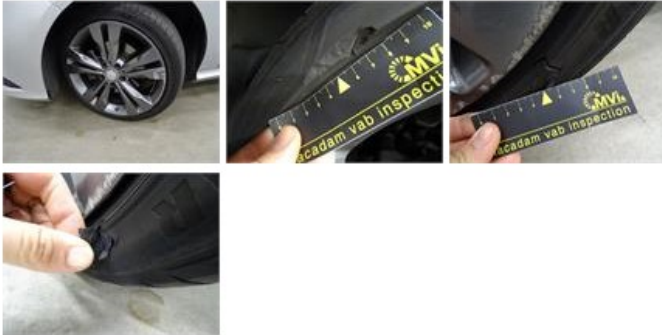
Tyre F L, Tear, E - Replace

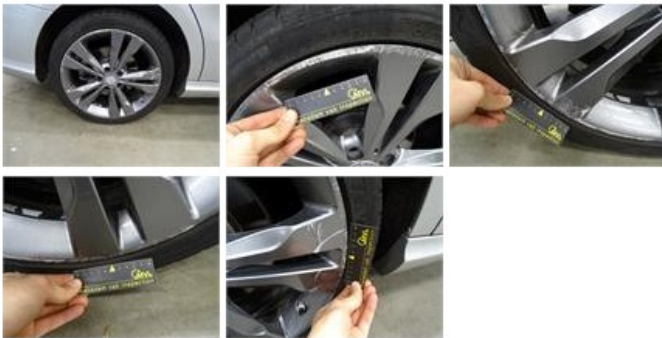
Alloy rim R R, Scratch(es), LI - Repair and paint (complete)

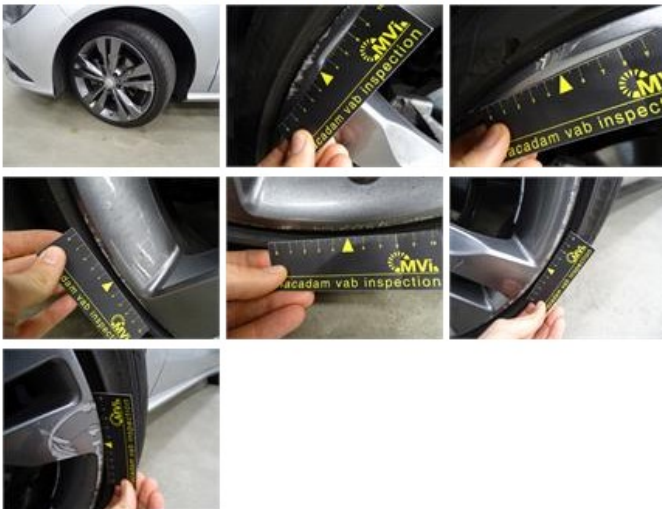
Alloy rim F L, Scratch(es), LI - Repair and paint (complete)

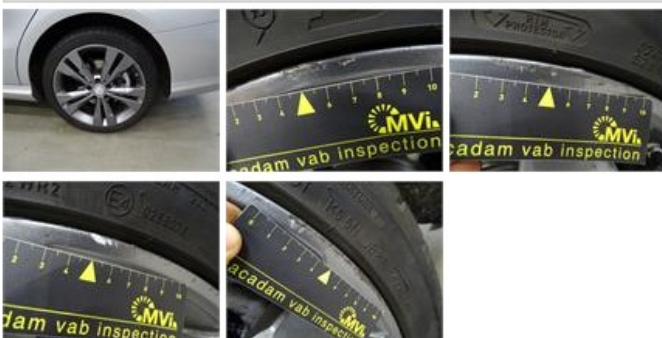
Alloy rim R L, Scratch(es), Acceptable

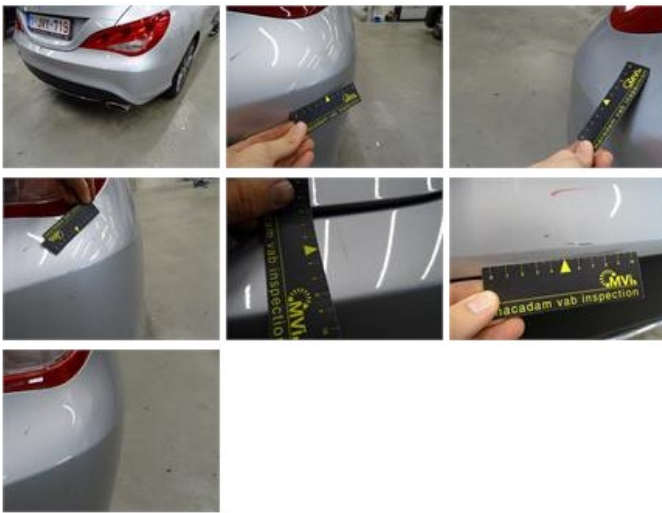
Bumper R, Dent(s) and scratch(es), LI - Repair and paint (complete)

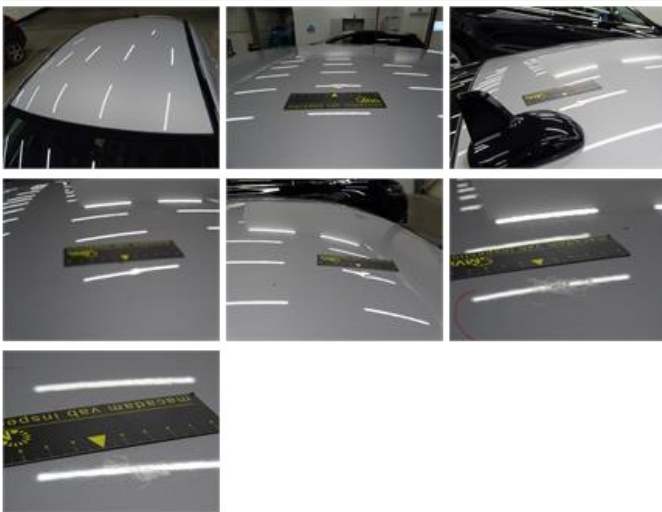
Roof, Dent(s), Acceptable 0,00

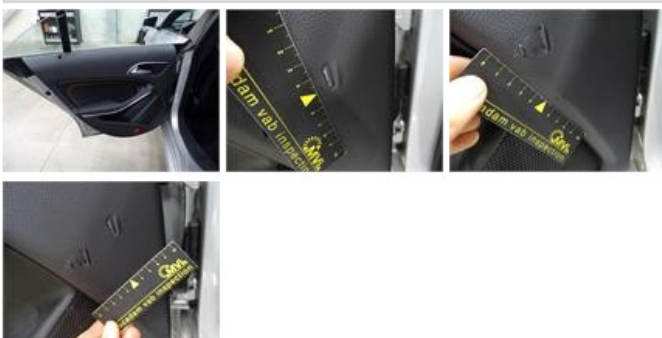
Door panel R L, Tear, E - Replace 114,00

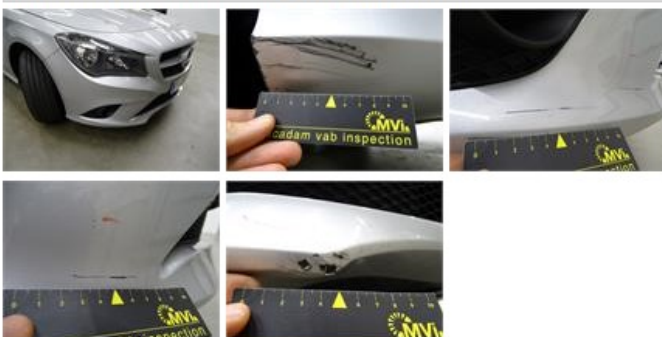
Bumper F, Scratch(es), LI - Repair and paint (complete) 211,80
