SKODA SUPERB COMBI: 1REZ354

Limited Technical Inspection

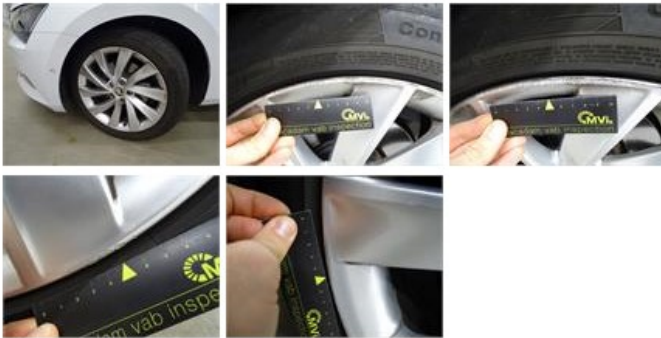
Alloy rim F L, Scratch(es), LI - Repair and paint (complete) 95,00

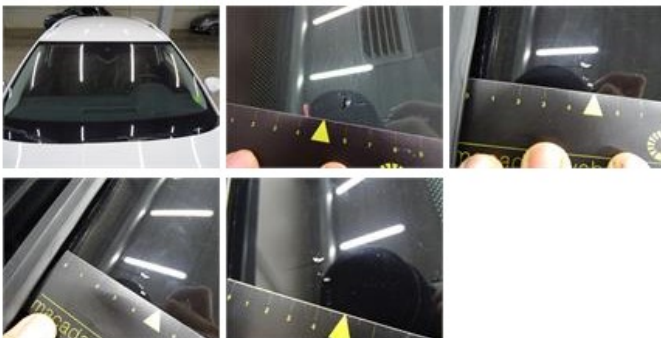
Windscreen, Stone chip(s), E - Replace 0,00

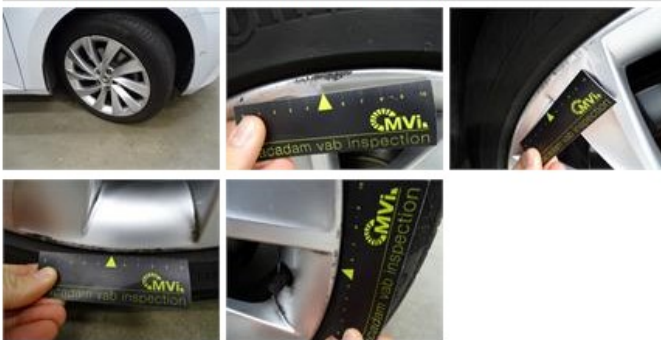
Alloy rim F R, Scratch(es), LI - Repair and paint (complete) 95,00

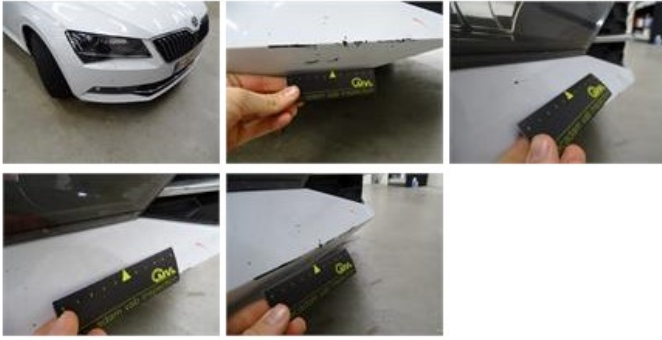
Bumper F, Scratch(es), LI - Repair and paint (complete) 254,16
