**SKODA Octavia: 1HYJ725**

**Limited Technical Inspection**

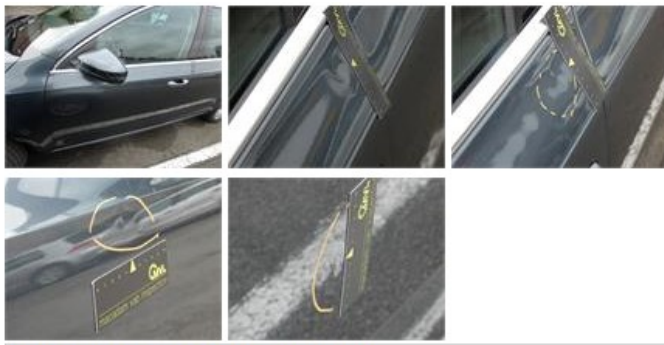
Total cost ex VAT	632,16
Door F L, Dent(s), PDR - Paintless dent repair	63,00

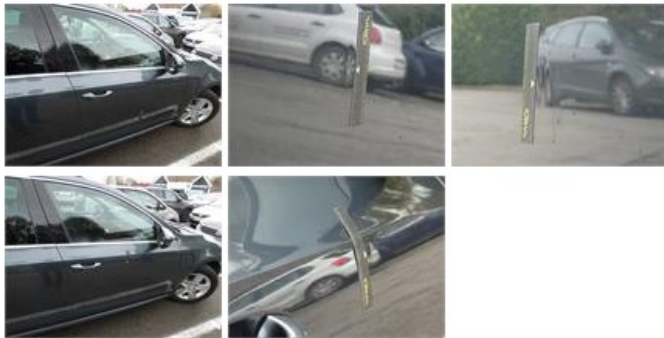
Door F R, Dent(s), PDR - Paintless dent repair 82,80

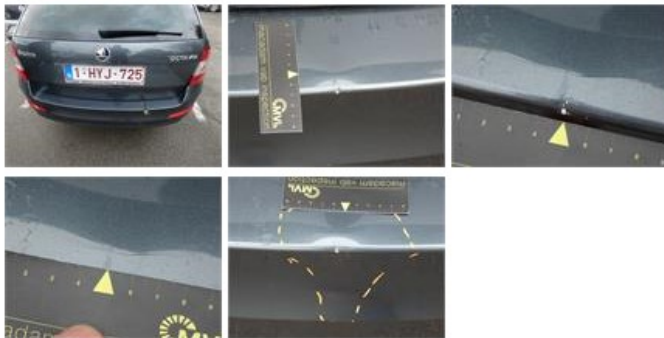
Bumper R, Dent(s) and scratch(es), LI - Repair and paint (complete) 307,80
