VOLKSWAGEN Golf: 1GTJ761

Limited Technical Inspection

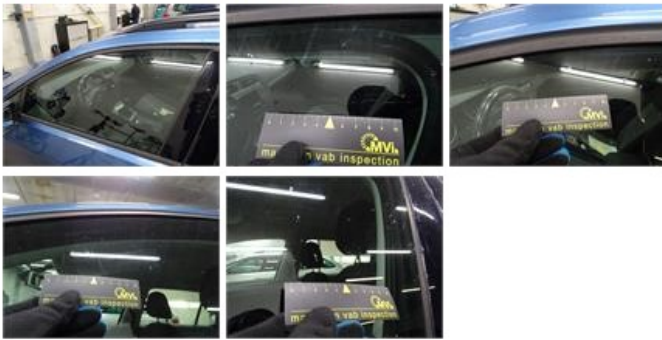
Window F L door, Scratch(es), E - Replace 97,20

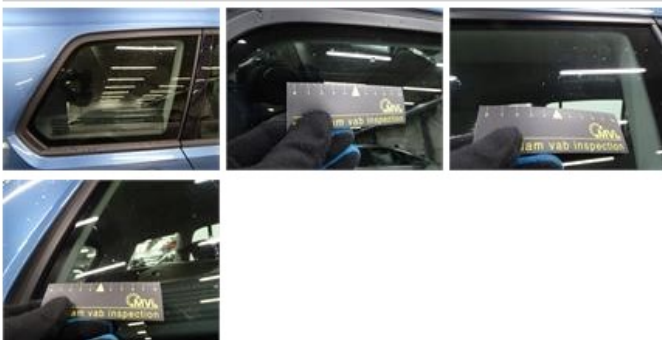
Window R R door, Scratch(es), E - Replace 272,60

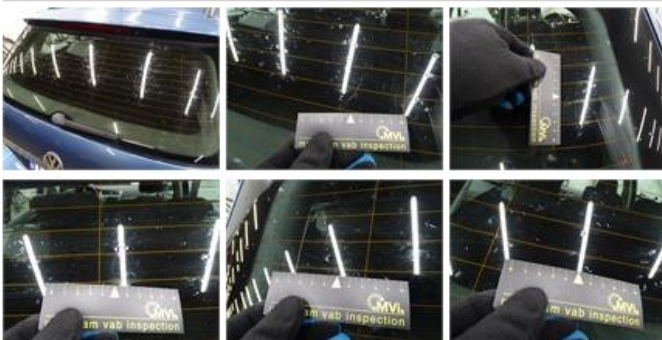
Rear window, Scratch(es), E - Replace 370,00

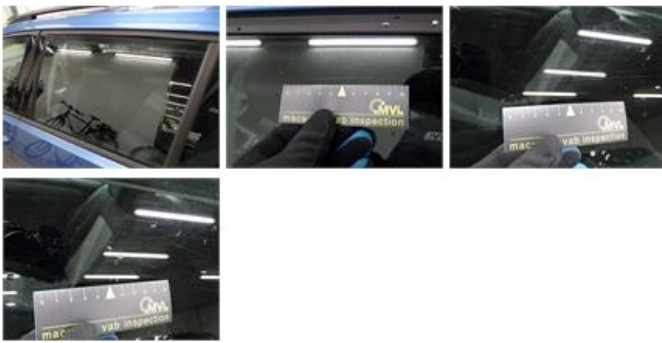
Window R L door, Scratch(es), E - Replace 97,30
