VOLVO V60: 1LEH278

Limited Technical Inspection

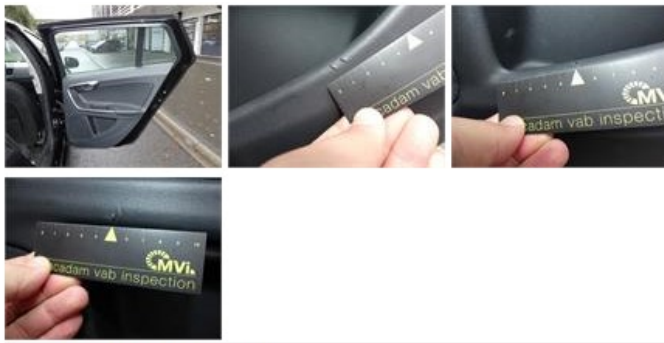
Total cost ex VAT	1161,60
Door panel R R, Hole, Smart repair	110,64

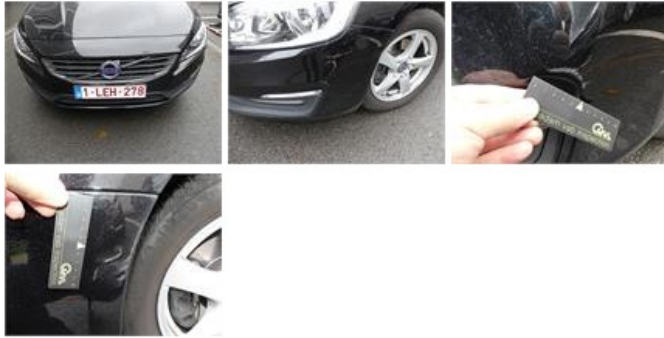
Bumper F, Scratch(es), It - Spot repair 115,56

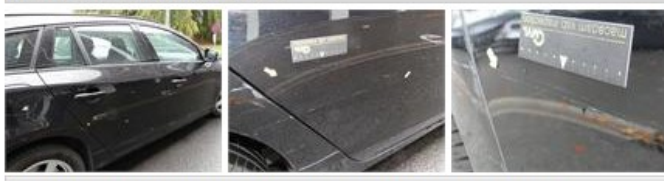
No pictures to display
Door R R, Scratch(es), 67 - Polish 0,00

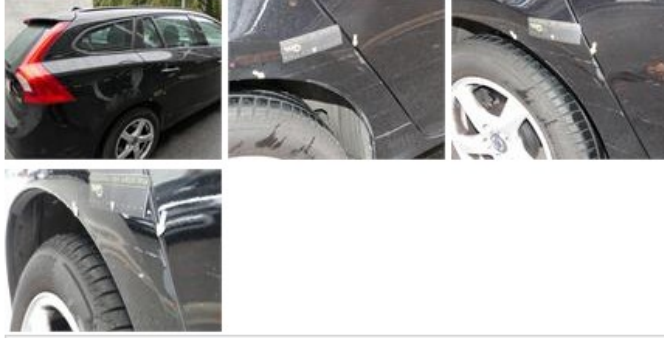
Wing R R, Dent(s) and scratch(es), LI - Repair and paint (complete) 404,20
