BMW 3: 1HCU436			
Vinnumber:	WBA3L11060K176755	Versionname:	3 TOURING 320d Eff.Dyn.Ed. 163PK
First Registrationdate:	19/06/2014	Fiscalpower:	
Expertise Mileage:	94603	Power Kw:	120
Bodytype:		Body color:	Grey
Gearbox:	MAN 6 VIT	Paint type:	Metalic
Transmission:	Back	Rims summer:	Aluminium
Fueltype:	Diesel	Oil level:	OK
Battery functioning:	Yes	Parking lot:	3223
Number of doors:	5		
Number of seats:	5		
Number head rests:	5		
Rims summer:	Aluminium		
Category:	Passenger Car		
Oil level:	OK		
Registration Certificate Car (BE):	Yes

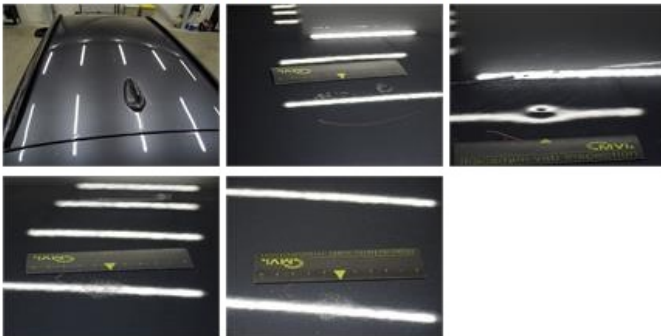
Roof, Chemical pollution, LI - Repair and paint (complete) 481,50

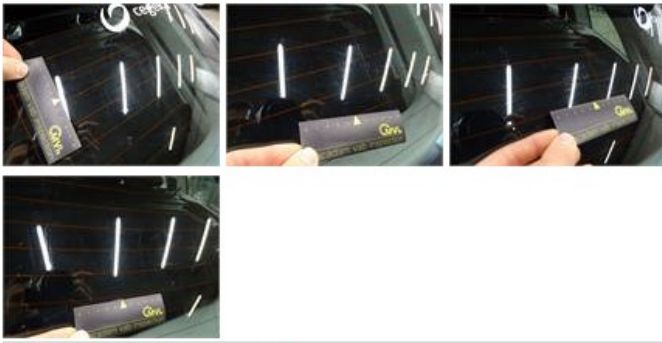
Rear window, Scratch(es), Acceptable 0,00
