**BMW 3: 1HYA695**

**Limited Technical Inspection**

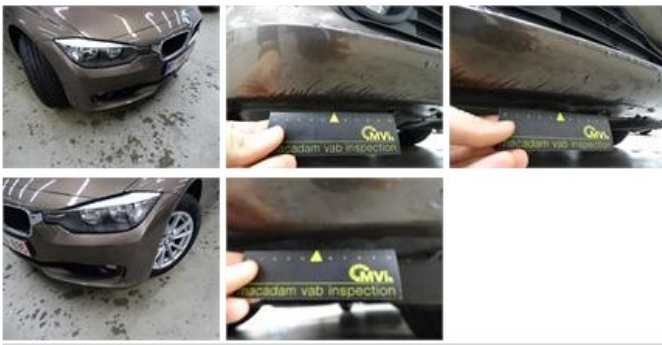
Bumper F, Scratch(es), LI - Repair and paint (complete) 211,80

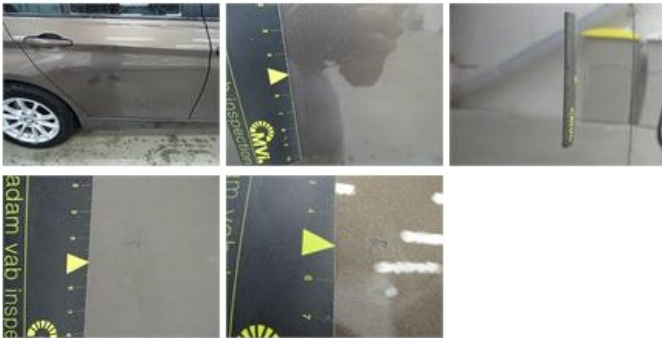
Alloy rim R R, Scratch(es), Acceptable	0,00
<i>No pictures to display</i>	
Roof, Scratch(es), 67 - Polish	0,00
<i>No pictures to display</i>	
Wing F R, Repaired, Acceptable	0,00
<i>No pictures to display</i>	
Door F R, Repaired, Acceptable	0,00
<i>No pictures to display</i>	
Door R R, Dent(s) and scratch(es), LI - Repair and paint (complete)	318,35
