SKODA OCTAVIA: 1KLU799

| Vinnumber: | TMBAG7NE8F0206737 | Versionname: | 1.6 CRTDI 77KW GREENTEC AMBITION |

Limited Technical Inspection

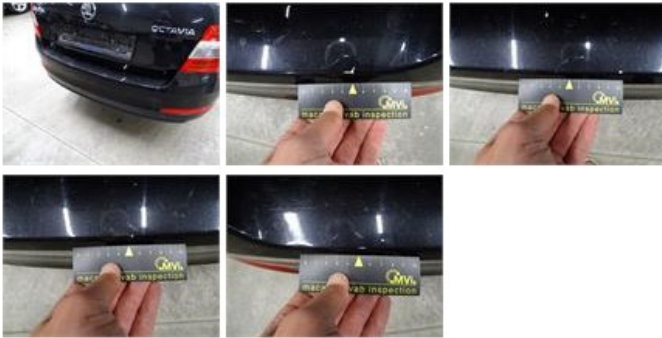
Bumper R, Scratch(es), LI - Repair and paint (complete)

211,80
