VOLVO V60: 1LPU662

Limited Technical Inspection

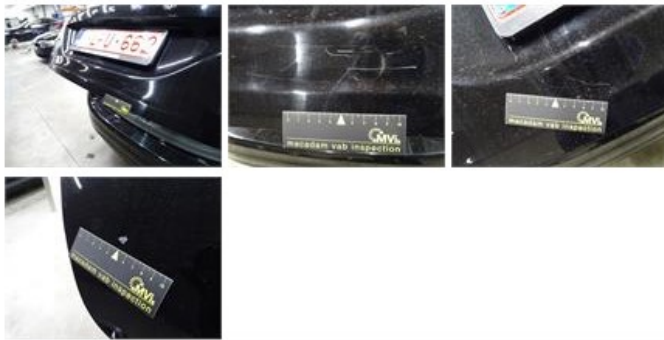
Tailgate, Scratch(es), LI - Repair and paint (complete)

301,68
