BMW 1 HATCH: JW7069

Limited Technical Inspection

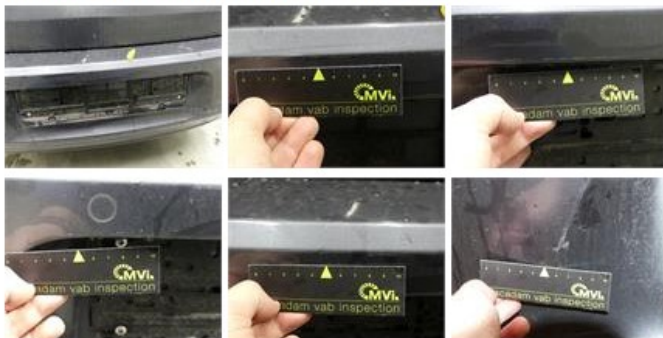
Bumper R, Scratch(es), LI - Repair and paint (complete)

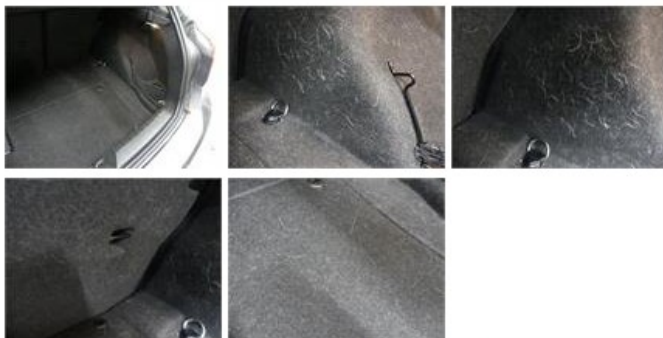
Interior, Dirty, Chemical cleaning

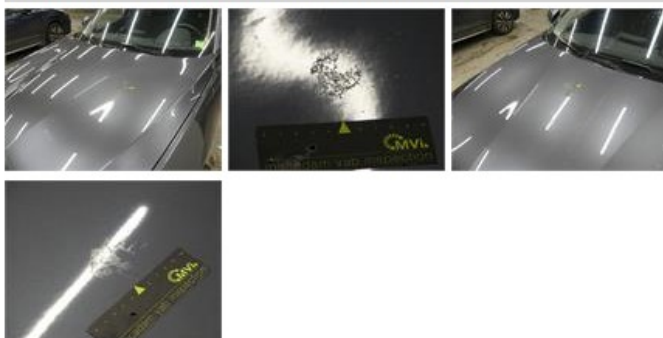
Bonnet, Chemical pollution, LI - Repair and paint (complete)

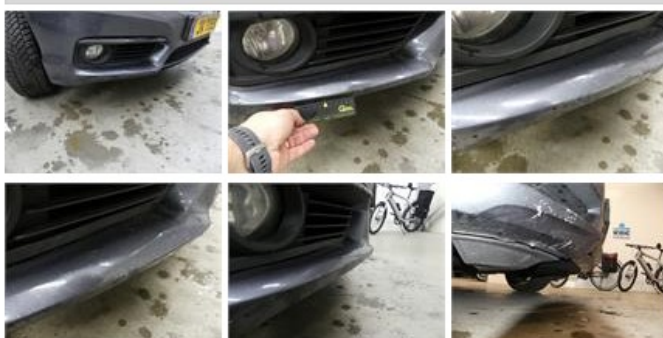
Bumper F, Dent(s) and scratch(es), LI - Repair and paint (complete)
