AUDI A6: 1HRY443

Limited Technical Inspection

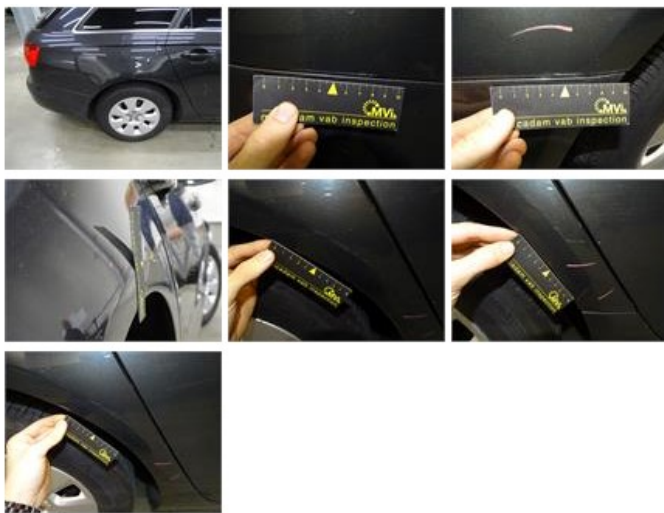
Wing R R, Dent(s) and scratch(es), LI - Repair and paint (complete)	0,00
---	-------------

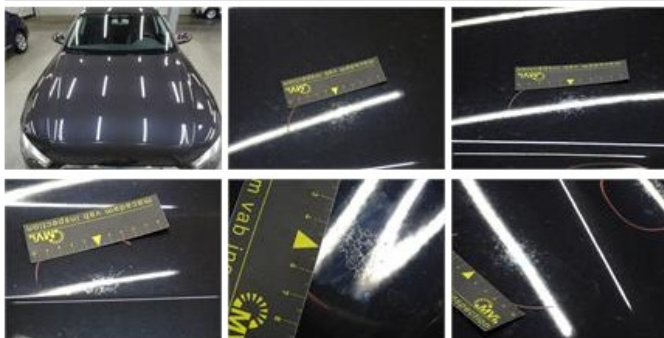
Bonnet, Chemical polution, LI - Repair and paint (complete) 348,09

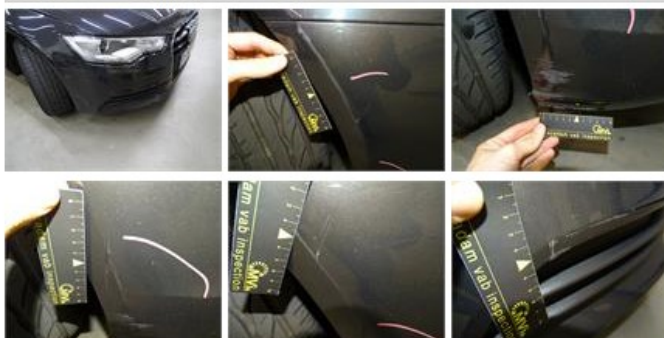
Bumper F, Scratch(es), LI - Repair and paint (complete) 254,16

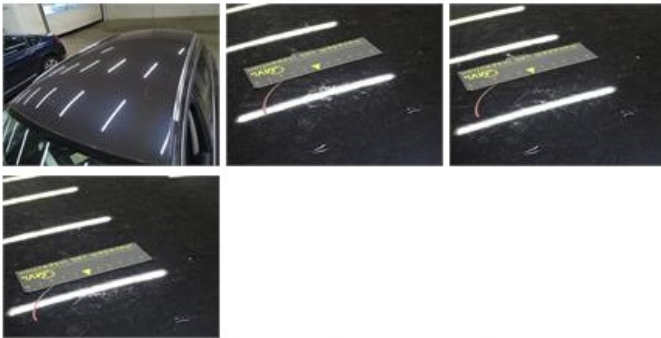
Roof, Chemical polution, LI - Repair and paint (complete)

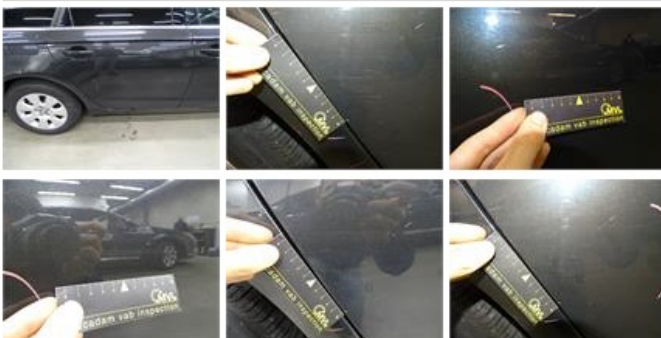
Door R R, Scratch(es), LI - Repair and paint (complete)

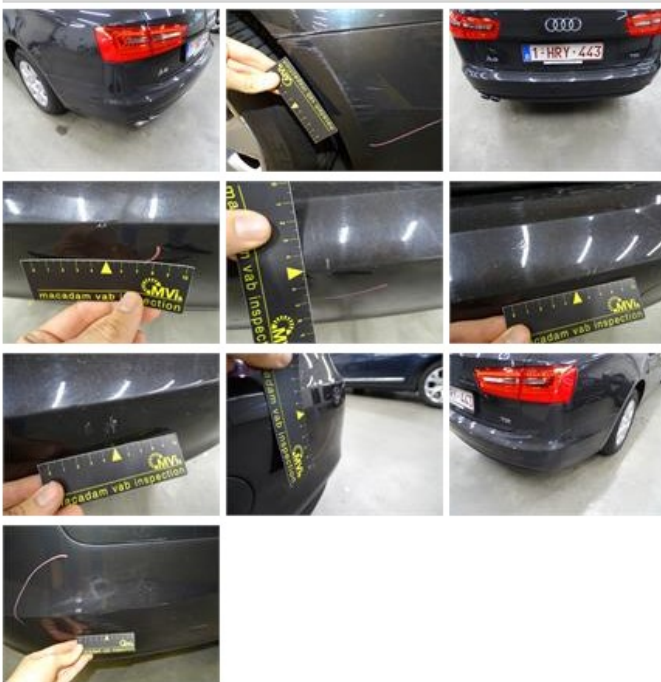
Bumper R, Dent(s) and scratch(es), LI - Repair and paint (complete)

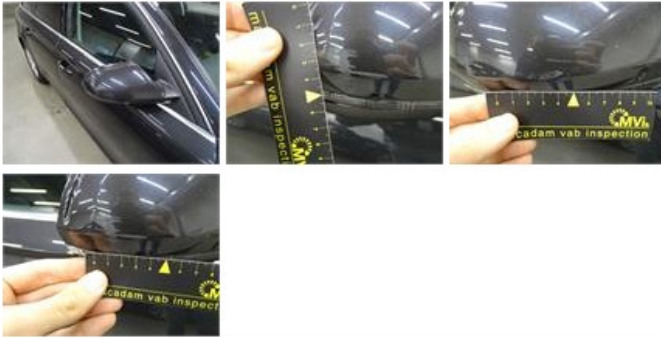
Rearview mirror housing R, Scratch(es), LI - Repair and paint (complete) 115,56
