BMW 1 HATCH: 1LHC917

Limited Technical Inspection

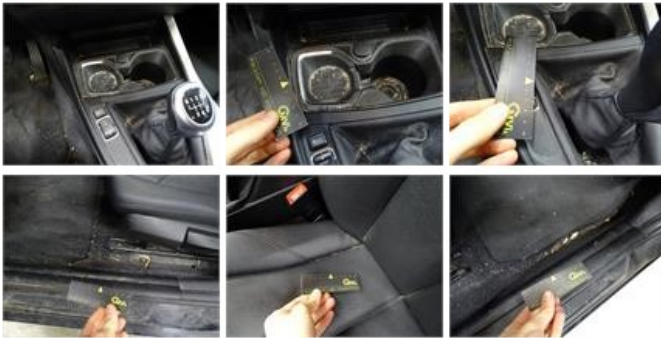
Interior, Dirty, Cleaning

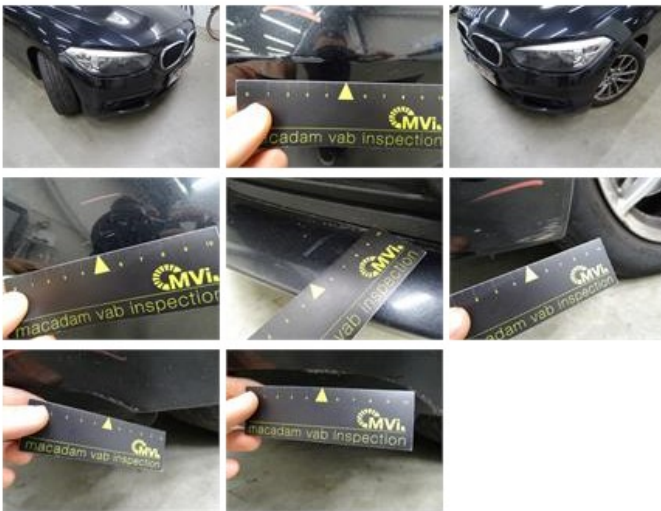
Bumper F, Scratch(es), LI - Repair and paint (complete)

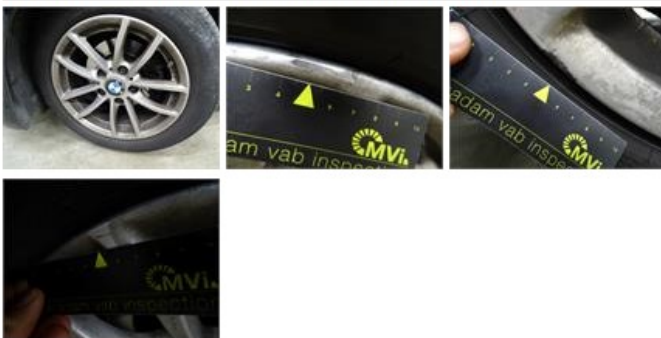
Alloy rim F L, Scratch(es), LI - Repair and paint (complete)

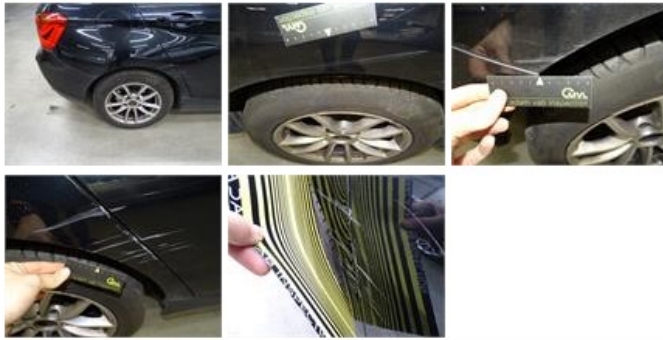
Wing R R, Dent(s) and scratch(es), LI - Repair and paint (complete)

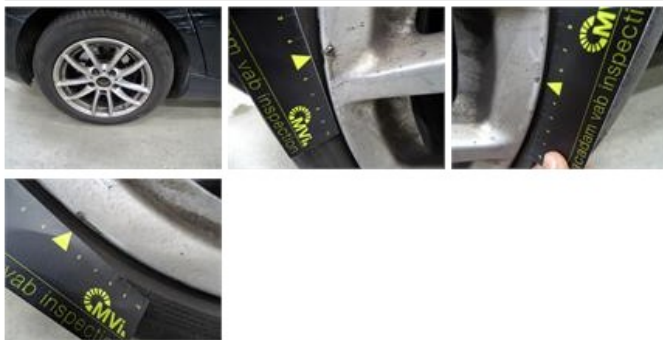
Alloy rim R R, Scratch(es), LI - Repair and paint (complete)

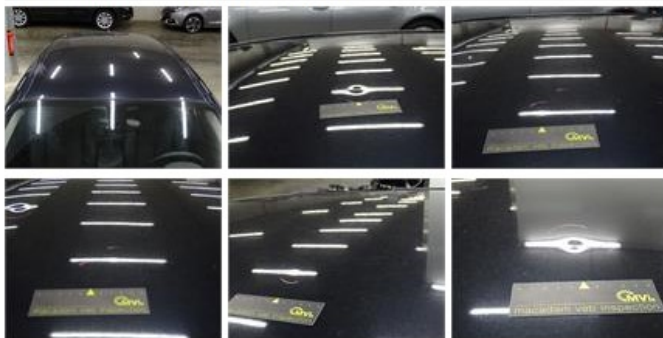
Roof, Dent(s), PDR - Paintless dent repair

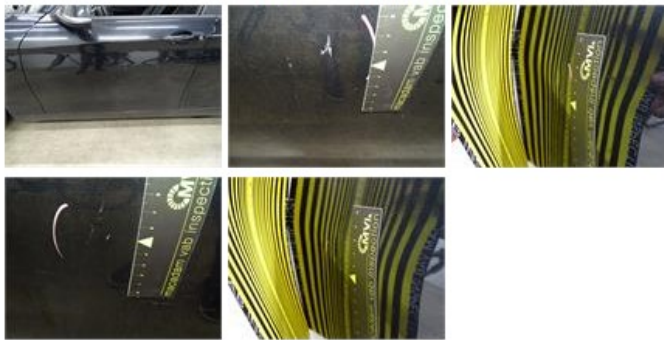
Door F L, Dent(s) and scratch(es), LI - Repair and paint (complete) 318,35

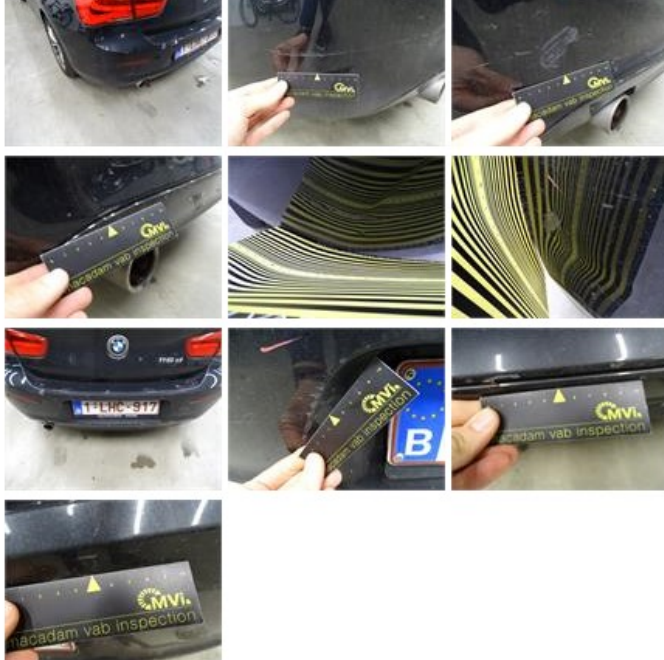
Bumper R, Dent(s) and scratch(es), LI - Repair and paint (complete) 211,80
