BMW 3: 1GXC608			
Vinnumber:	WBA3K11040F833094	Versionname:	3 TOURING 318d 136PK
First Registrationdate:	23/05/2014	Fiscalpower:	
Expertise Mileage:	133841	Power Kw:	100
Bodytype:		Body color:	Light Grey
Gearbox:	MAN 6 VIT	Paint type:	Metalic
Transmission:	Back	Rims summer:	Aluminium
Fueltype:	Diesel	Oil level:	OK
Battery functioning:	Yes	Parking lot:	4409
Number of doors:	5		
Number of seats:	5		
Number head rests:	5		
Rims summer:	Aluminium		
Category:	Passenger Car		
Oil level:	OK		
Registration Certificate Car (BE):	Yes

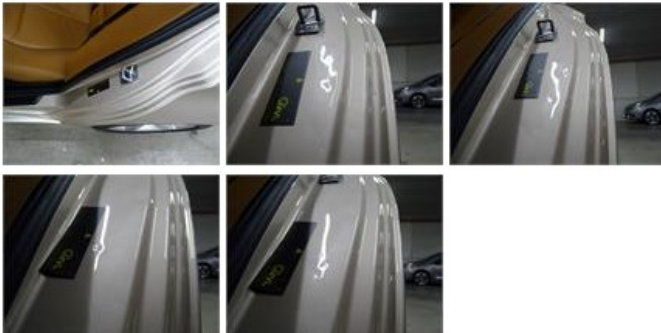
Rocker panel inner R L, Dent(s), LI - Repair and paint (complete) 115,56

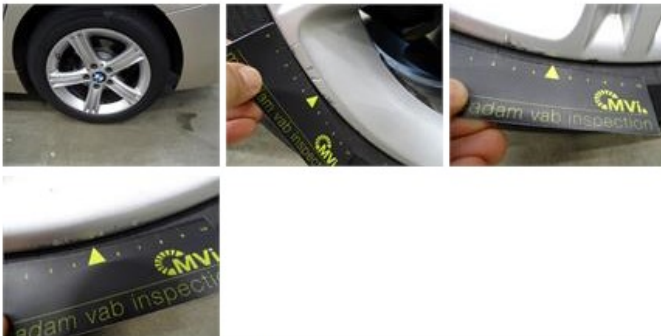
Alloy rim R L, Scratch(es), LI - Repair and paint (complete) 95,00

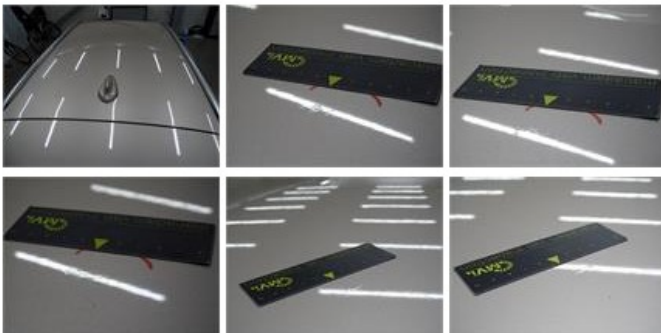
Roof, Chemical pollution, LI - Repair and paint (complete) 481,50
