**VOLVO V40: 1JFH505**

**Limited Technical Inspection**

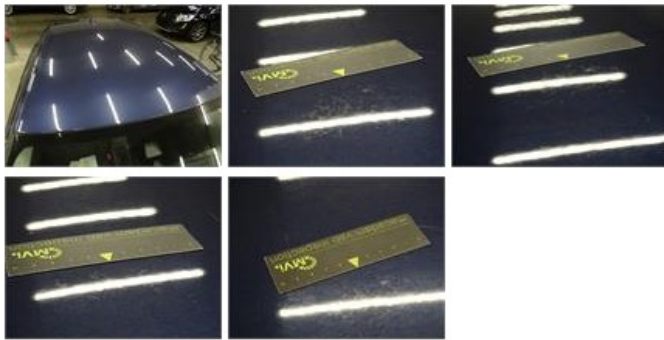
Roof, Chemical pollution, LI - Repair and paint (complete)

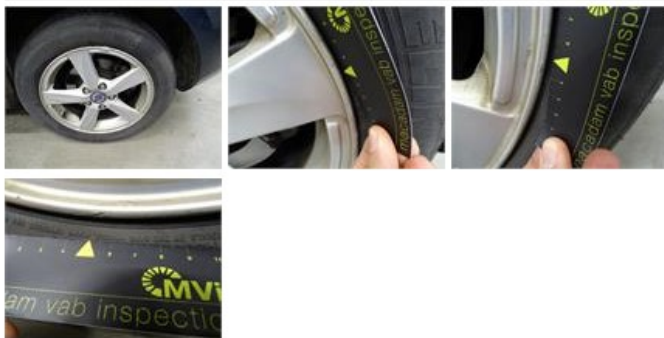
Alloy rim R L, Scratch(es), LI - Repair and paint (complete)

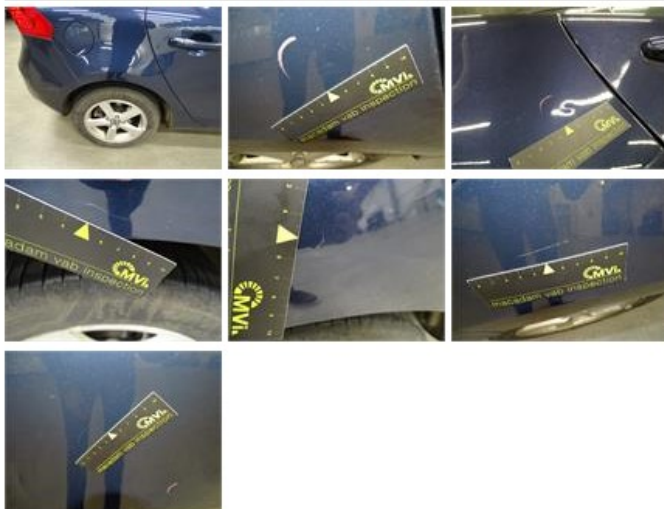
Wing R R, Dent(s) and scratch(es), LI - Repair and paint (complete)

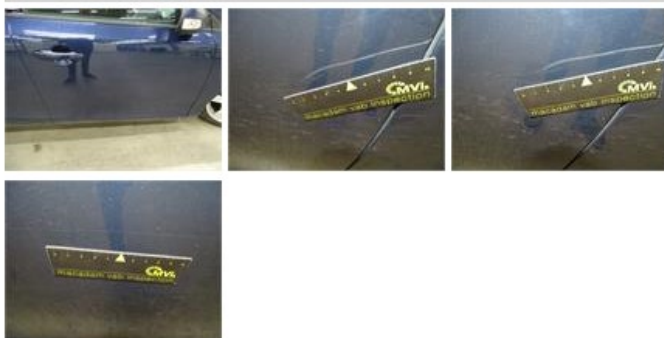
Door F R, Scratch(es), LI - Repair and paint (complete)

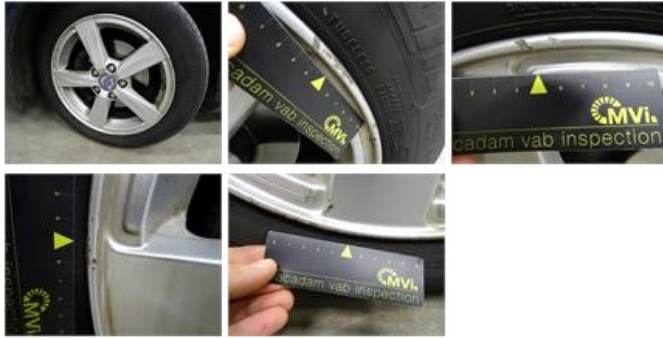
Alloy rim F L, Scratch(es), LI - Repair and paint (complete)

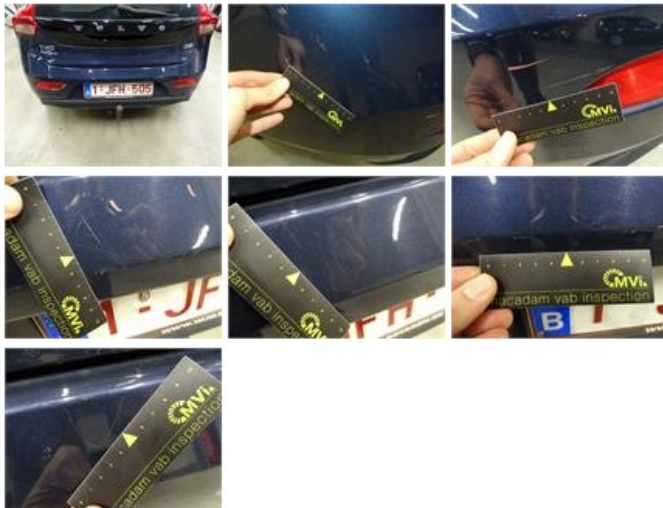
Bumper R, Scratch(es), LI - Repair and paint (complete)

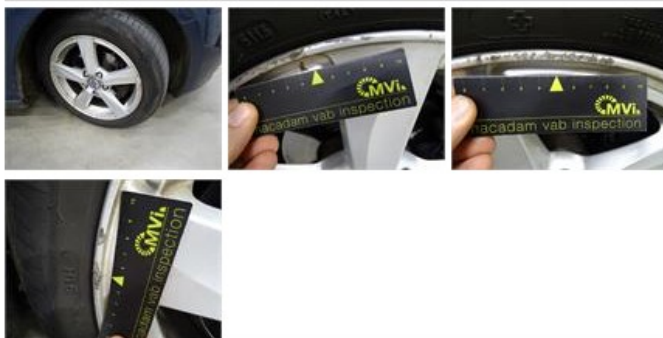
Alloy rim F R, Scratch(es), LI - Repair and paint (complete)

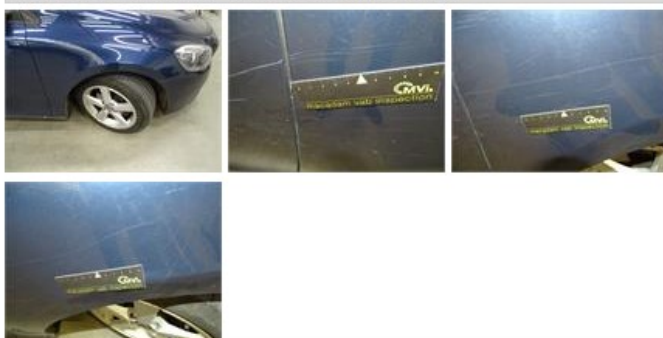
Wing F R, Scratch(es), LI - Repair and paint (complete)

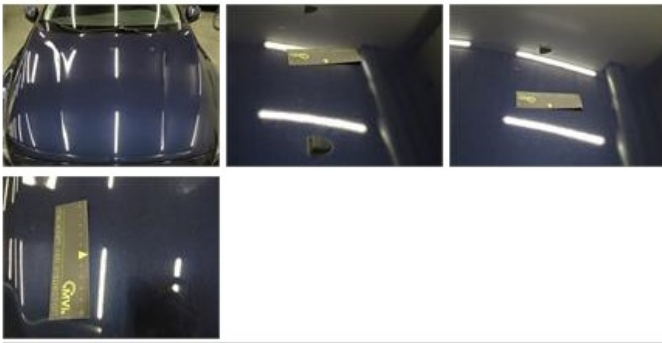
Bonnet, Bad repair, Acceptable

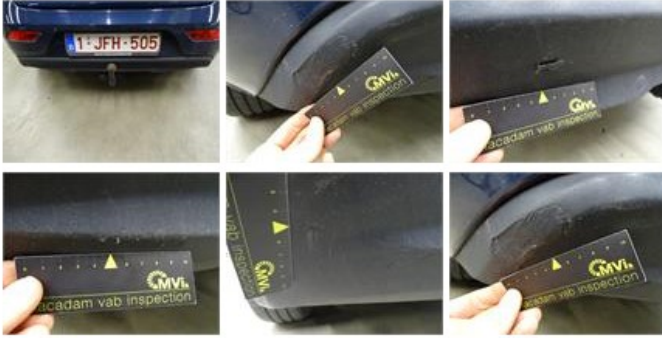
Tailgate, Scratch(es), Acceptable	0,00
<i>No pictures to display</i>	
Bumper cover R M, Scratch(es), Smart repair	110,64
