BMW 4 CABRIO: NQ4324			
Vinnumber:	WBS3U910105C22193	Versionname:	3.0 M4
First Registrationdate:	27/01/2016	Fiscalpower:	
Expertise Mileage:	61456	Power Kw:	317
Bodytype:		Body color:	Grey
Gearbox:	Automatic	Paint type:	Metalic
Transmission:	Back	Rims summer:	Aluminium
Fueltype:	Petrol	Oil level:	OK
Battery functioning:	Yes	Parking lot:	3209
Number of doors:	2		
Number of seats:	4		
Number head rests:	4		
Rims summer:	Aluminium		
Category:	Passenger Car		
Oil level:	OK

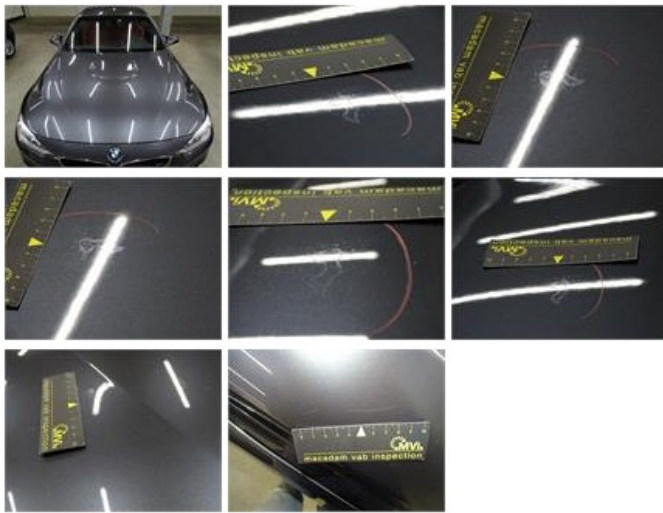
Assistance equipment			
Repair kit	Yes	Compressor	Yes
Number of charging cables (normal)	0		
Number of charging cables (rapid charge)	0		
Total cost ex VAT			1496,29
Bonnet, Chemical polution, LI - Repair and paint (complete)			348,09

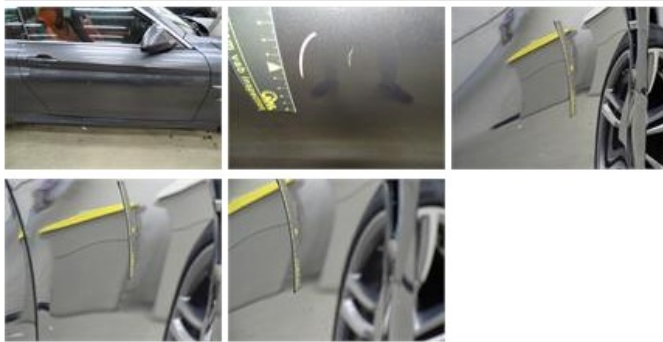
Wing R L, Scratch(es), Acceptable	0,00
<i>No pictures to display</i>	
Wing R R, Scratch(es), 67 - Polish	0,00
<i>No pictures to display</i>	
Roof, Scratch(es), Acceptable	0,00
<i>No pictures to display</i>	
Ignition key, Missing, E - Replace	150,00
<i>No pictures to display</i>	
Windscreen, Stone chip(s), Acceptable	0,00
<i>No pictures to display</i>	
Door F R, Dent(s) and scratch(es), LI - Repair and paint (complete)	382,02

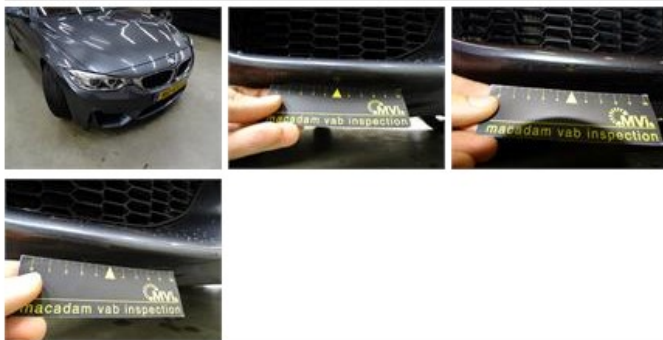
Alloy rim R R polished, Scratch(es), Acceptable	0,00
<i>No pictures to display</i>	
Bumper F, Scratch(es), LI - Repair and paint (complete)	254,16

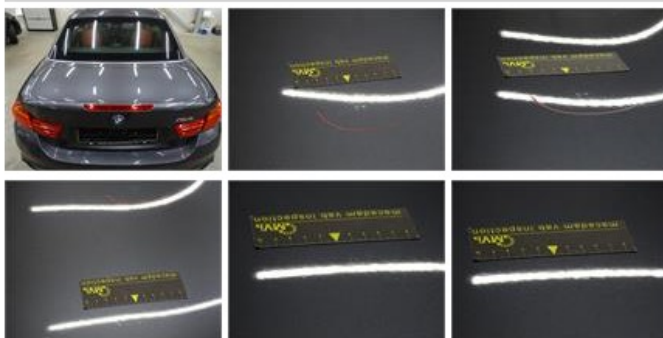
Door F L, Dent(s) and scratch(es), Acceptable	0,00
<i>No pictures to display</i>	
Tailgate, Chemical pollution, LI - Repair and paint (complete)	362,02
