BMW 1 HATCH: 1KRP768

Limited Technical Inspection

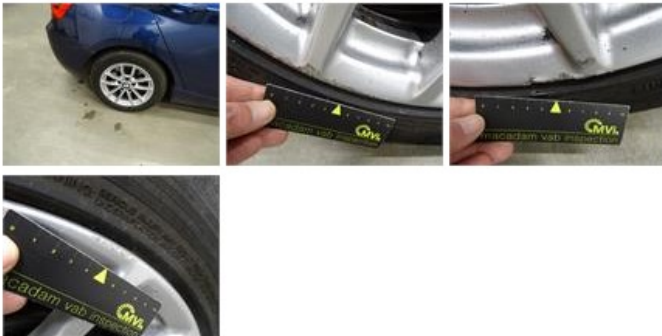
Alloy rim R R, Scratch(es), LI - Repair and paint (complete) 95,00
