BMW 1: 1HPX063

| Vinnumber: | WBA1C91070P695452 | Versionname: | 1 HATCH 116d Eff.Dyn.Ed. 116PK |

Limited Technical Inspection

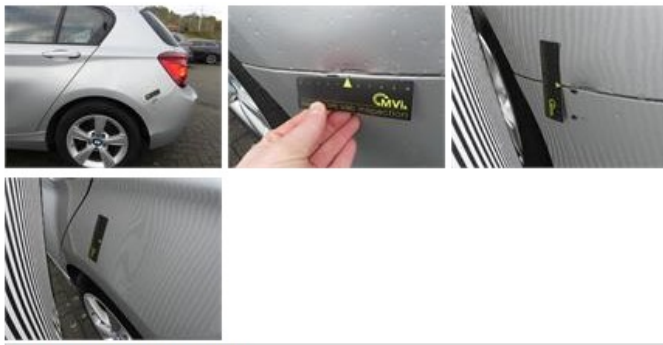
Wing R L, Dent(s) and scratch(es), LI - Repair and paint (complete) 404,20

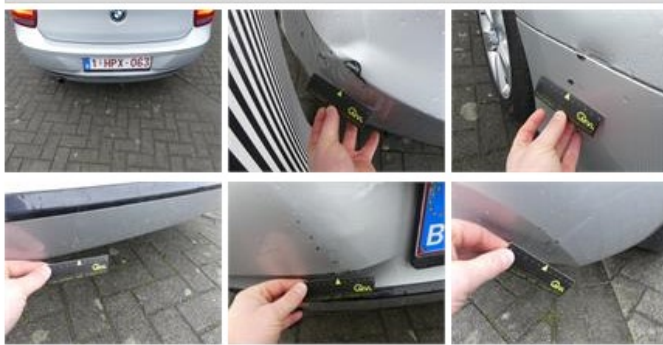
Bumper R, Dent(s) and scratch(es), LI - Repair and paint (complete) 307,80
