AUDI A6: 1HLY903

Limited Technical Inspection

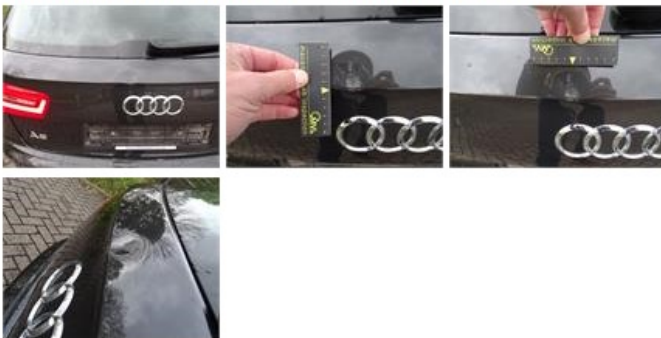
Tailgate, Dent(s) and scratch(es), LI - Repair and paint (complete) 254,16
