**BMW 2 ACTIVE TOURER: 1KGK445**

Vinnumber:	<b>WBA2C11070VZ57682</b>	Versionname:	<b>2.0 218D (100KW) ACTIVE TOURER</b>
First Registrationdate:	<b>28/04/2015</b>	Fiscalpower:	
Expertise Mileage:	<b>91104</b>	Power Kw:	<b>100</b>
Bodytype:		Body color:	<b>Grey</b>
Gearbox:	<b>MAN 6 VIT</b>	Paint type:	<b>Metallic</b>
Transmission:	<b>Front</b>	Rims summer:	<b>Aluminium</b>
Fueltype:	<b>Diesel</b>	Oil level:	<b>OK</b>
Maintenance:	<b>SINDS 800 KM</b>	Parking lot:	<b>4725</b>
Maintenance:	<b>NOT OK</b>		
Battery functioning:	<b>Yes</b>		
Number of doors:	<b>5</b>		
Number of seats:	<b>5</b>		
Number head rests:	<b>5</b>		
Rims summer:	<b>Aluminium</b>		
Category:	<b>Passenger Car</b>		
Oil level:	<b>OK</b>		
Registration Certificate Car (BE):	<b>Yes</b>

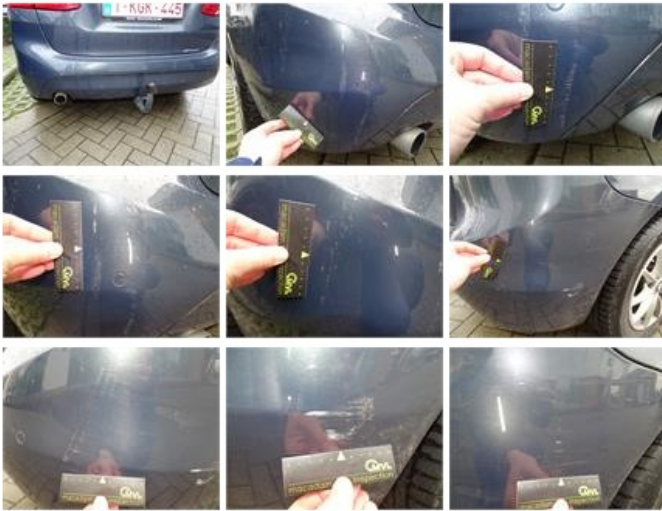
Bumper R, Scratch(es), LI - Repair and paint (complete) 211,80
