MERCEDES A: 1HYB097

Limited Technical Inspection

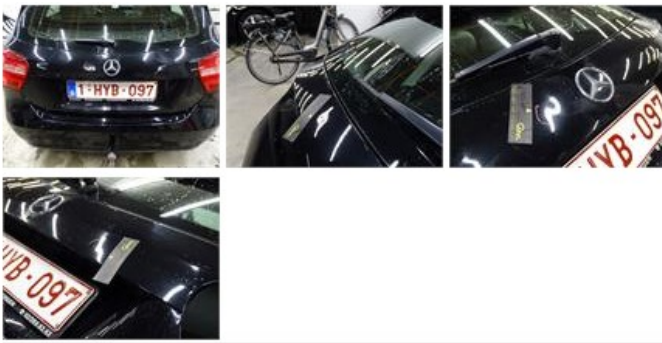
Total cost ex VAT	4318,69
Door panel R L, Scratch(es), Acceptable	0,00
<i>No pictures to display</i>	
Tailgate, Dent(s), PDR - Paintless dent repair	82,80

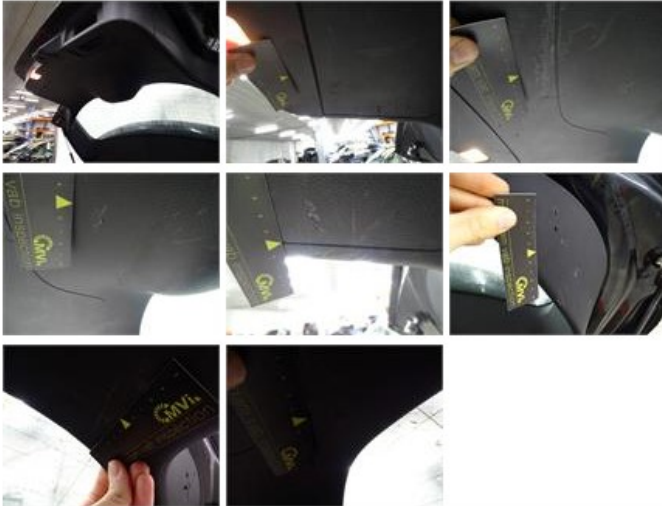
Trunk lid covering R, Scratch(es), Smart repair

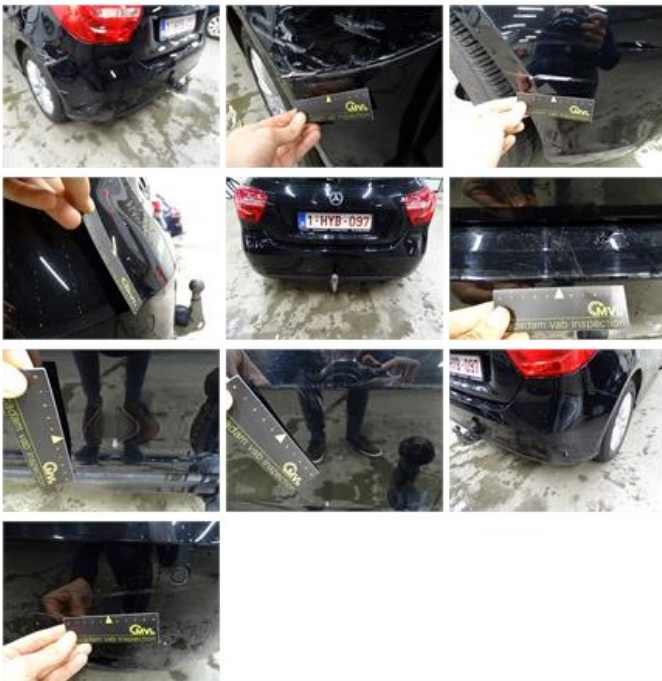
Bumper R, Dent(s) and scratch(es), LI - Repair and paint (complete)

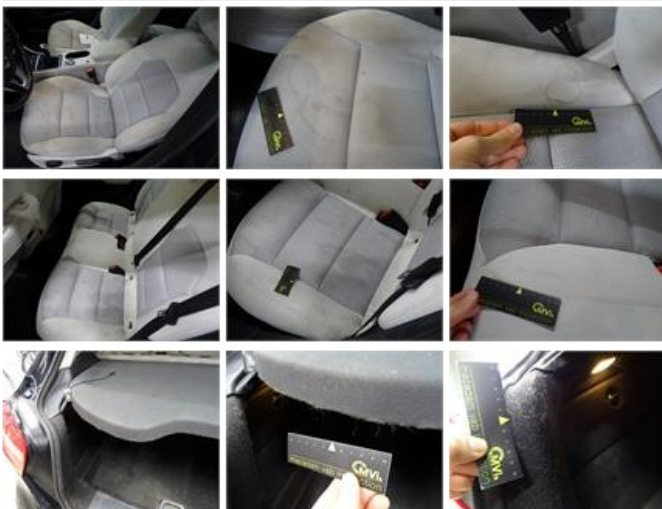
Interior, Dirty, Cleaning

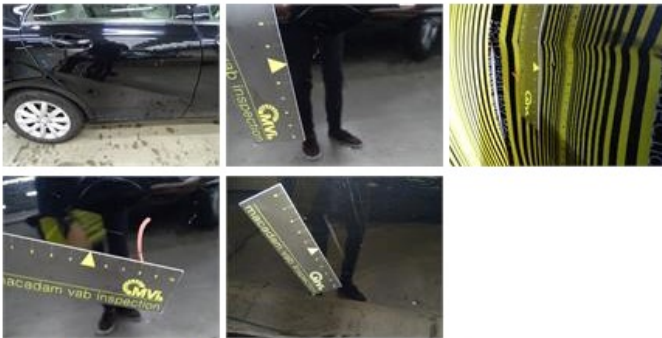
Door R R, Dent(s) and scratch(es), LI - Repair and paint (complete) 318,35

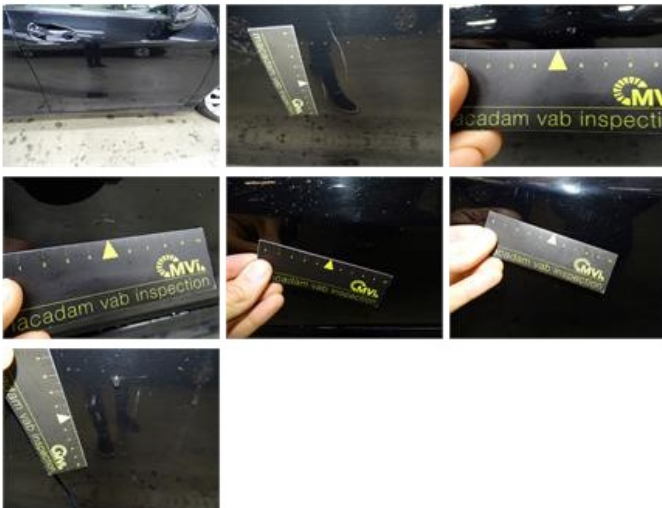
Door F R, Scratch(es), LI - Repair and paint (complete) 318,35

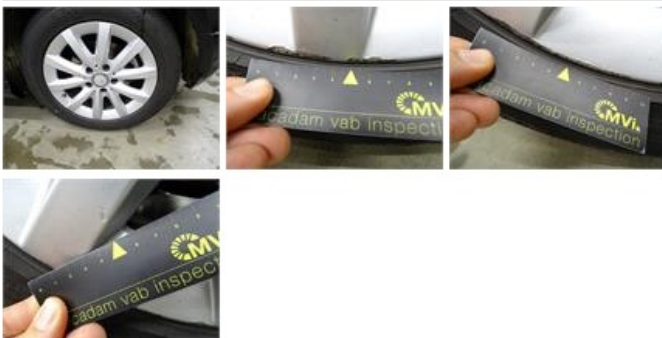
Alloy rim R L, Scratch(es), LI - Repair and paint (complete) 95,00

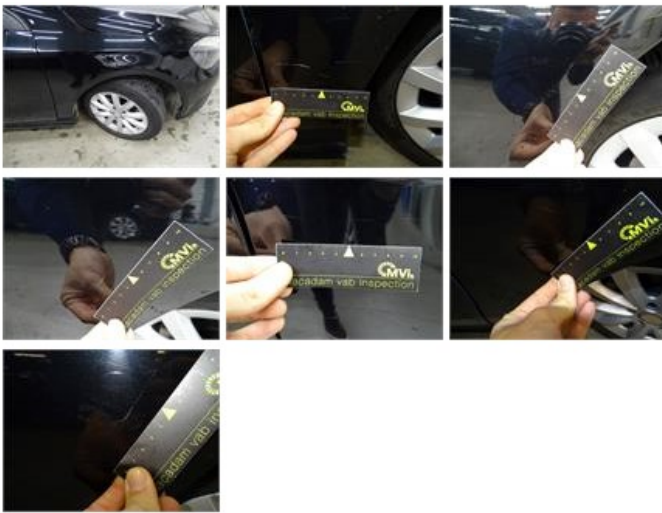
Wing F R, Scratch(es), LI - Repair and paint (complete) 220,18

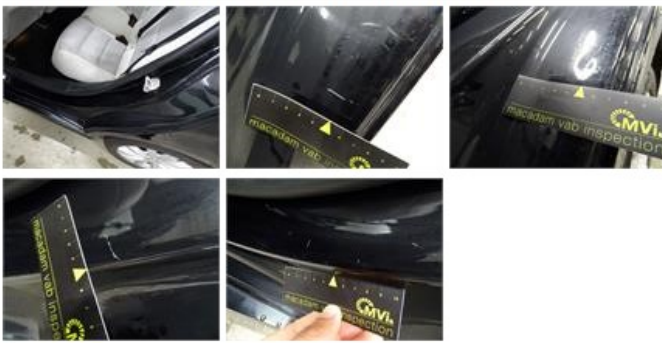
Rocker panel inner R L, Dent(s), LI - Repair and paint (complete) 115,56

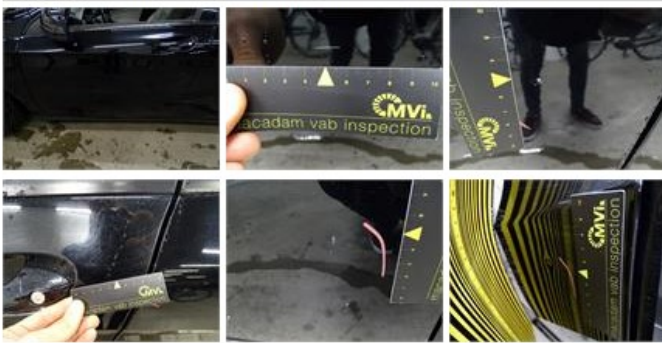
Door F L, Dent(s) and scratch(es), LI - Repair and paint (complete) 318,35

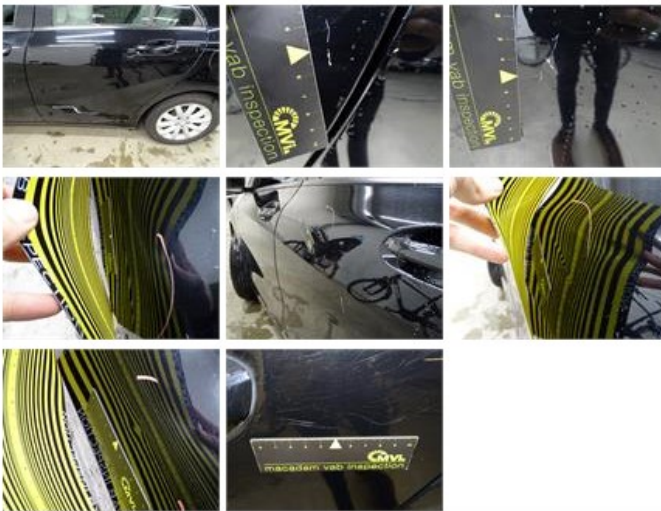
Door R L, Dent(s) and scratch(es), LI - Repair and paint (complete)

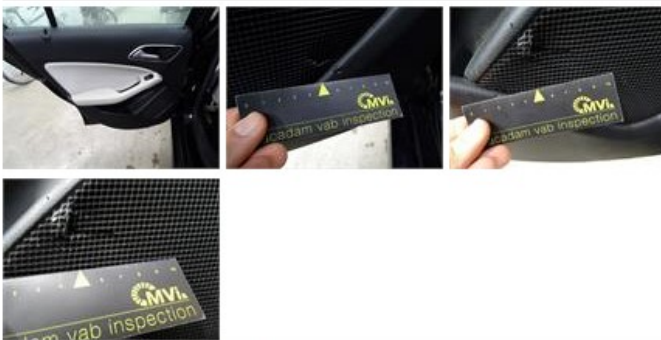
Speaker cover R L, Broken, E - Replace

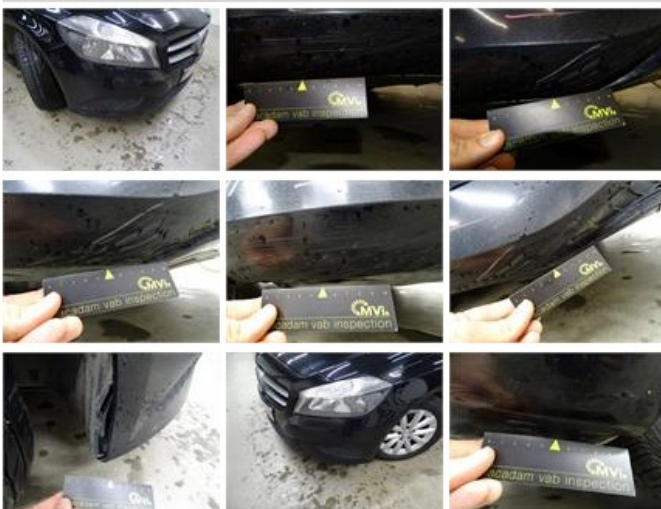
Bumper F, Scratch(es), LI - Repair and paint (complete)

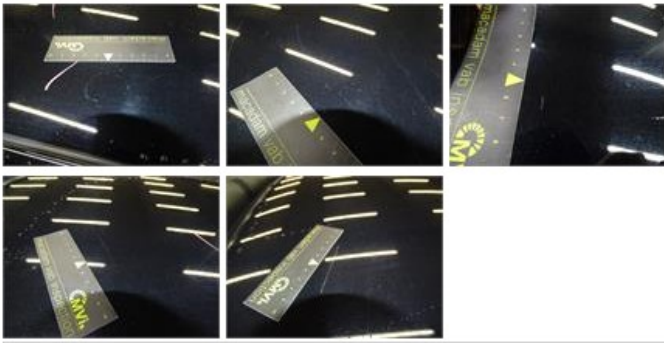
Roof, Dent(s) and scratch(es), LI - Repair and paint (complete)

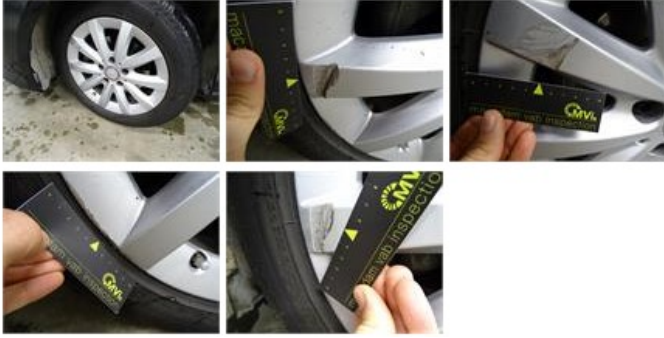
Alloy rim F L, Deformed / Strained, E - Replace
