MERCEDES C COUP?: ZM8125

Limited Technical Inspection

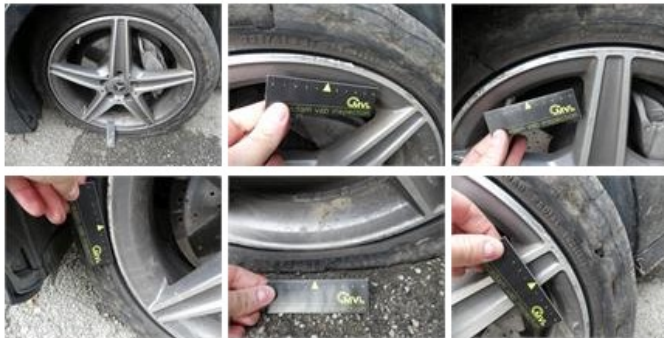
Alloy rim F L polished, Scratch(es), LI - Repair and paint (complete)

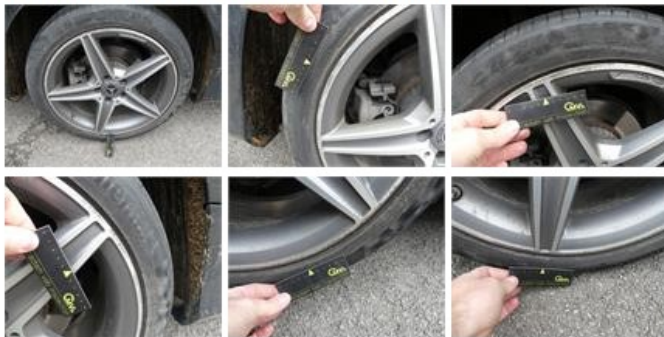
Alloy rim R R polished, Scratch(es), LI - Repair and paint (complete)

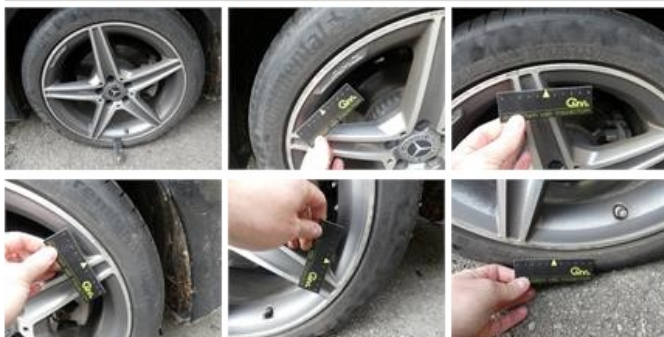
Alloy rim R L polished, Scratch(es), LI - Repair and paint (complete)

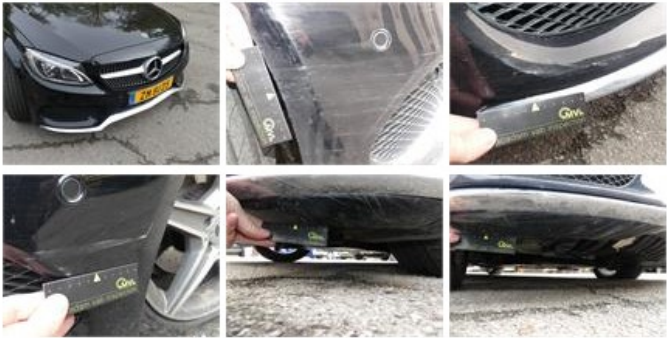
Bumper F, Scratch(es), LI - Repair and paint (complete)	211,80

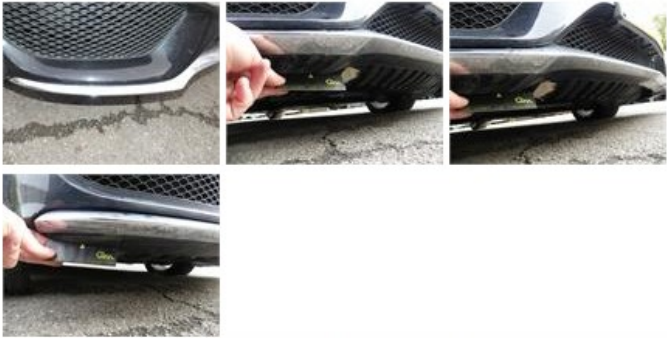
Bumper moulding F R, Scratch(es), E - Replace	14,40

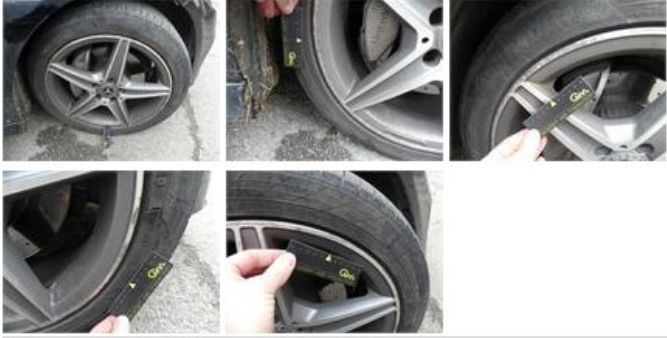
Alloy rim F R polished, Scratch(es), LI - Repair and paint (complete)	95,00

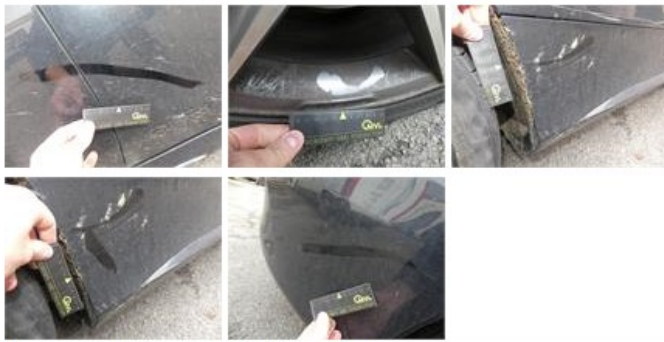
Bodywork, Dirty, P - Check

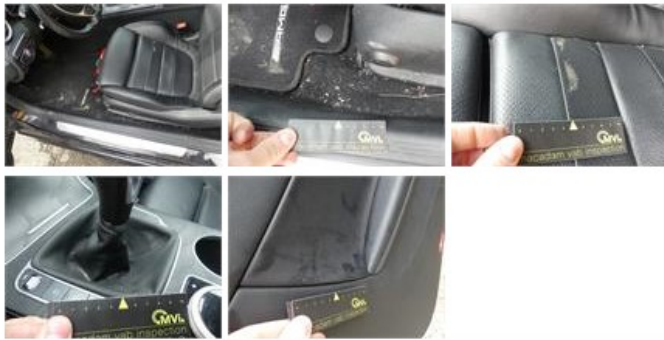
Interior, Dirty, Cleaning

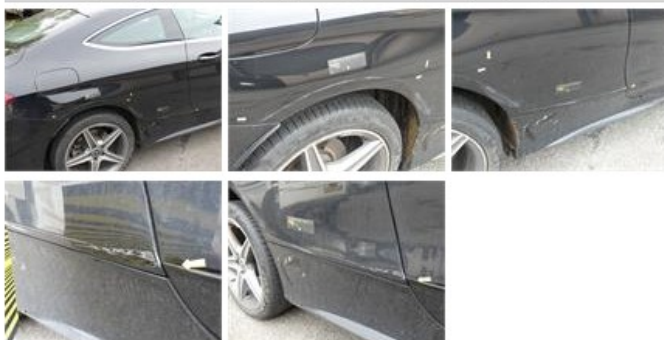
Wing R R, Dent(s) and scratch(es), LI - Repair and paint (complete)
