VOLVO V60: 1GKT057

Limited Technical Inspection

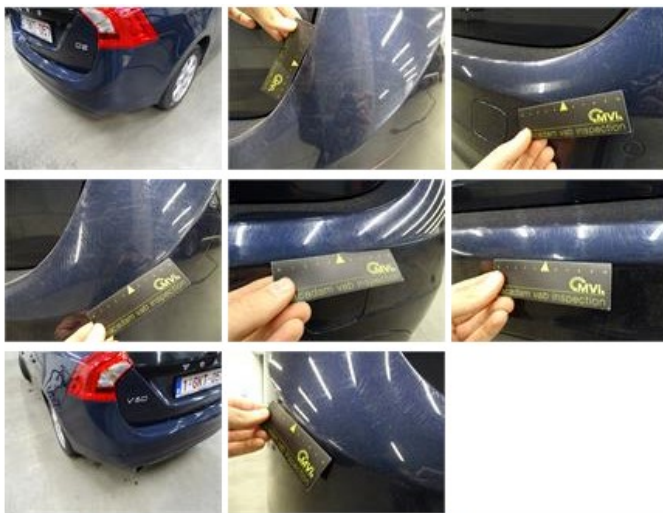
Total cost ex VAT	1209,24
Roof, Scratch(es), 67 - Polish	0,00
<i>No pictures to display</i>	
Bumper R, Scratch(es), LI - Repair and paint (complete)	211,80

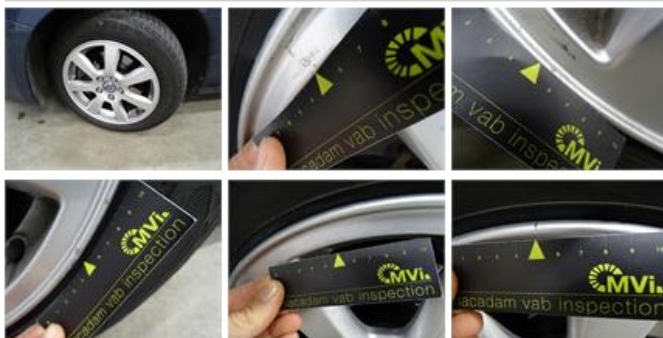
Alloy rim F L, Scratch(es), LI - Repair and paint (complete)

95,00

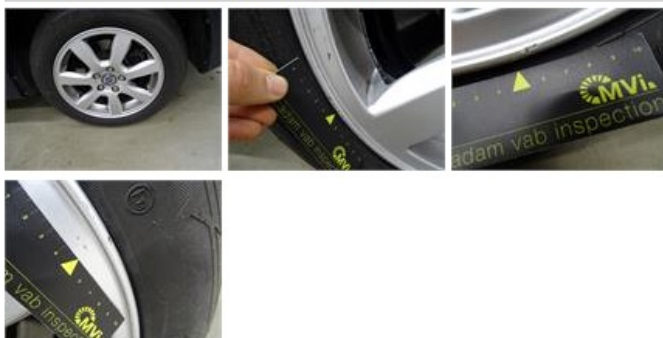
Alloy rim R L, Scratch(es), LI - Repair and paint (complete)

95,00

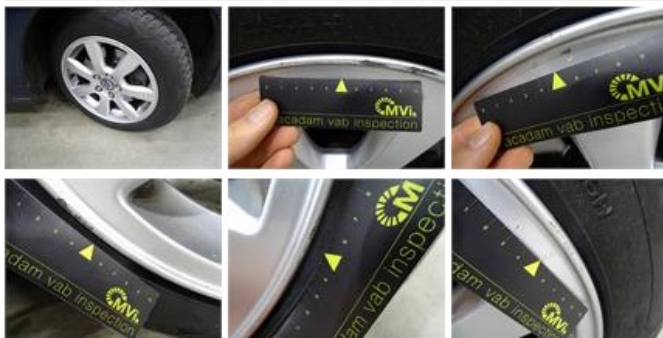
Alloy rim F R, Scratch(es), LI - Repair and paint (complete)

95,00

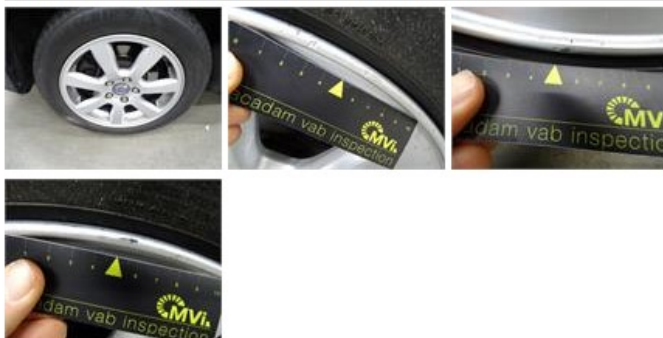
Alloy rim R R, Scratch(es), LI - Repair and paint (complete)

95,00

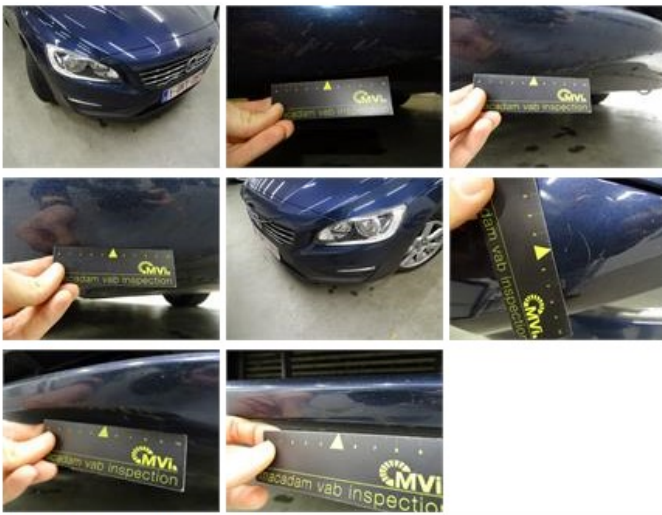
Bumper F, Scratch(es), LI - Repair and paint (complete)

211,80

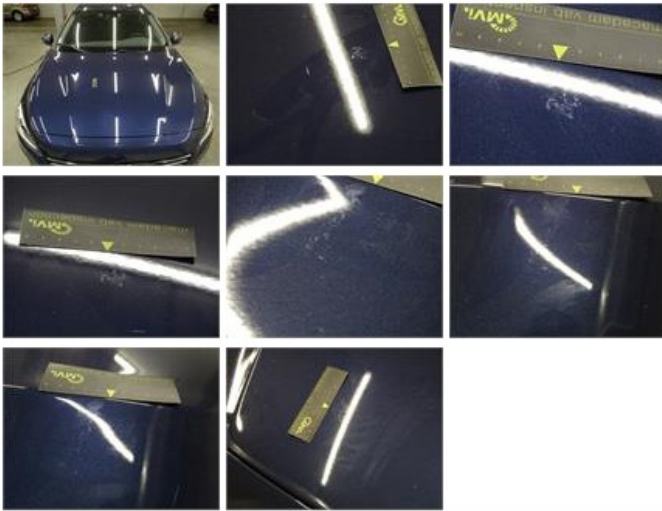
Bonnet, Chemical polution, LI - Repair and paint (complete) 290,08
