MERCEDES C COUP?: ZM8136

Limited Technical Inspection

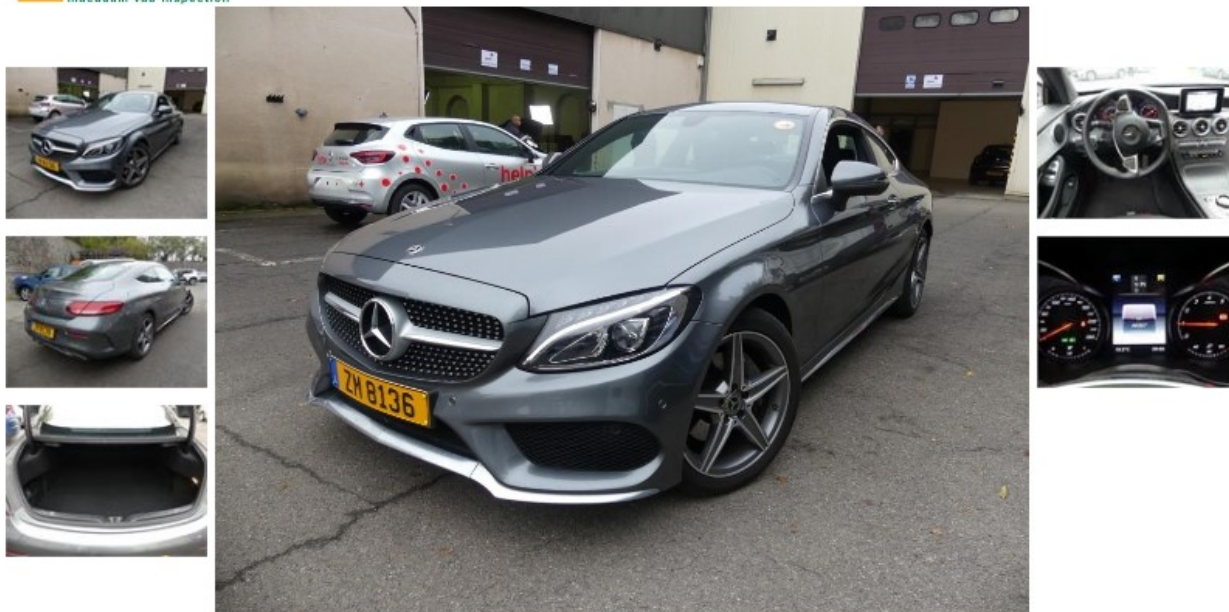
Repair kit	Yes	Compressor	Yes
Total cost ex VAT			278,20
Rear bulkhead lining, Scratch(es), Acceptable			0,00
