**OPEL CORSA: 1KAA144**

**Limited Technical Inspection**

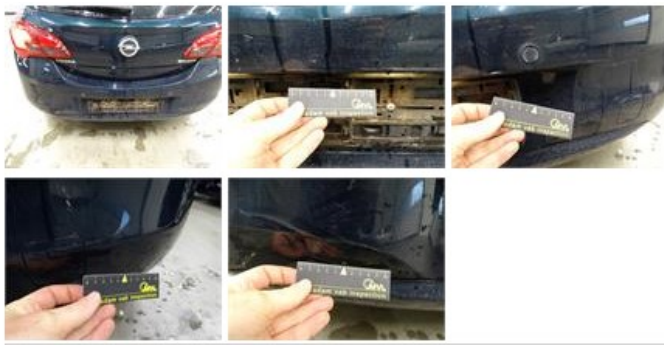
Total cost ex VAT	1394,64
Rearview mirror housing R, Scratch(es), Acceptable	0,00
<i>No pictures to display</i>	
Bumper R, Scratch(es), LI - Repair and paint (complete)	169,44

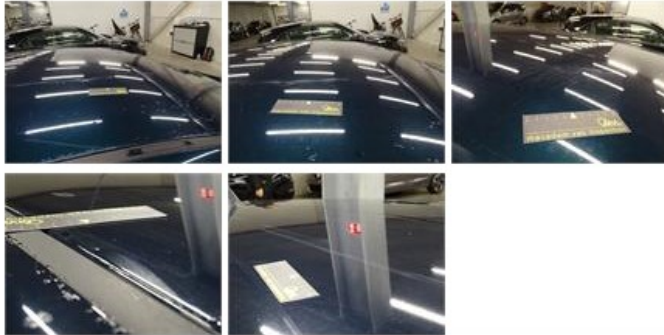
Roof, Dent(s) and scratch(es), LI - Repair and paint (complete) 385,20
