**PEUGEOT 308 SW: 1PBD008**

**Limited Technical Inspection**

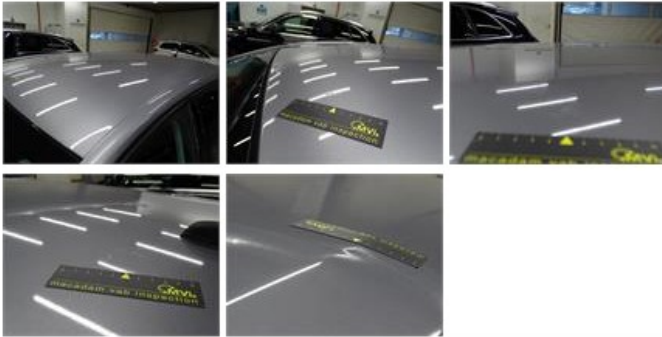
Roof, Chemical pollution, LI - Repair and paint (complete) 481,50
