MINI : 1PCU732			
Vinnumber:	WMWXN110X02A17123	Versionname:	1.5 ONE D
First Registrationdate:	7/06/2016	Fiscalpower:	
Expertise Mileage:	64170	Power Kw:	70
Bodytype:		Body color:	Black
Gearbox:	MAN 6 VIT	Paint type:	Metalic
Transmission:	Front	Rims summer:	Aluminium
Fueltype:	Diesel	Oil level:	OK
Battery functioning:	Yes	Parking lot:	3919
Number of doors:	3		
Number of seats:	4		
Number head rests:	4		
Rims summer:	Aluminium		
Category:	Passenger Car		
Oil level:	OK		
Registration Certificate Car (BE):	Yes

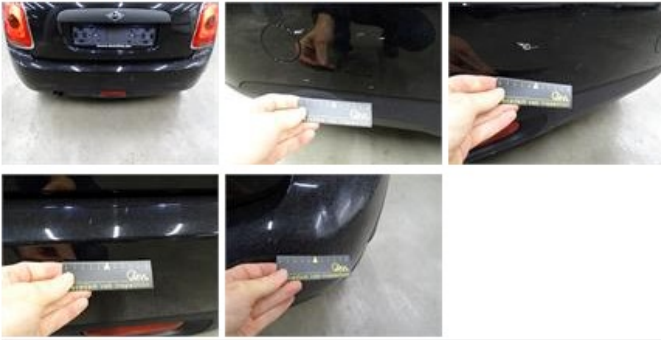
Bumper R, Scratch(es), LI - Repair and paint (complete) 211,80
