**RENAULT Clio: 1HRB321**

Vinnumber:	<b>VF15RJL0H51404015</b>	Versionname:	<b>CLIO IV BER e-Business St&amp;St 90PK</b>
First Registrationdate:	<b>10/09/2014</b>	Fiscalpower:	
Expertise Mileage:	<b>89349</b>	Power Kw:	<b>66</b>
Bodytype:		Body color:	<b>Red</b>
Gearbox:	<b>MAN 5 VIT</b>	Paint type:	<b>Metalic</b>
Transmission:	<b>Front</b>	Rims summer:	<b>Steel</b>
Fueltype:	<b>Diesel</b>	Oil level:	<b>OK</b>
Battery functioning:	<b>Yes</b>	Parking lot:	<b>4629</b>
Number of doors:	<b>5</b>		
Number of seats:	<b>5</b>		
Number head rests:	<b>4</b>		
Rims summer:	<b>Steel</b>		
Category:	<b>Passenger Car</b>		
Oil level:	<b>OK</b>		
Registration Certificate Car (BE):	<b>Yes</b>

**Limited Technical Inspection**

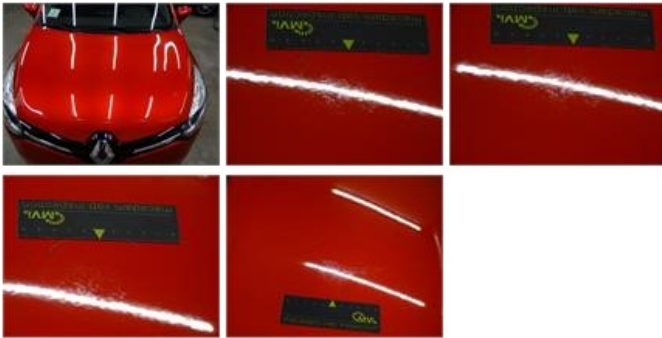
Bonnet, Chemical polution, LI - Repair and paint (complete) 232,06

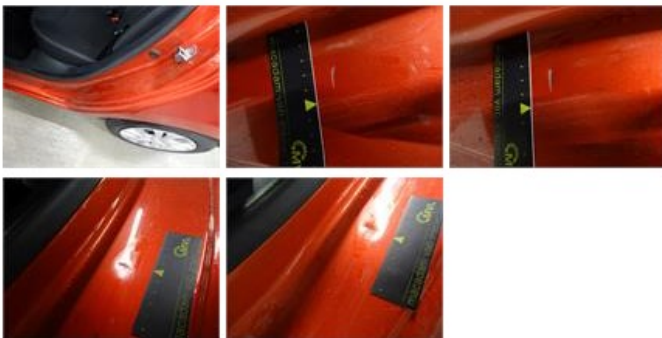
Rocker panel inner R L, Dent(s), LI - Repair and paint (complete) 115,56

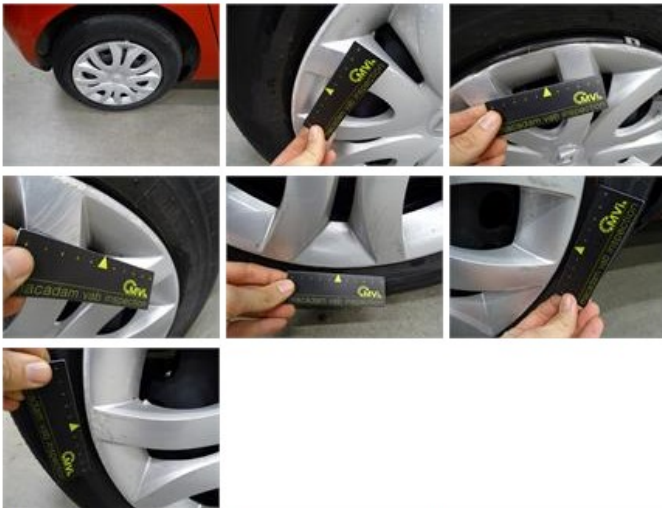
Wheel cover R R, Scratch(es), E - Replace 24,00

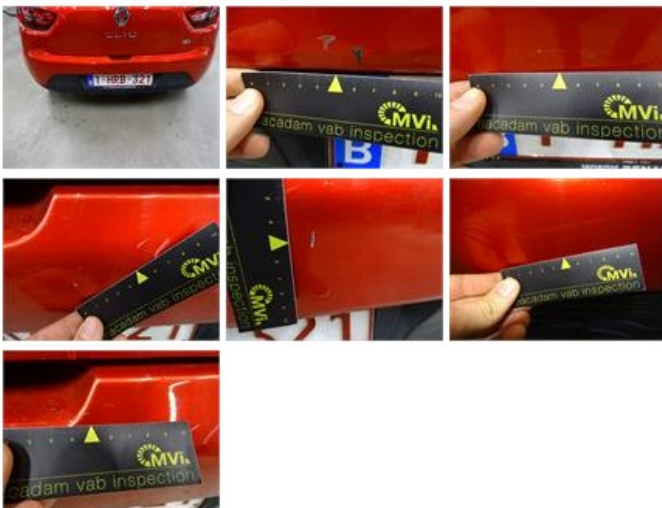
Bumper R, Scratch(es), LI - Repair and paint (complete) 169,44

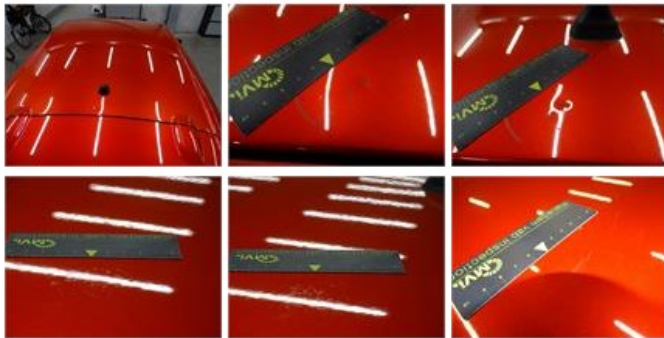
Roof, Dent(s) and scratch(es), LI - Repair and paint (complete)

385,20

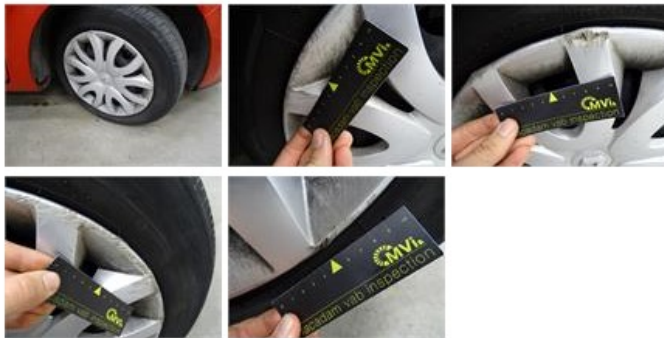
Wheel cover F R, Scratch(es), E - Replace

24,00

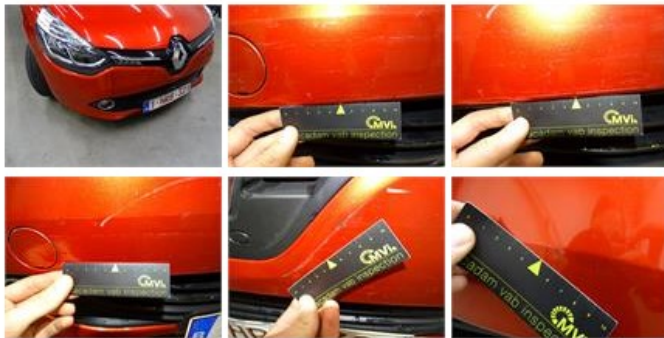
Bumper F, Scratch(es), LI - Repair and paint (complete)

169,44

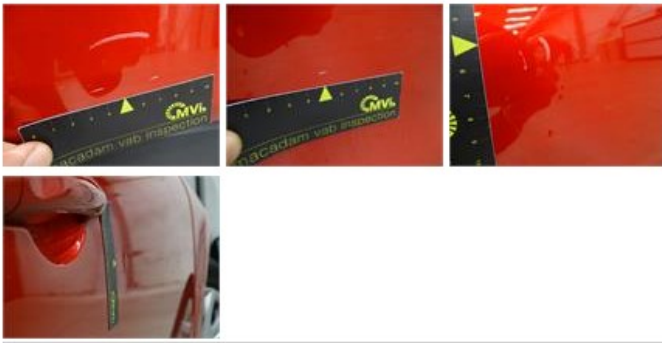
Door F R, Dent(s) and scratch(es), LI - Repair and paint (complete)

254,68

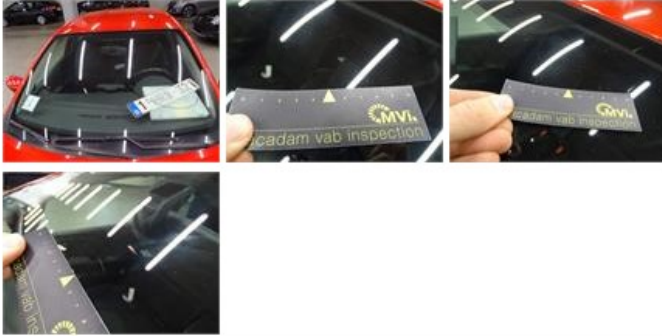
Windscreen, Scratch(es), Acceptable 0,00
