VOLVO V40: 1KFE517

Limited Technical Inspection

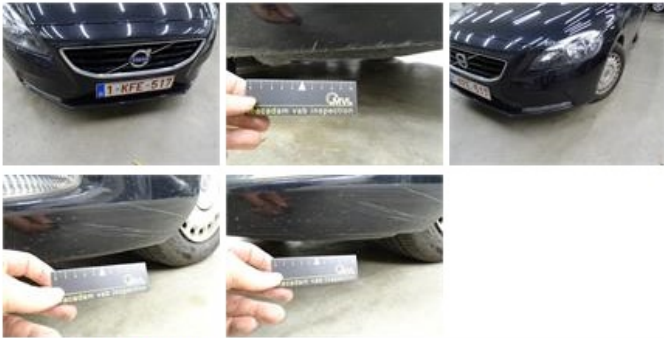
Wheel cover F L, Scratch(es), Acceptable	0,00
<i>No pictures to display</i>	
Wheel cover R L, Scratch(es), Acceptable	0,00
<i>No pictures to display</i>	
Bumper F, Scratch(es), LI - Repair and paint (complete)	211,80
