**BMW 1: 1HYU796**

Vinnumber:	<b>WBA1C91070P873828</b>	Versionname:	<b>1 HATCH 116d Eff.Dyn.Ed. 116PK</b>
First Registrationdate:	<b>31/10/2014</b>	Fiscalpower:	
Expertise Mileage:	<b>62071</b>	Power Kw:	<b>85</b>
Bodytype:	<b>Hatchback</b>	Body color:	<b>Black</b>
Gearbox:	<b>MAN 6 VIT</b>	Paint type:	<b>Metalic</b>
Transmission:	<b>Back</b>	Rims summer:	<b>Aluminium</b>
Fueltype:	<b>Diesel</b>	Oil level:	<b>OK</b>
Battery functioning:	<b>Yes</b>	Parking lot:	<b>4829</b>
Number of doors:	<b>5</b>		
Number of seats:	<b>5</b>		
Number head rests:	<b>5</b>		
Rims summer:	<b>Aluminium</b>		
Category:	<b>Passenger Car</b>		
Oil level:	<b>OK</b>		
Registration Certificate Car (BE):	<b>Yes</b>

**Limited Technical Inspection**

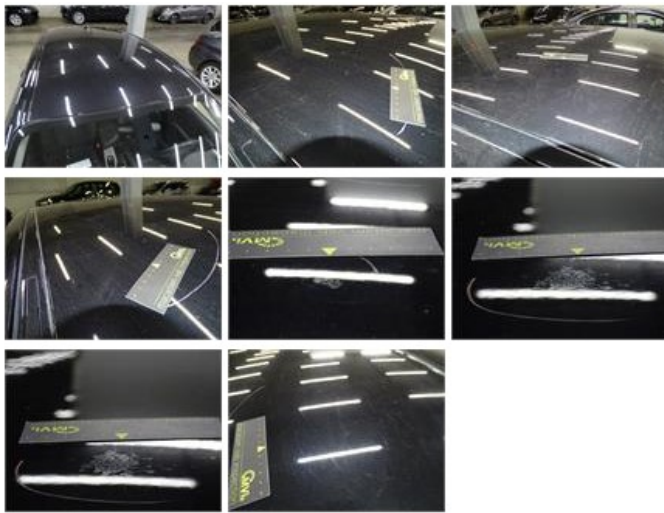
Total cost ex VAT	1395,49
Roof, Chemical polution, LI - Repair and paint (complete)	481,50

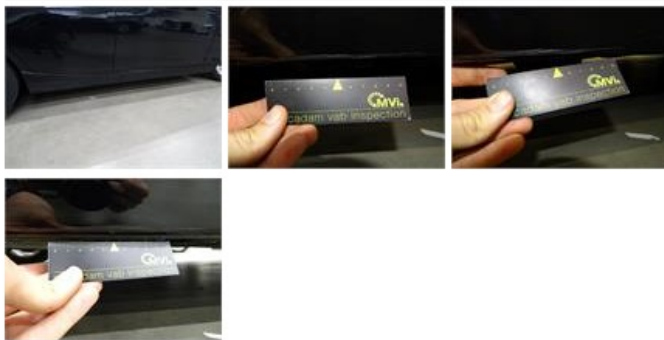
Sill outer R, Scratch(es), It - Spot repair

115,56

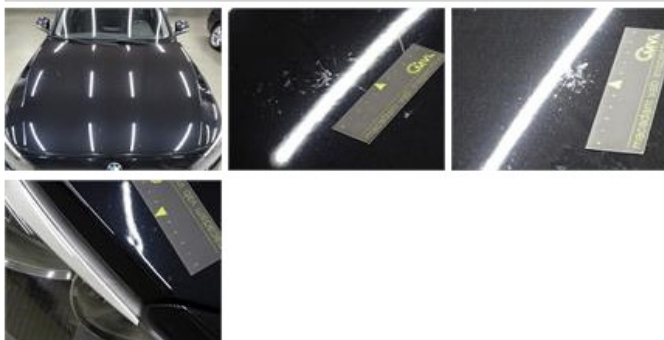
Bonnet, Chemical pollution, LI - Repair and paint (complete)

290,08

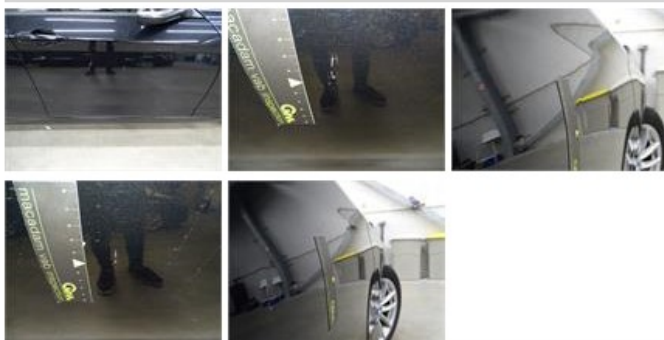
Door F R, Dent(s) and scratch(es), LI - Repair and paint (complete)

318,35
