OPEL Zafira: 1HSF082

Limited Technical Inspection

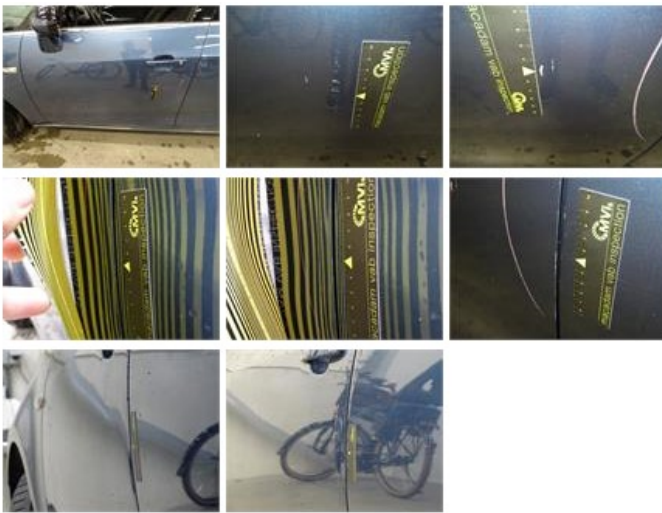
Total cost ex VAT	1385,77
Door F L, Dent(s) and scratch(es), LI - Repair and paint (complete)	318,35

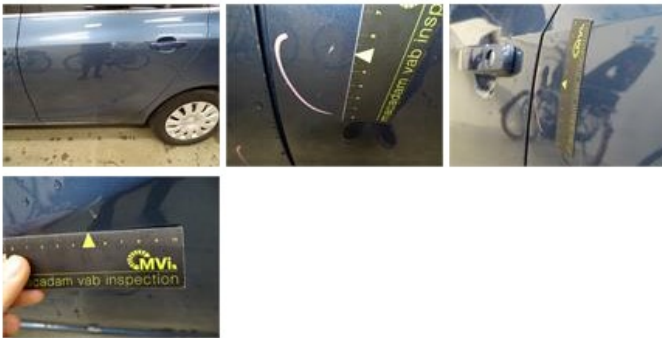
Wing R L, Dent(s), Acceptable	0,00
<i>No pictures to display</i>	
Door R R, Dent(s), Acceptable	0,00
<i>No pictures to display</i>	
Tailgate, Scratch(es), Acceptable	0,00
<i>No pictures to display</i>	
Wing F R, Repaired, Acceptable	0,00
<i>No pictures to display</i>	
Door R L, Dent(s) and scratch(es), LI - Repair and paint (complete)	318,35

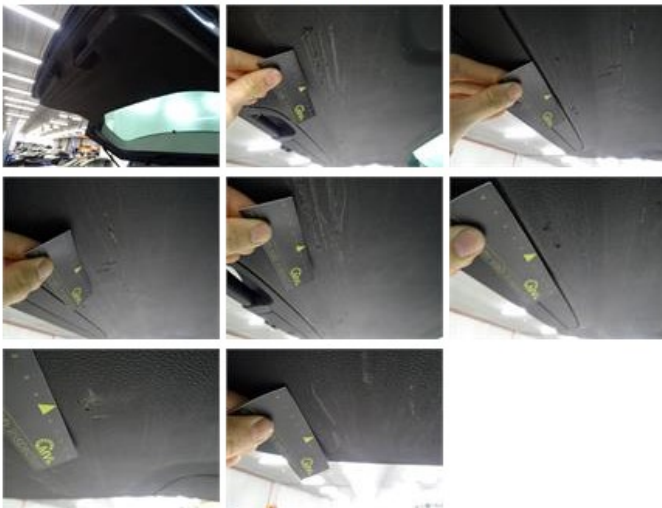
Trunk lid covering R, Scratch(es), Smart repair	110,64
---	--------

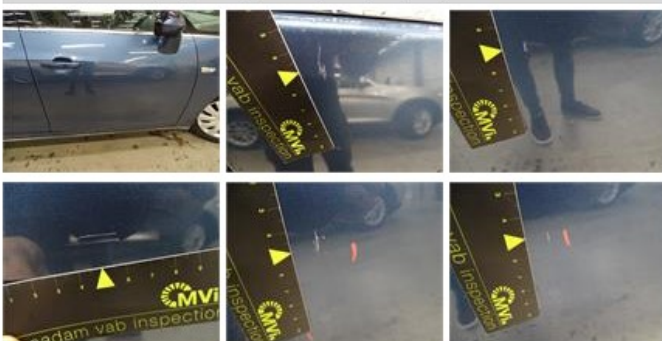
Bumper F, Scratch(es), Acceptable	0,00
<i>No pictures to display</i>	
Door F R, Scratch(es), LI - Repair and paint (complete)	318,35

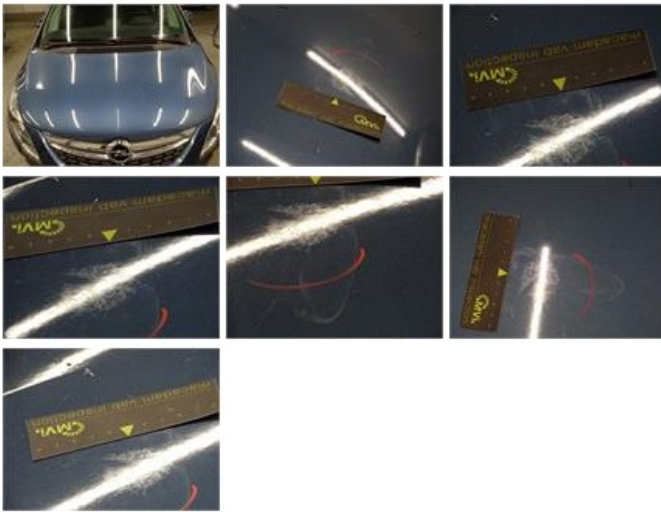
Bonnet, Chemical polution, LI - Repair and paint (complete) 290,08
