BMW 2 ACTIVE TOURER: 1LJR084

Limited Technical Inspection

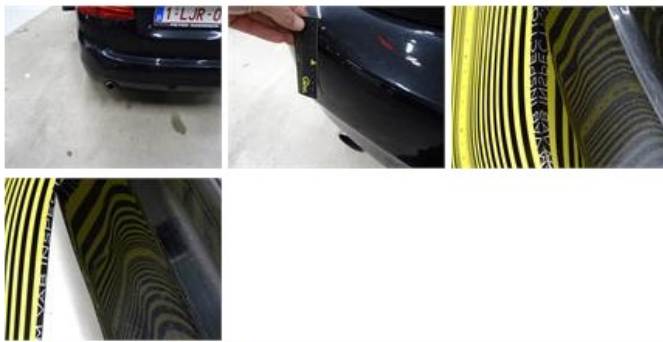
Bumper R, Dent(s) and scratch(es), H. Repair and paint (complete)	244,00
--	---------------
