SKODA FABIA COMBI: 1KUC026

Limited Technical Inspection

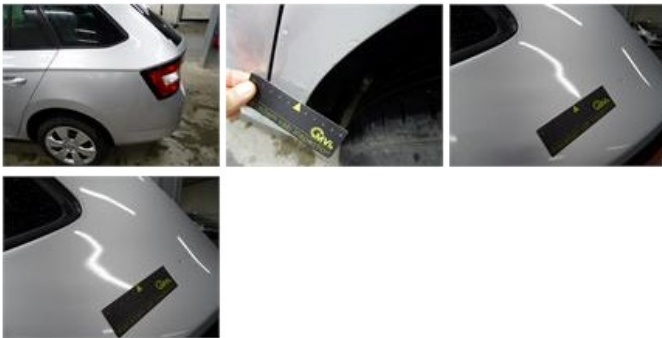
Wing R L, Bad repair, Acceptable

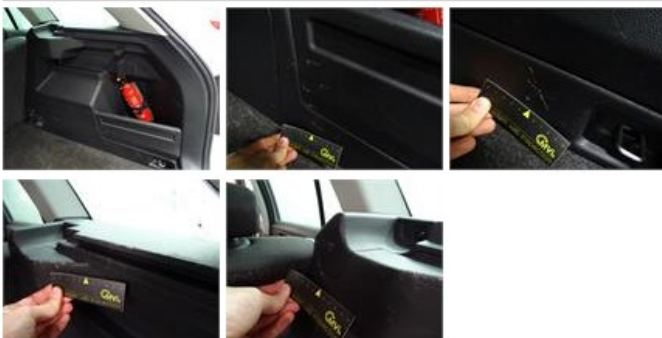
Internal Boot Lining R, Scratch(es), Smart repair

110,64

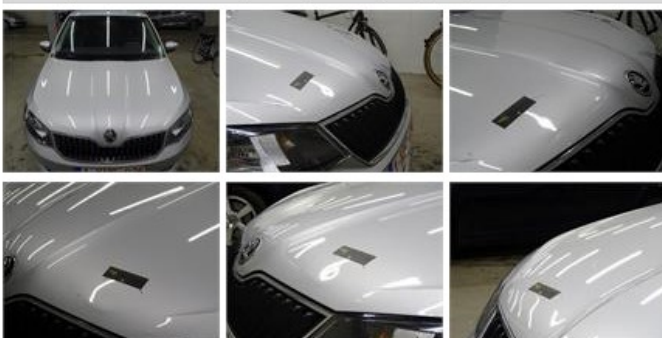
Bonnet, Deformed / Strained, LI - Repair and paint (complete)

232,06

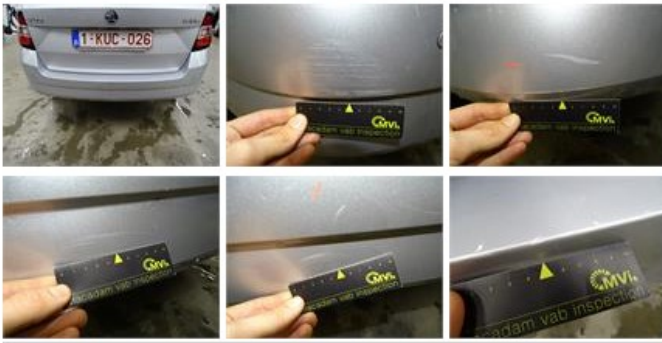
Bumper R, Scratch(es), LI - Repair and paint (complete) 169,44
