BMW 3: 1HTP604			
Vinnumber:	WBA3K91030F935937	Versionname:	3 TOURING 316d 116PK
First Registrationdate:	30/09/2014	Fiscalpower:	
Expertise Mileage:	57062	Power Kw:	85
Bodytype:		Body color:	Grey
Gearbox:	MAN 6 VIT	Paint type:	Metalic
Transmission:	Back	Rims summer:	Aluminium
Fueltype:	Diesel	Oil level:	OK
Battery functioning:	Yes	Parking lot:	3721
Number of doors:	5		
Number of seats:	5		
Number head rests:	5		
Rims summer:	Aluminium		
Category:	Passenger Car		
Oil level:	OK		
Registration Certificate Car (BE):	Yes

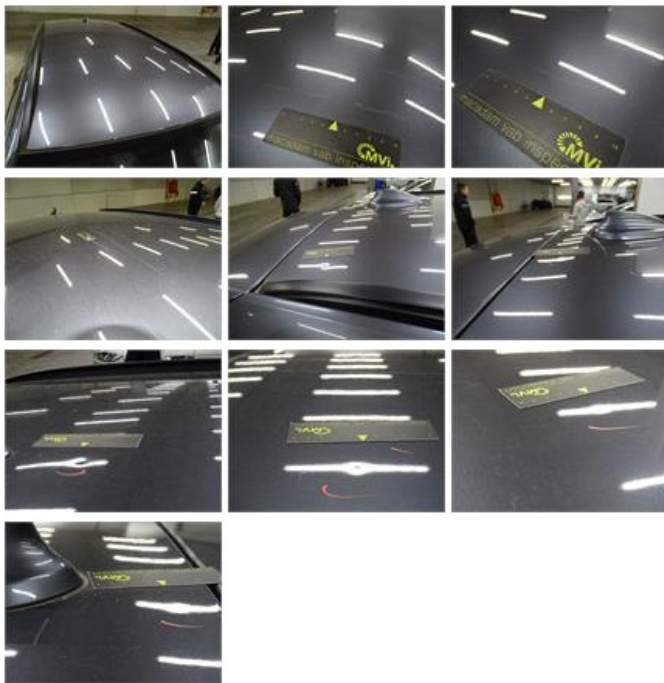
Total cost ex VAT	1952,58
Roof, Dent(s) and scratch(es), LI - Repair and paint (complete)	529,50

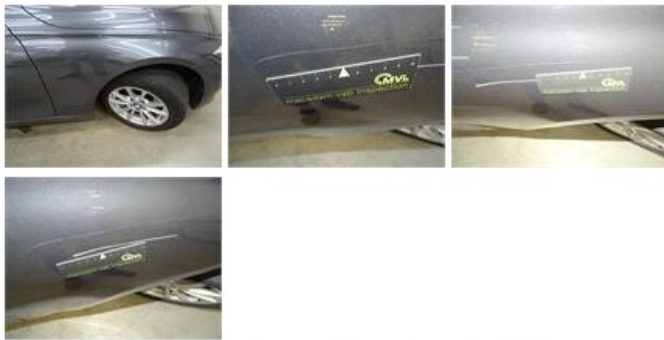
Wing F R, Scratch(es), LI - Repair and paint (complete) 220,18

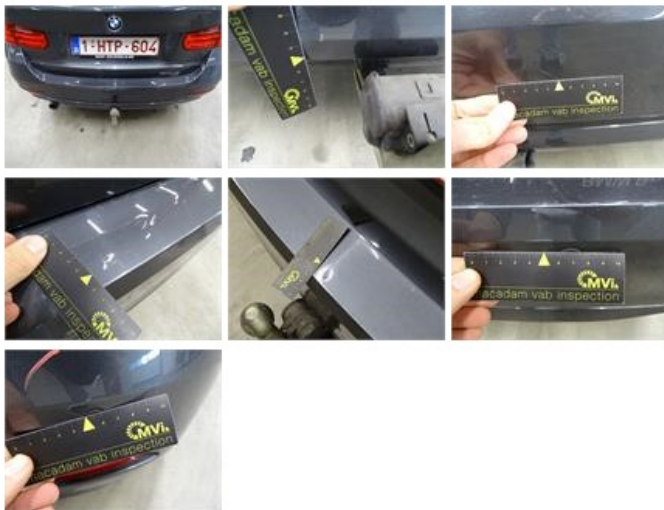
Bumper R, Dent(s) and scratch(es), LI - Repair and paint (complete) 211,80

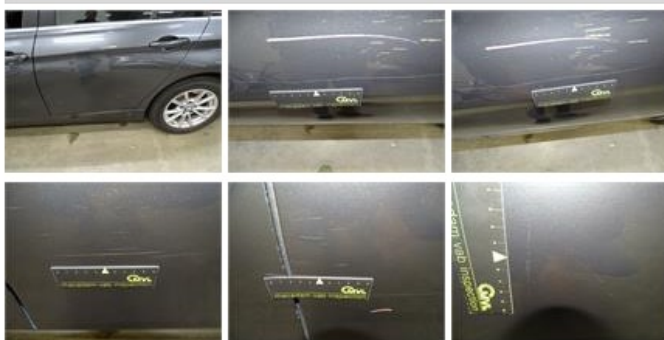
Door R L, Scratch(es), LI - Repair and paint (complete) 318,35

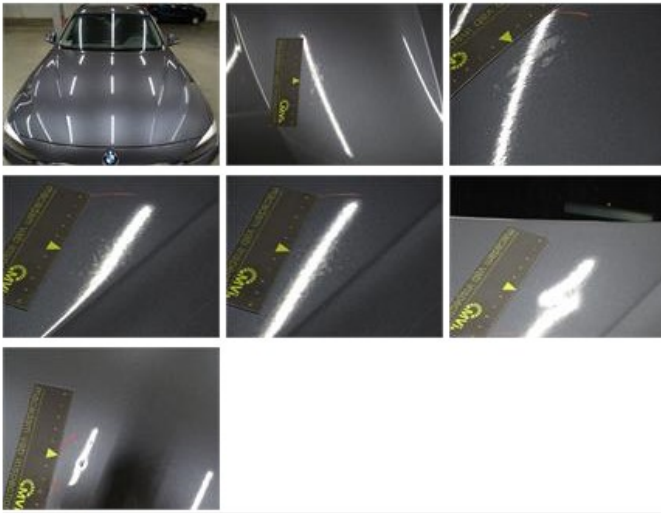
Bonnet, Chemical polution, LI - Repair and paint (complete) 290,08
