| BMW 5: 1HXJ245 | | | |
| Vinnumber: | WBA5L11090D785786 | Versionname: | 5 TOURING 518d 136PK |

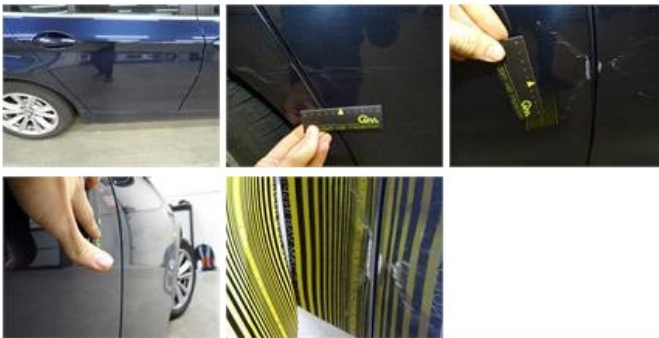
Door R R, Dent(s) and scratch(es), LI - Repair and paint (complete)

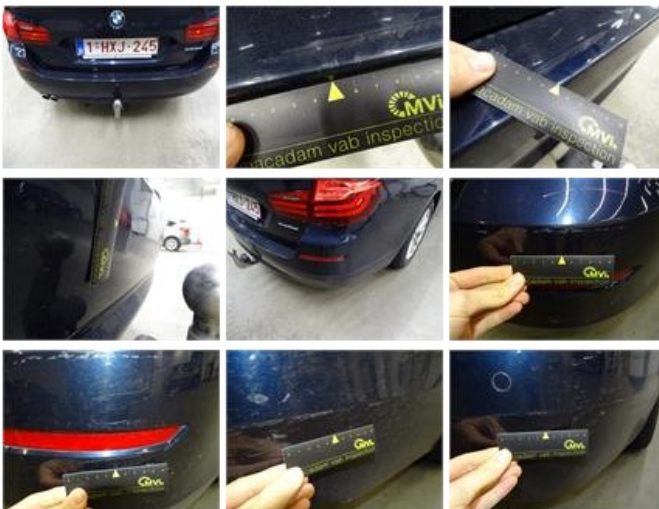
Bumper R, Dent(s) and scratch(es), LI - Repair and paint (complete)

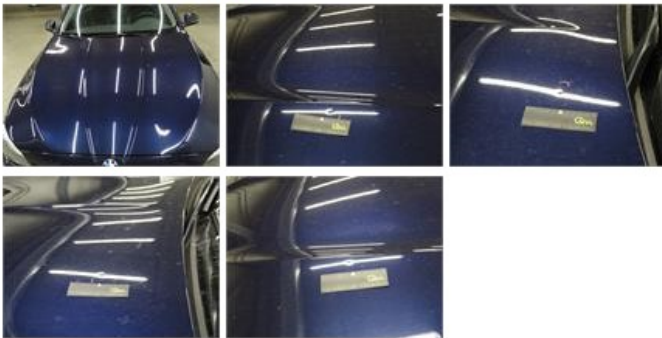
Bonnet, Hail damage, PDR - Hail 200,00

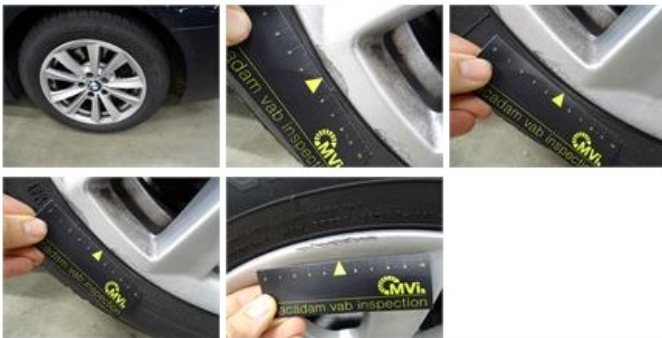
Alloy rim R L, Scratch(es), LI - Repair and paint (complete) 95,00

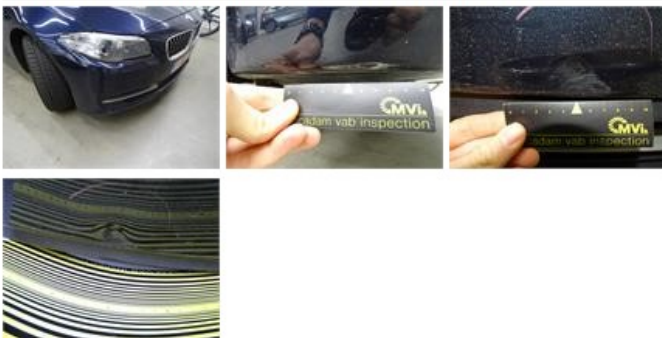
Bumper F, Dent(s) and scratch(es), LI - Repair and paint (complete) 254,16

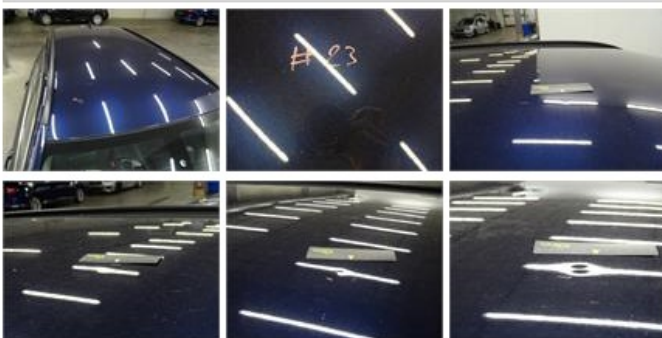
Roof, Hail damage, PDR - Hail 575,00
