BMW 3 GRAN TURISMO: 1KXV395

Limited Technical Inspection

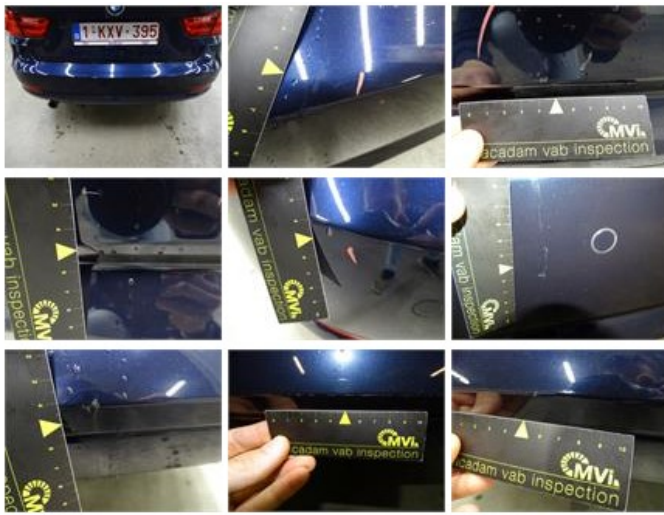
Total cost ex VAT	1570,06
Bumper R, Dent(s) and scratch(es), LI - Repair and paint (complete)	211,80

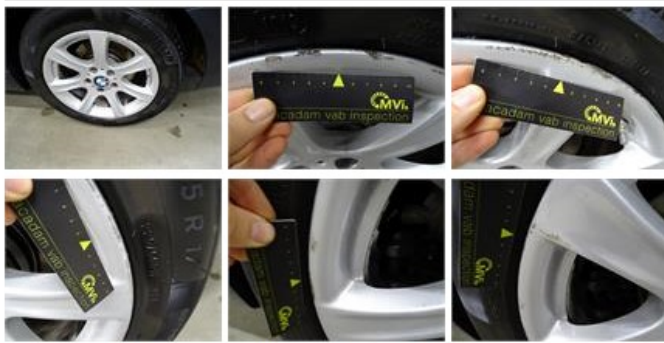
Alloy rim F R, Scratch(es), Acceptable	0,00
<i>No pictures to display</i>	
Wing R L, Dent(s) and scratch(es), Acceptable	0,00
<i>No pictures to display</i>	
Alloy rim R L, Scratch(es), LI - Repair and paint (complete)	95,00

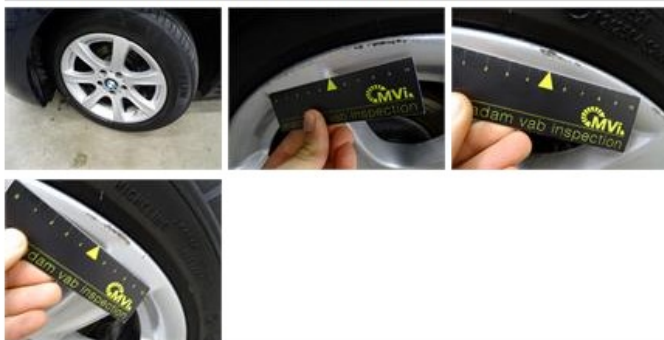
Alloy rim F L, Scratch(es), LI - Repair and paint (complete)	95,00
--	-------

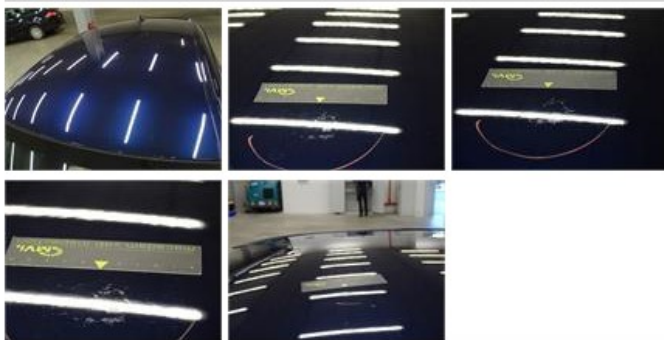
Roof, Chemical polution, LI - Repair and paint (complete)	481,50
---	--------

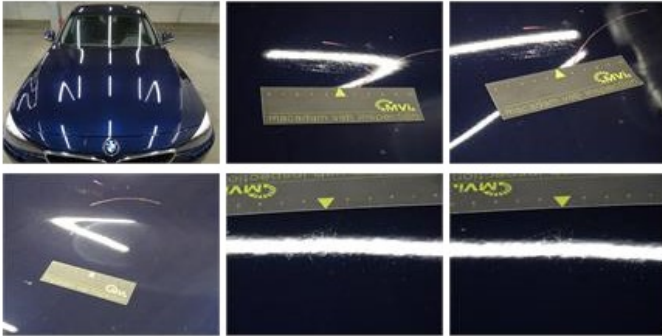
Bonnet, Chemical polution, LI - Repair and paint (complete) 290,08

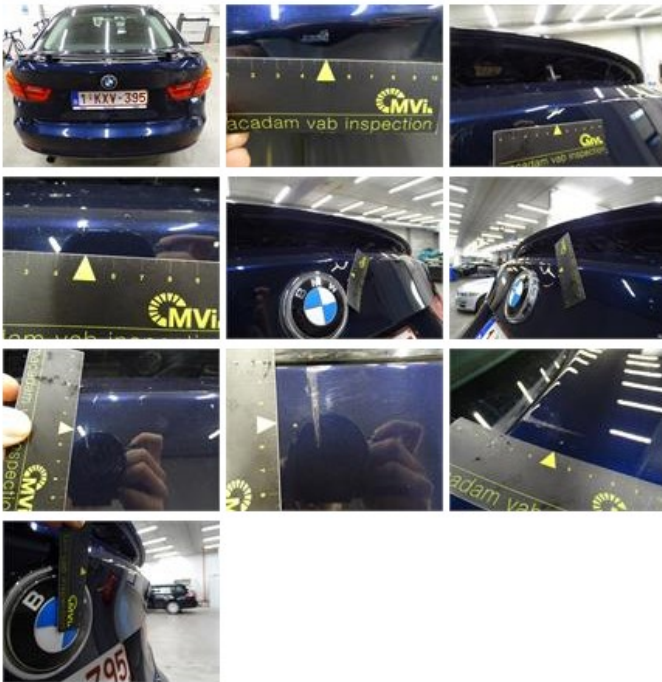
Tailgate, Dent(s) and scratch(es), LI - Repair and paint (complete) 301,68
