LAND ROVER RANGE ROVER SPORT: CM7014

Limited Technical Inspection

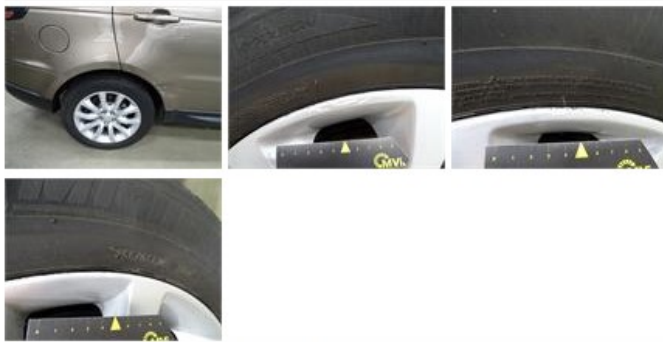
Alloy rim R R, Scratch(es), LI - Repair and paint (complete)
