MERCEDES A: 1KCV977

Limited Technical Inspection

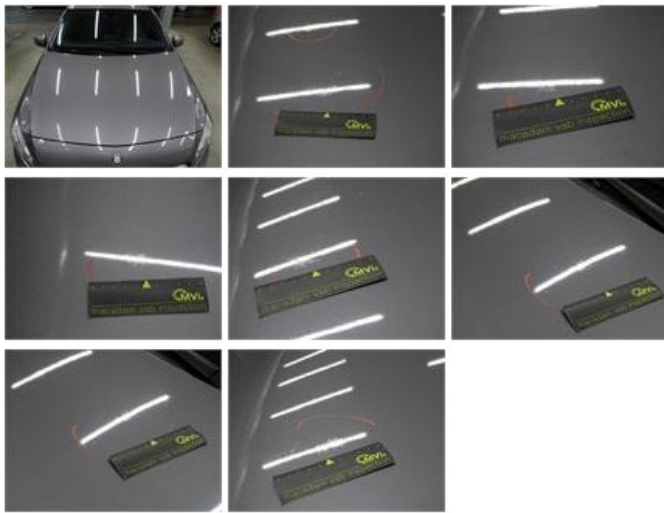
Total cost ex VAT	3370,14
Bonnet, Chemical polution, LI - Repair and paint (complete)	290,08

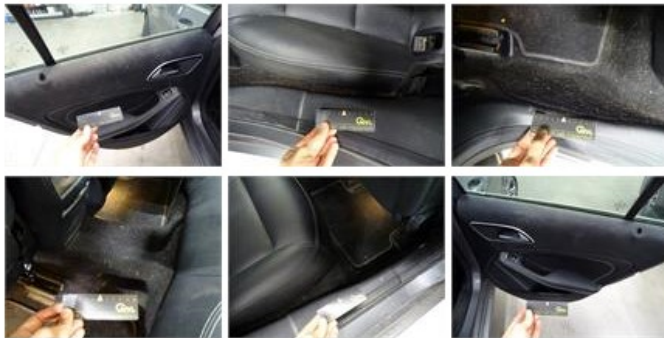
Interior, Dirty, Cleaning 50,00

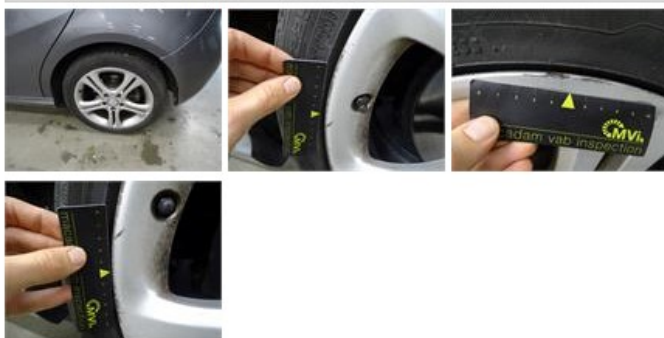
Alloy rim R L, Scratch(es), LI - Repair and paint (complete) 95,00

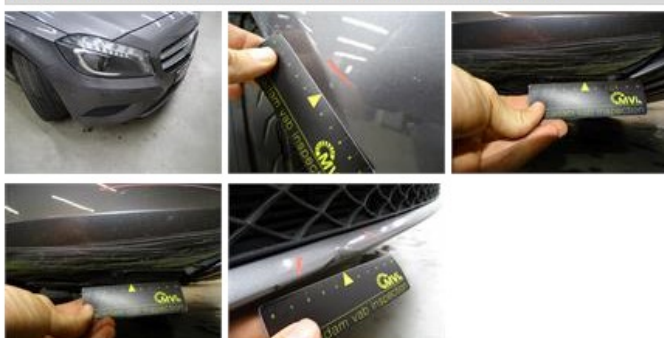
Bumper F, Dent(s) and scratch(es), LI - Repair and paint (complete) 211,80

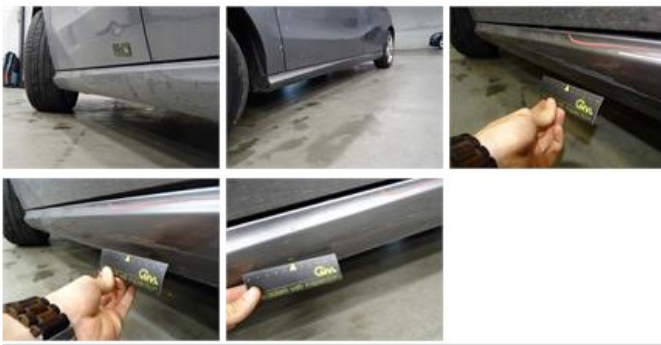
Sill outer L, Scratch(es), LI - Repair and paint (complete) 310,50

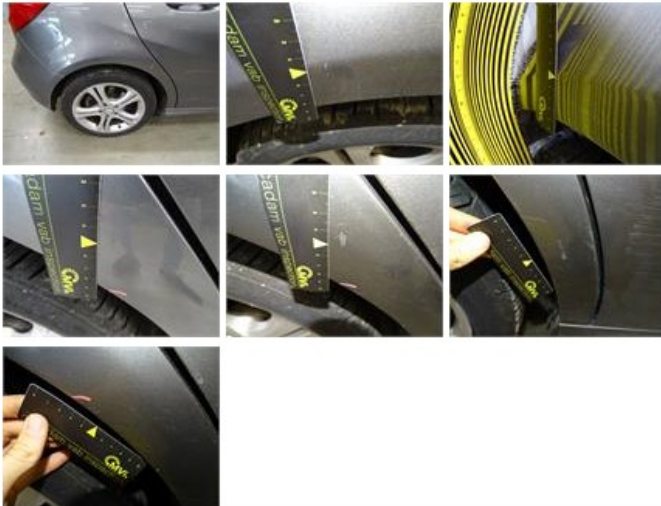
Wing R R, Dent(s) and scratch(es), LI - Repair and paint (complete) 308,20

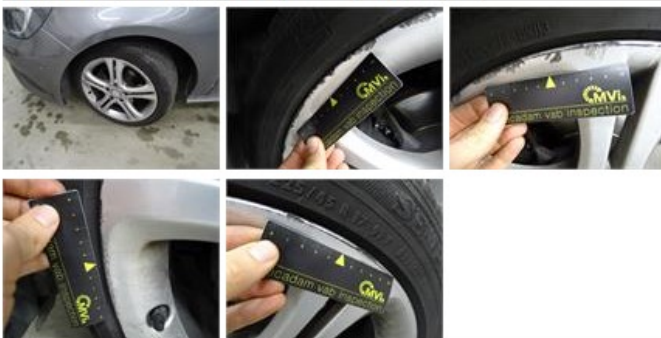
Alloy rim F L, Scratch(es), LI - Repair and paint (complete) 95,00

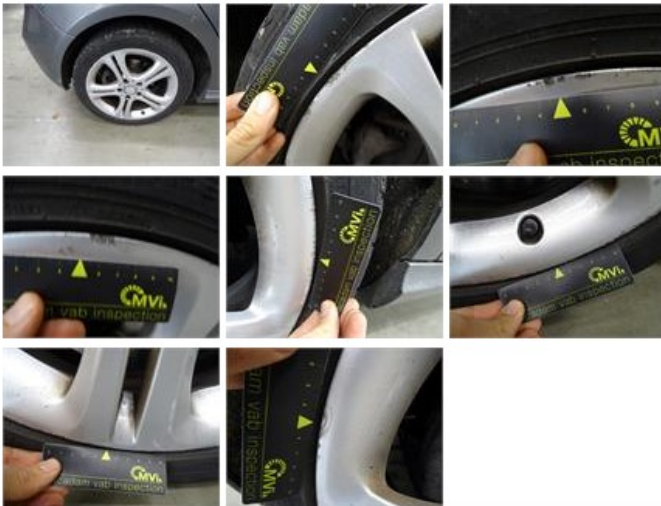
Alloy rim R R, Scratch(es), LI - Repair and paint (complete) 95,00

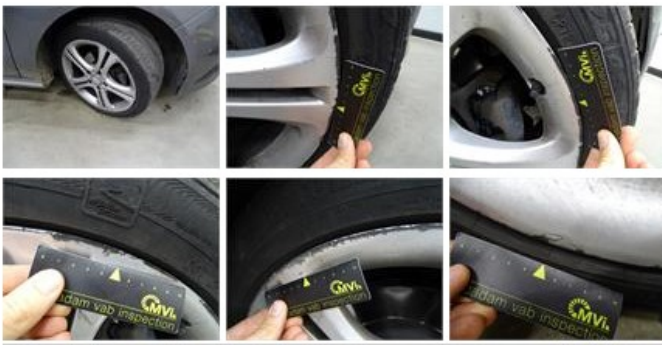
Alloy rim F R, Scratch(es), LI - Repair and paint (complete) 95,00

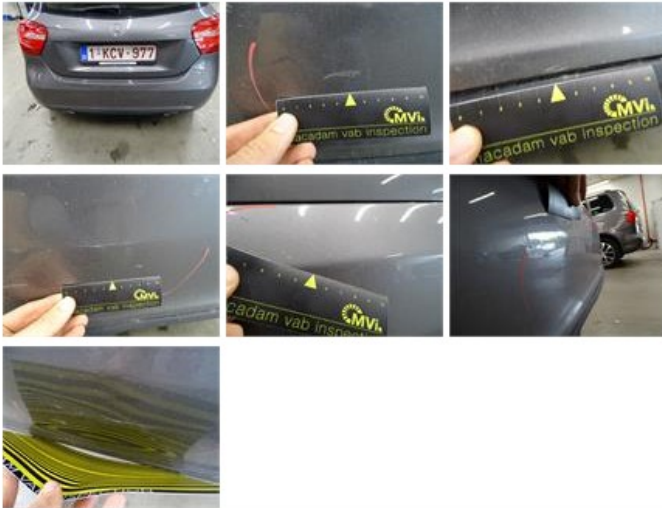
Bumper R, Dent(s) and scratch(es), LI - Repair and paint (complete) 211,80

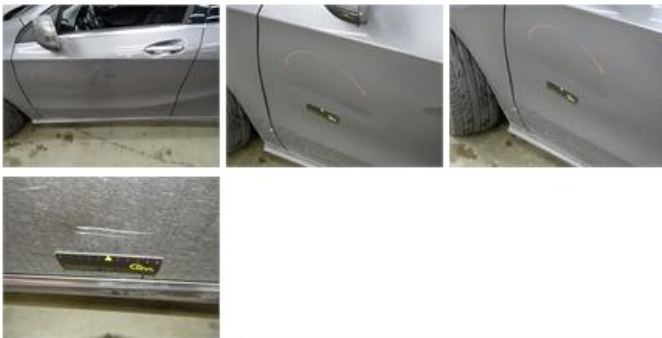
Door F L, Dent(s) and scratch(es), LI - Repair and paint (complete) 390,35

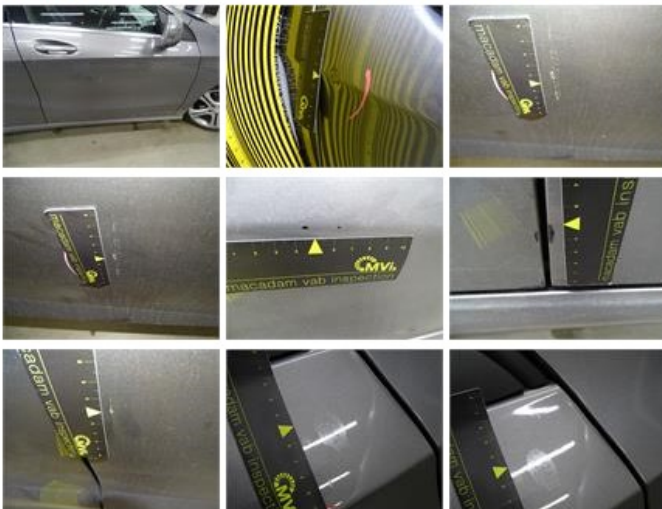
Door F R, Dent(s) and scratch(es), LI - Repair and paint (complete) 318,35
