**MERCEDES CLA: 1JVG822**

Vinnumber:	<b>WDD1173121N188607</b>	Versionname:	<b>1.5 CLA 180 CDI</b>
First Registrationdate:	<b>5/03/2015</b>	Fiscalpower:	
Expertise Mileage:	<b>61292</b>	Power Kw:	<b>80</b>
Bodytype:		Body color:	<b>Brown</b>
Gearbox:	<b>MAN 6 VIT</b>	Paint type:	<b>Metalic</b>
Transmission:	<b>Front</b>	Rims summer:	<b>Aluminium</b>
Fueltype:	<b>Diesel</b>	Oil level:	<b>OK</b>
Battery functioning:	<b>Yes</b>	Parking lot:	<b>LCV</b>
Number of doors:	<b>4</b>		
Number of seats:	<b>5</b>		
Number head rests:	<b>1</b>		
Rims summer:	<b>Aluminium</b>		
Category:	<b>Passenger Car</b>		
Oil level:	<b>OK</b>		
Registration Certificate Car (BE):	<b>Yes</b>

**Limited Technical Inspection**

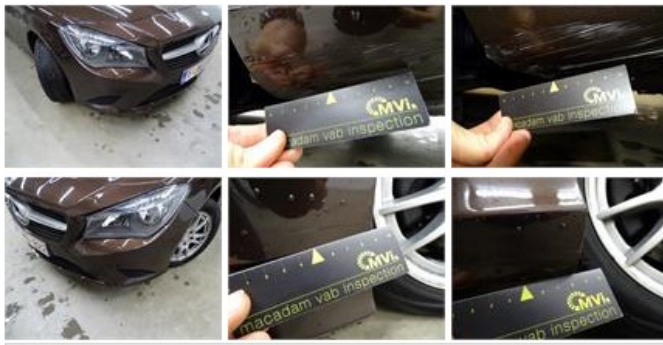
Total cost ex VAT	1473,17
Bonnet, Scratch(es), 67 - Polish	0,00
<i>No pictures to display</i>	
Bumper F, Scratch(es), LI - Repair and paint (complete)	211,80

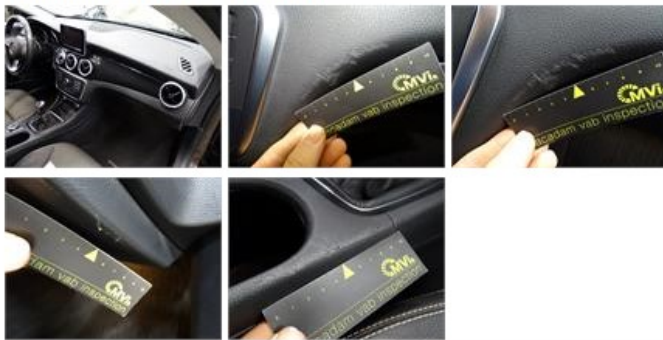
Dashboard, Scratch(es), Smart repair 110,64

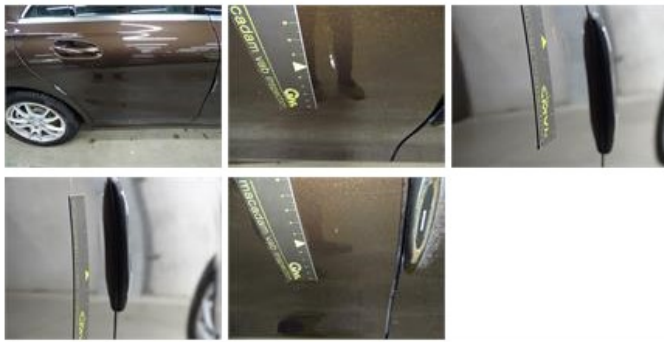
Door R R, Scratch(es), Acceptable

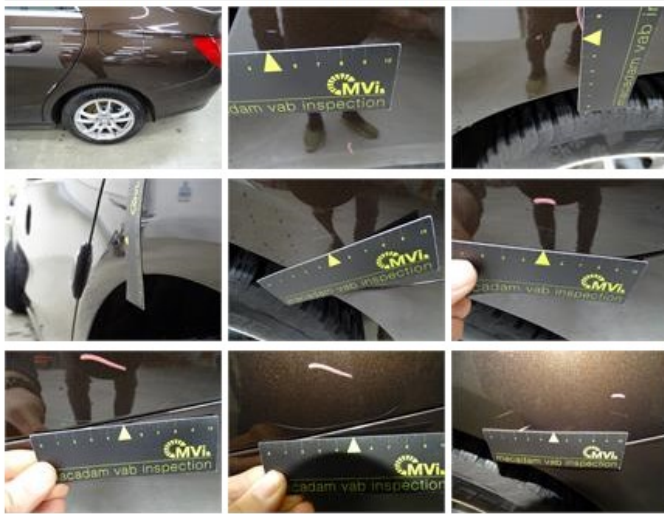
Wing R L, Dent(s) and scratch(es), LI - Repair and paint (complete)

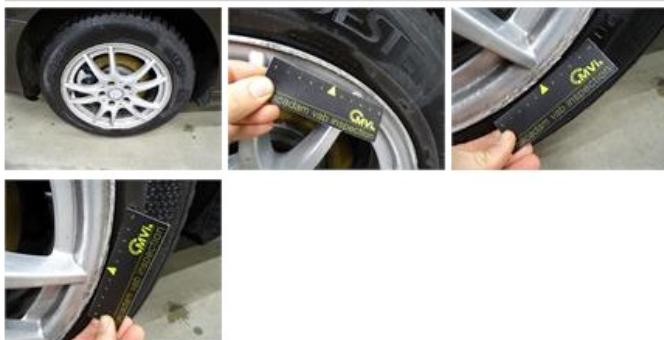
Alloy rim R R, Scratch(es), LI - Repair and paint (complete)

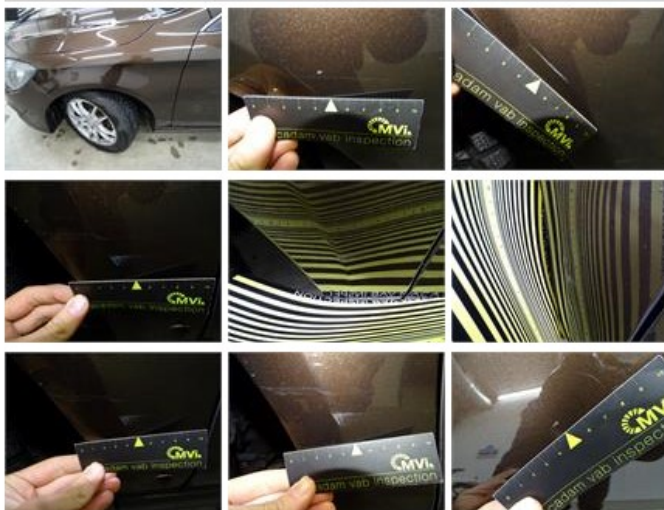
Wing F L, Dent(s) and scratch(es), LI - Repair and paint (complete)
