VOLVO V60: 1HSR496

Limited Technical Inspection

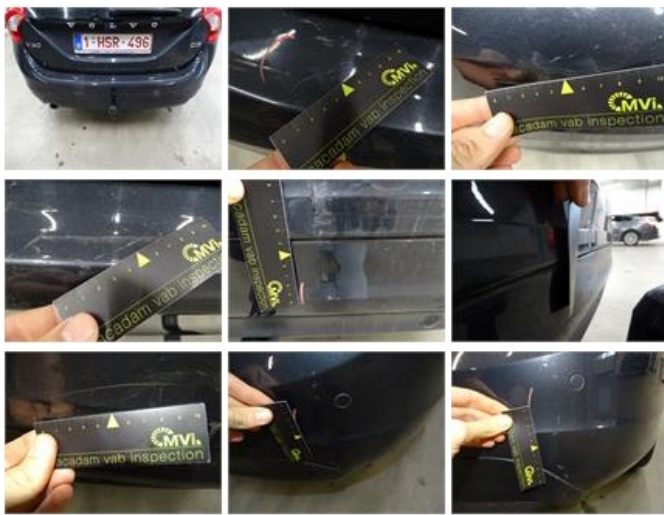
Total cost ex VAT	1766,53
Bumper R, Dent(s) and scratch(es), LI - Repair and paint (complete)	211,80

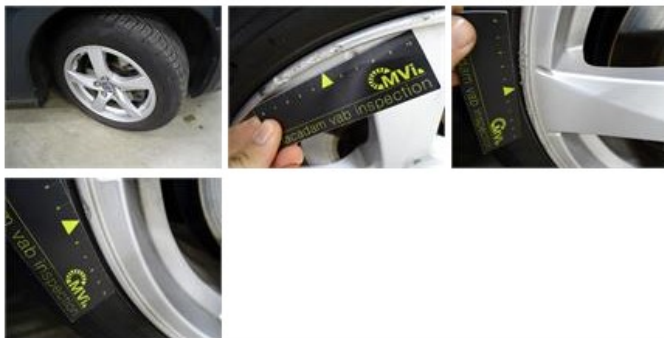
Alloy rim F R, Scratch(es), LI - Repair and paint (complete) 95,00

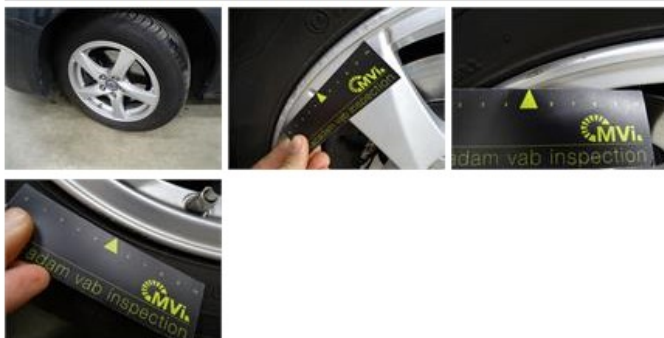
Alloy rim F L, Scratch(es), LI - Repair and paint (complete) 95,00

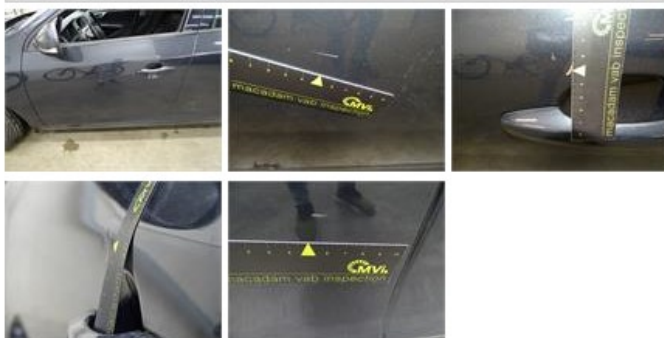
Door F L, Dent(s) and scratch(es), LI - Repair and paint (complete) 318,35

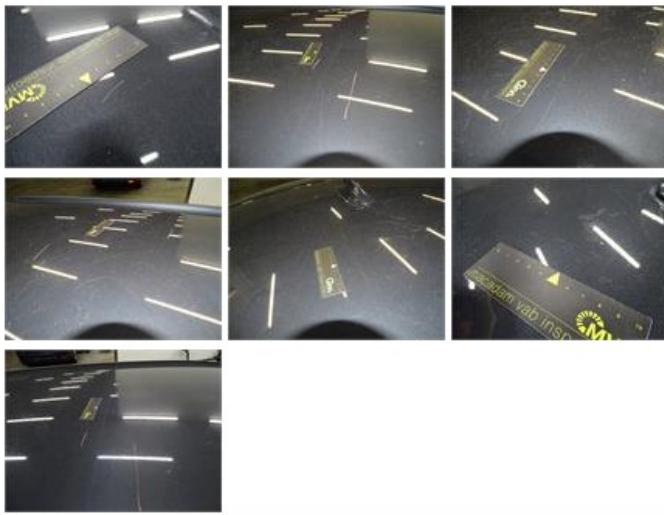
Roof, Scratch(es), LI - Repair and paint (complete) 481,50

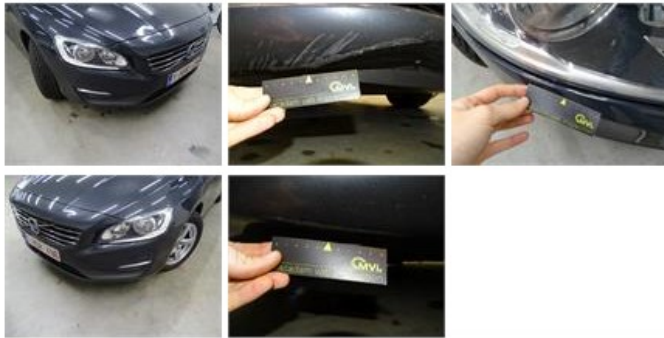
Bumper F, Scratch(es), LI - Repair and paint (complete)

211,80

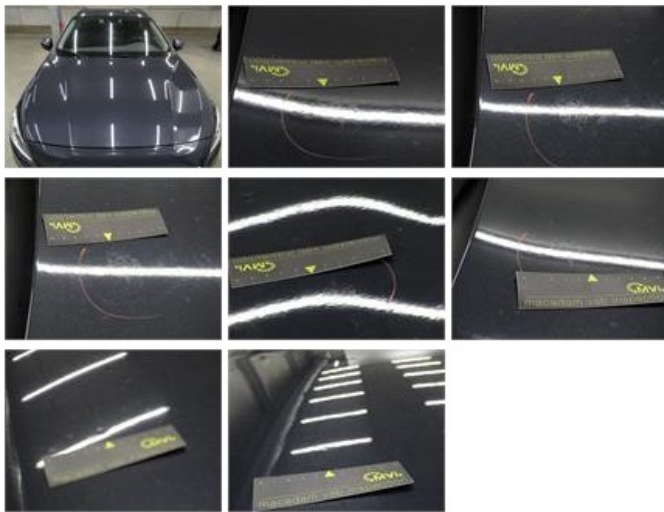
Bonnet, Chemical polution, LI - Repair and paint (complete)

290,08
