**VOLVO V40: 1TBQ089**

**Limited Technical Inspection**

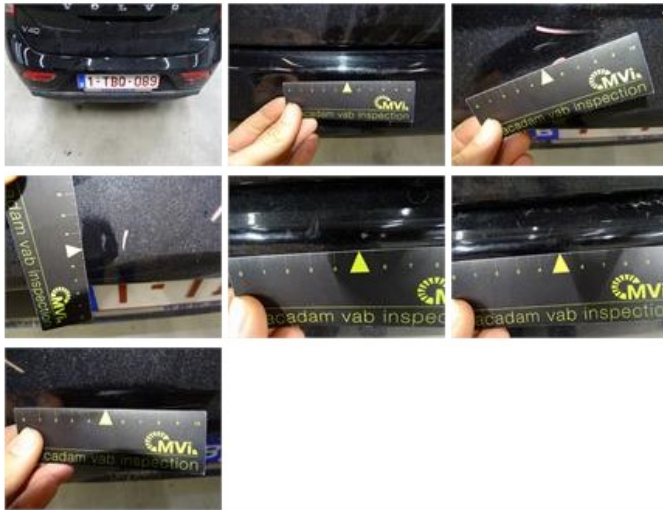
Wing R R, Scratch(es), 67 - Polish

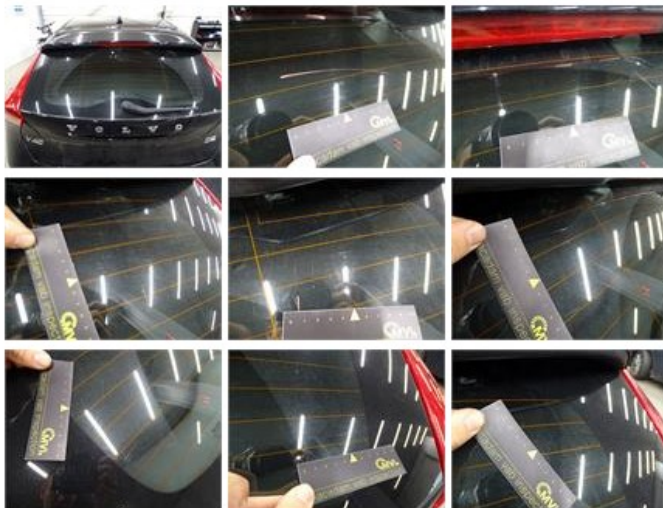
Rear window, Scratch(es), E - Replace

370,00

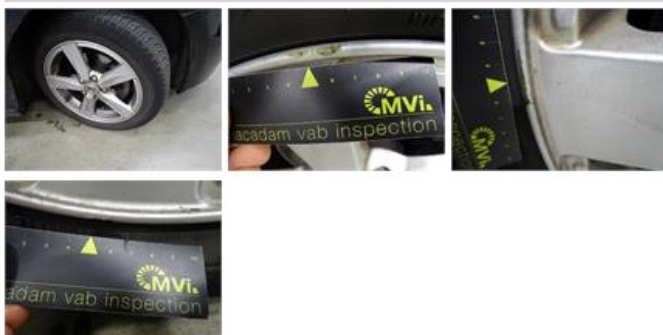
Alloy rim F R, Scratch(es), LI - Repair and paint (complete)

95,00

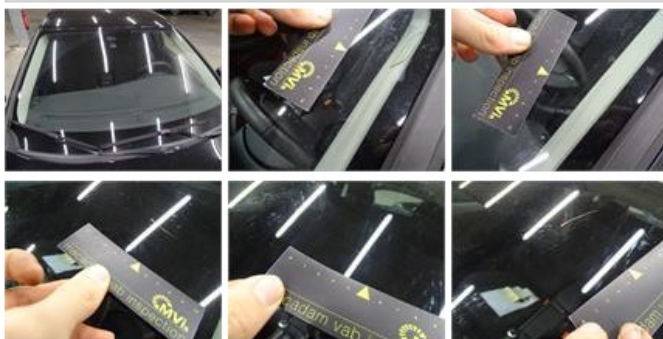
Windscreen, Scratch(es), Acceptable
