VOLVO V40: 1NER831

Limited Technical Inspection

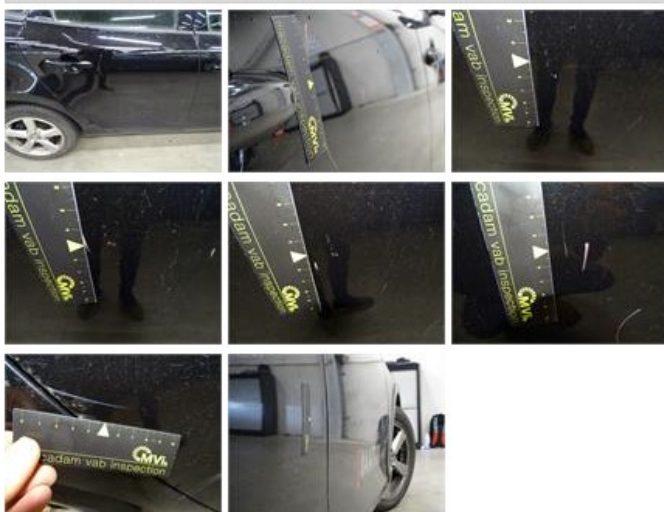
Door R R, Dent(s) and scratch(es), LI - Repair and paint (complete)

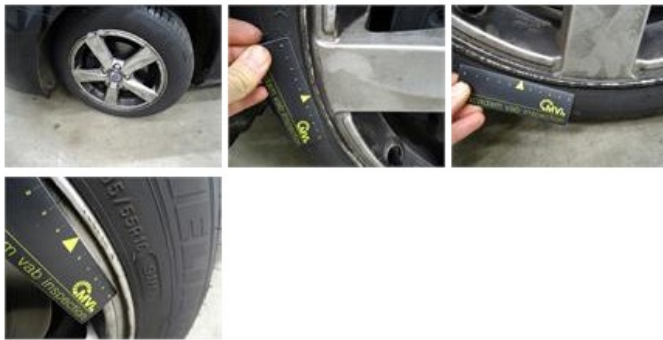
Alloy rim F L, Scratch(es), LI - Repair and paint (complete)

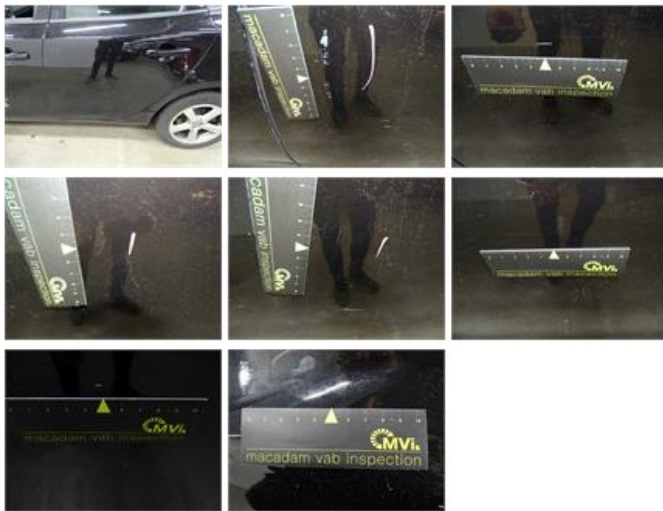
Door R L, Scratch(es), LI - Repair and paint (complete)

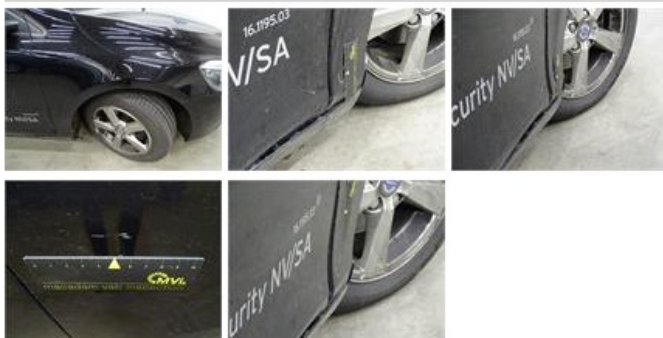
Wing F R, Deformed / Strained, LI - Repair and paint (complete)
