**VOLVO V60: 1HRD248**

**Limited Technical Inspection**

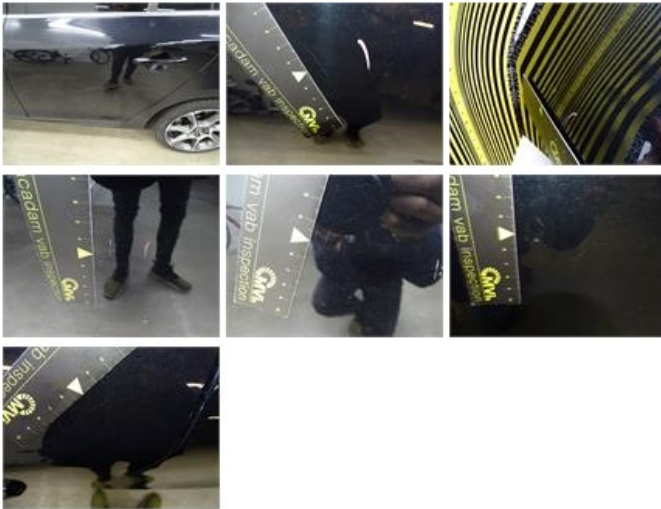
Door R L, Dent(s) and scratch(es), LI - Repair and paint (complete)

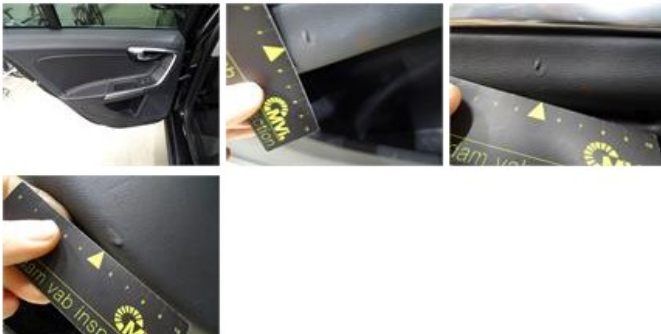
Door panel R L, Scratch(es), Acceptable

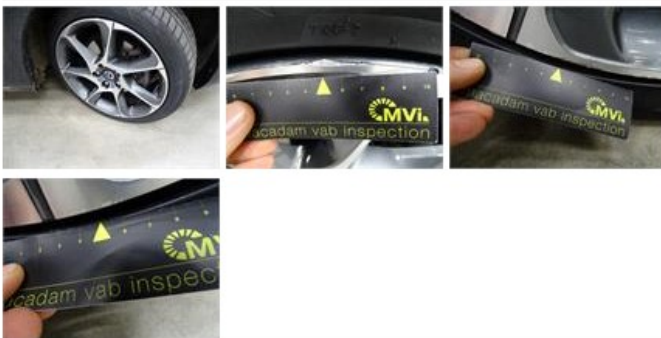
Alloy rim F R polished, Scratch(es), LI - Repair and paint (complete)

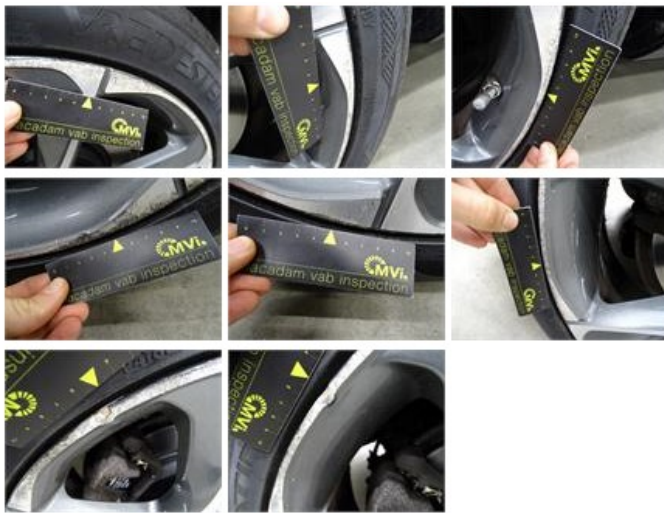
Alloy rim R R polished, Scratch(es), LI - Repair and paint (complete)

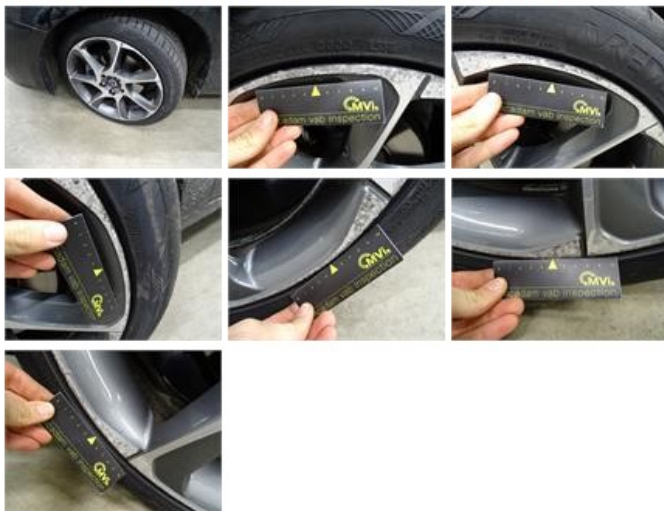
Alloy rim F L polished, Scratch(es), LI - Repair and paint (complete)

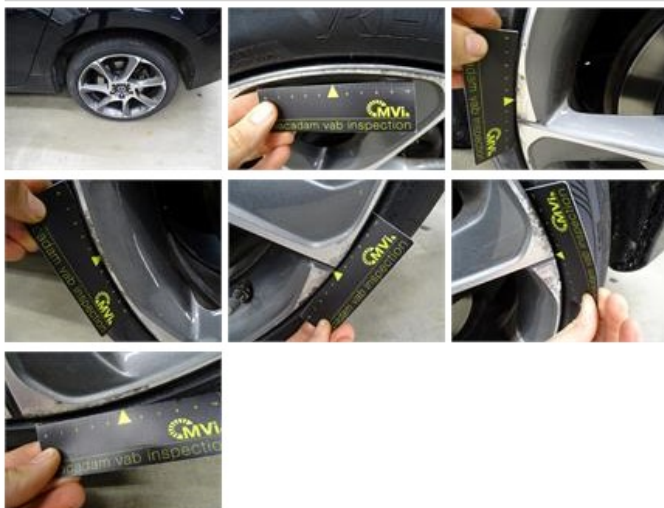
Alloy rim R L polished, Scratch(es), LI - Repair and paint (complete)

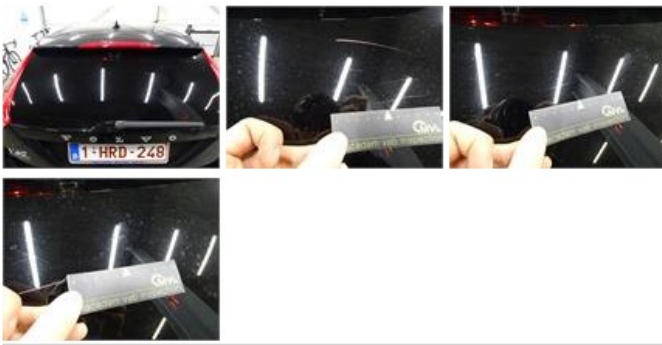
Rear window, Scratch(es), E - Replace
