**BMW 2 Active Tourer: 1HYE146**

| Vinnumber: | WBA2C11070VZ54748 | Versionname: | 2 ACTIVE TOURER 218d 136PK |

**Limited Technical Inspection**

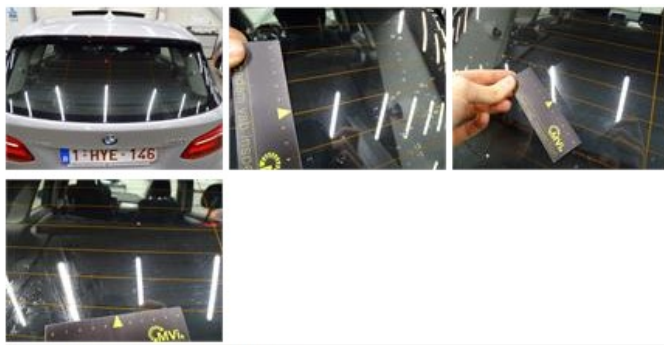
| Rear window, Scratch(es), Acceptable | 0,00 |

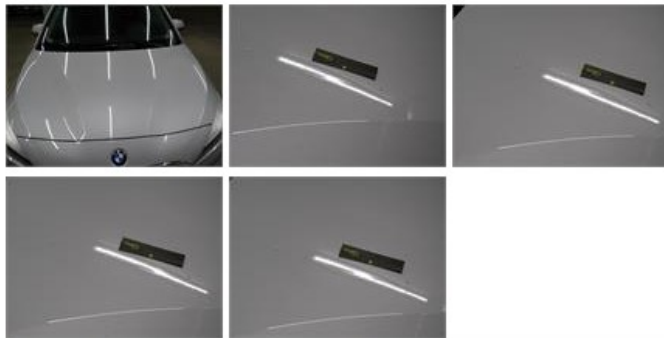
| Bonnet, Dent(s), PDR - Paintless dent repair | 63,00 |

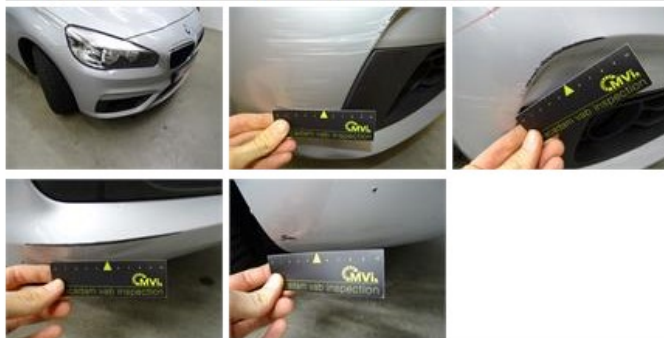
| Bumper F, Scratch(es), LI - Repair and paint (complete) | 211,80 |

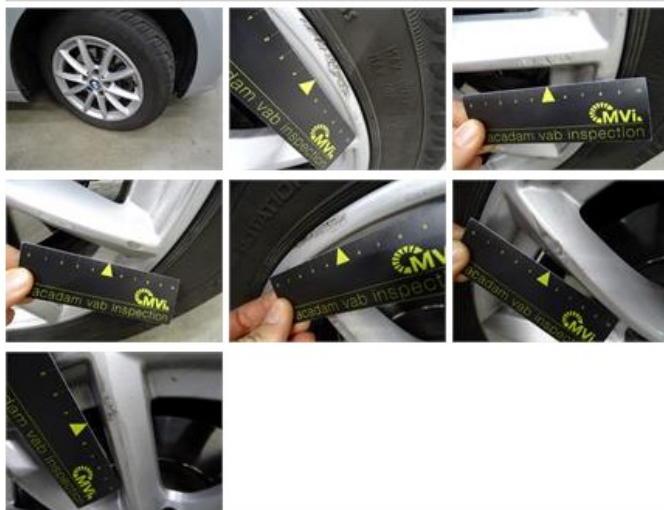
| Alloy rim F R, Scratch(es), LI - Repair and paint (complete) | 95,00 |

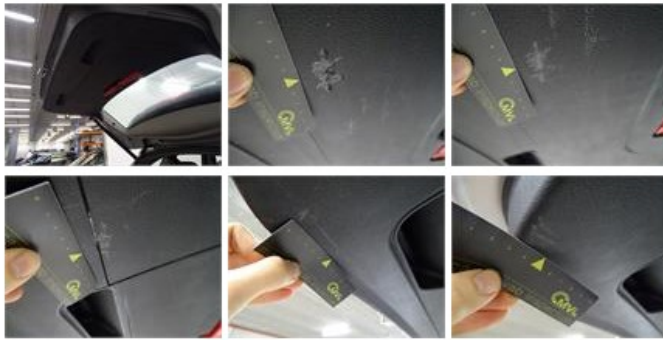
Trunk lid covering R, Scratch(es), Smart repair

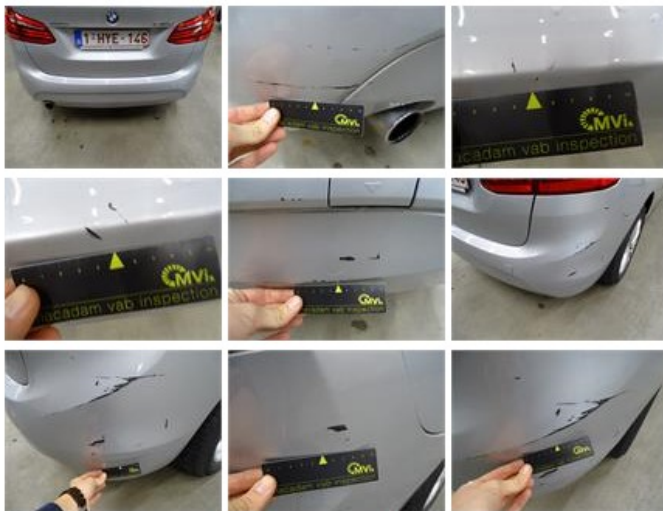
Bumper R, Scratch(es), LI - Repair and paint (complete)

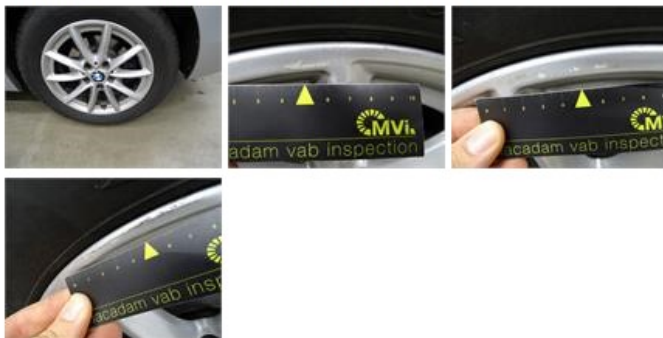
Alloy rim R L, Scratch(es), LI - Repair and paint (complete)
