# AUDI A4 AVANT: 1LHG590

| Vinnumber: | WAUZZZ8K6FA162237 | Versionname: | 2.0 TDI ULTRA 100KW |

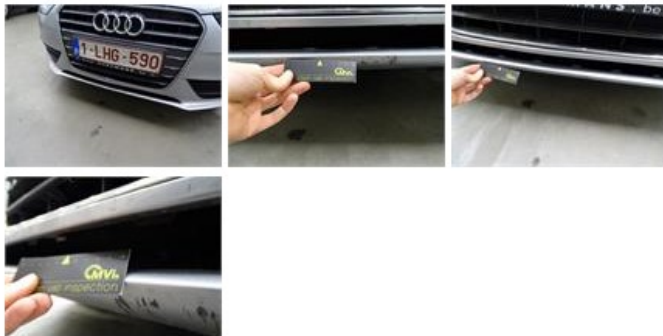
Bumper grille, Missing, E - Replace 32,40

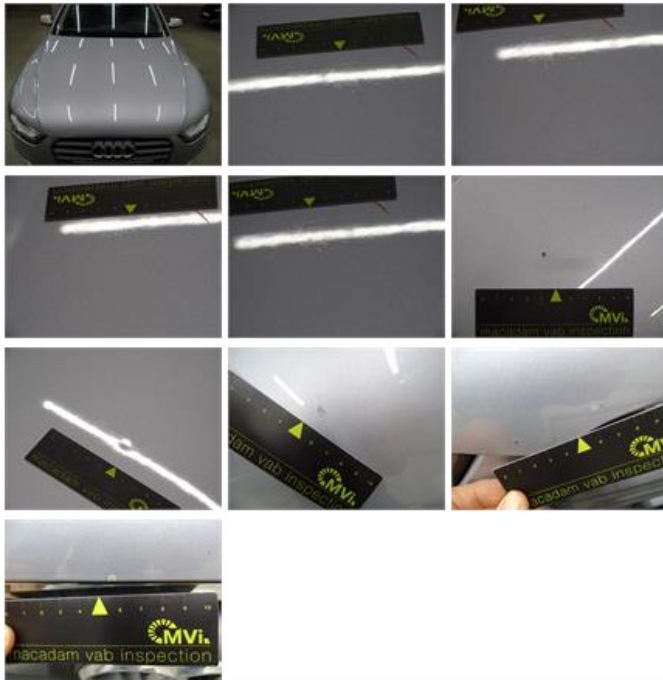
Bonnet, Chemical polution, LI - Repair and paint (complete) 290,08

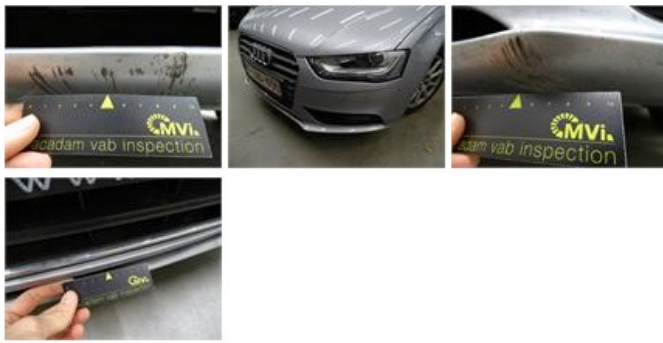
Bumper F, Scratch(es), LI - Repair and paint (complete) 211,80

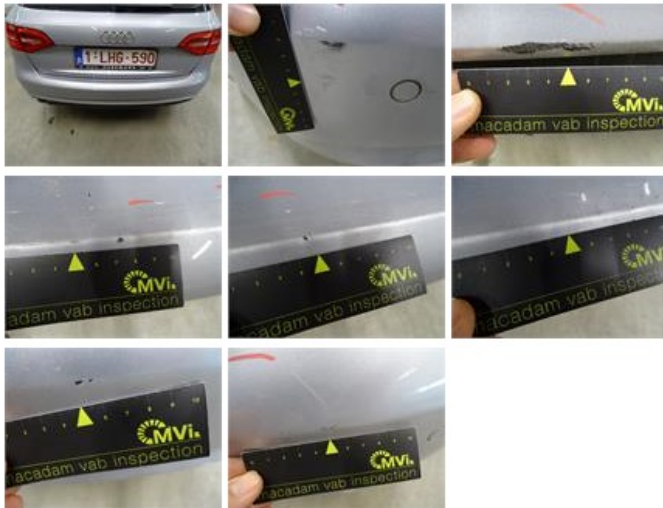
Bumper R, Scratch(es), LI - Repair and paint (complete) 211,80

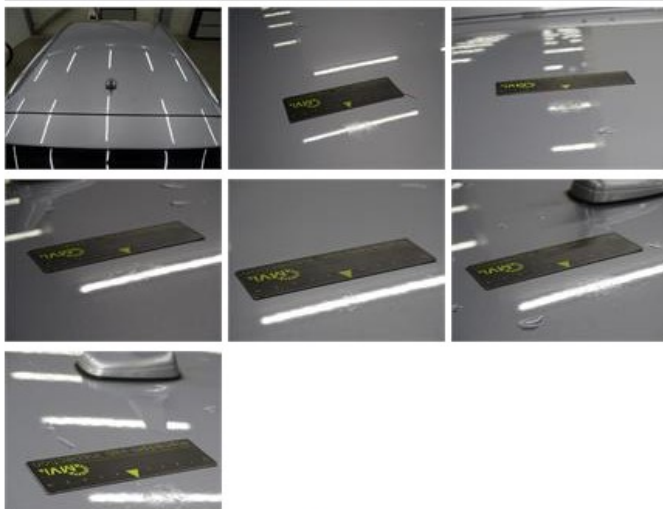
Roof, Chemical polution, LI - Repair and paint (complete) 481,50
