**SEAT ALHAMBRA: 1LRE962**

**Limited Technical Inspection**

**Degree of wear**

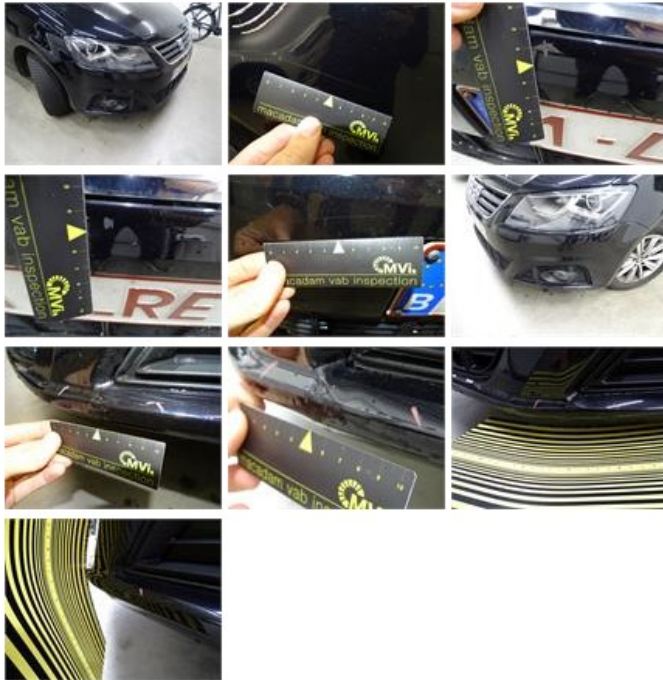
Bumper F, Dent(s) and scratch(es), LI - Repair and paint (complete)

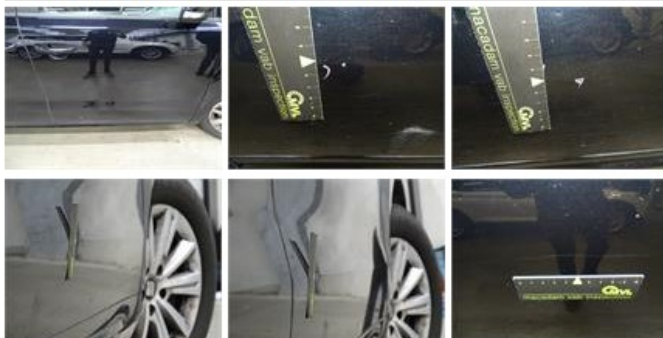
Door F R, Dent(s) and scratch(es), LI - Repair and paint (complete)

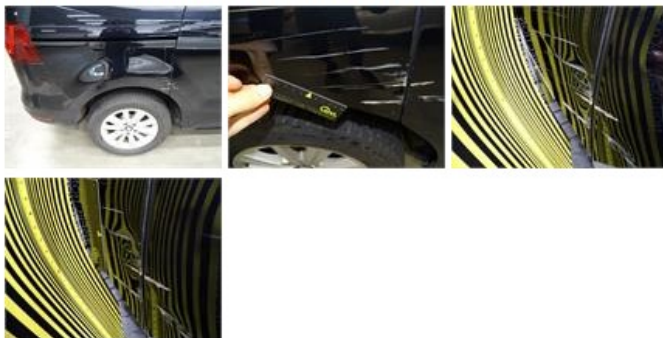
Wing R R, Dent(s) and scratch(es), LI - Repair and paint (complete)

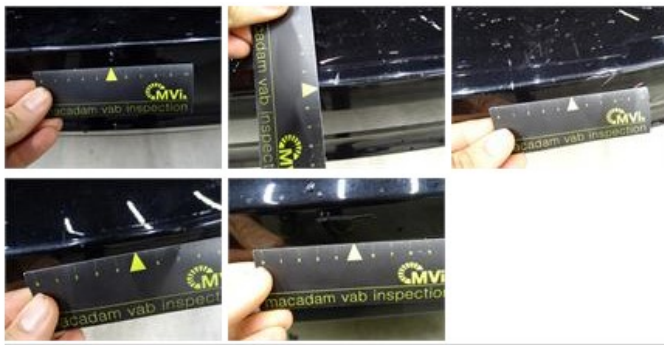
Bumper R, Scratch(es), LI - Repair and paint (complete)

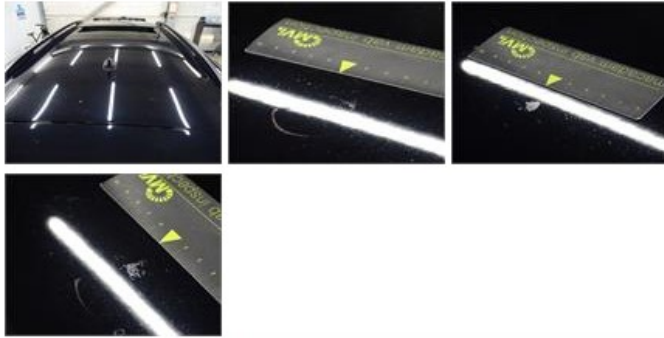
Roof, Chemical polution, LI - Repair and paint (complete)

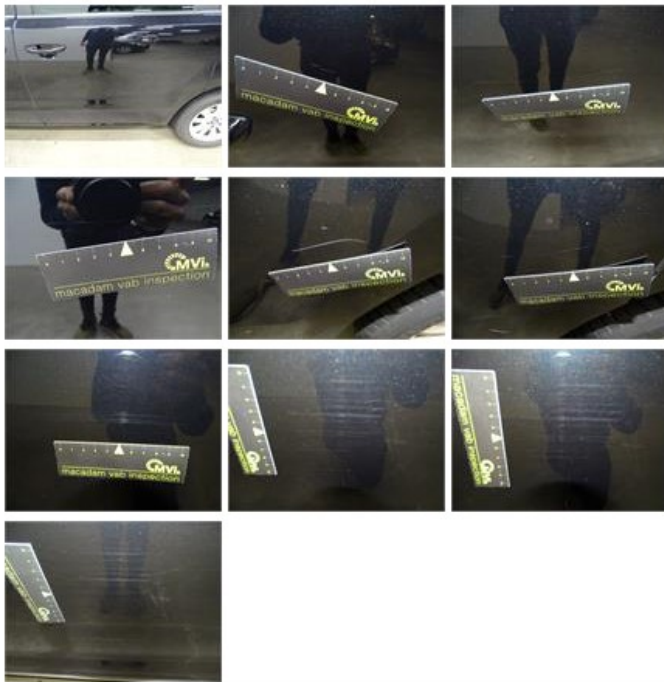
Door R L, Scratch(es), LI - Repair and paint (complete)
