**SKODA Octavia: 1HVX232**

| Vinnumber: | <b>TMBJG7NE4F0095409</b> | Versionname: | <b>OCTAVIA COMBI Ambition 105PK</b> |

**Limited Technical Inspection**

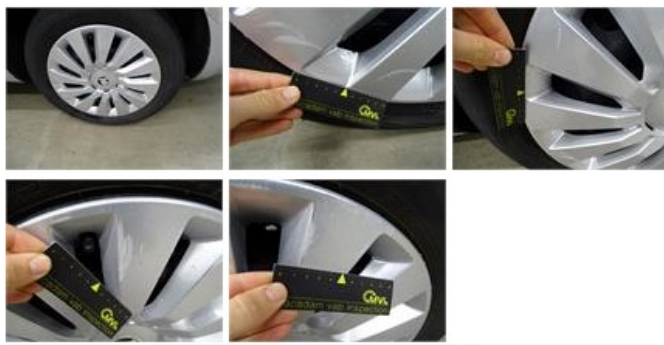
| Wheel cover R L, Scratch(es), E - Replace | <b>30,00</b> |

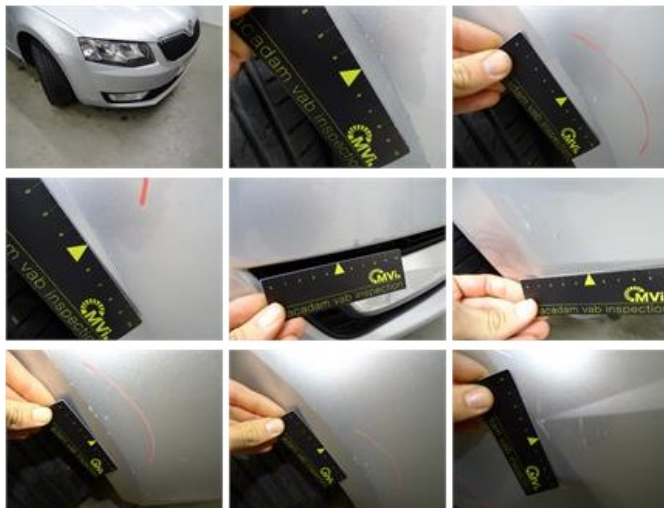
Bumper F, Scratch(es), LI - Repair and paint (complete)

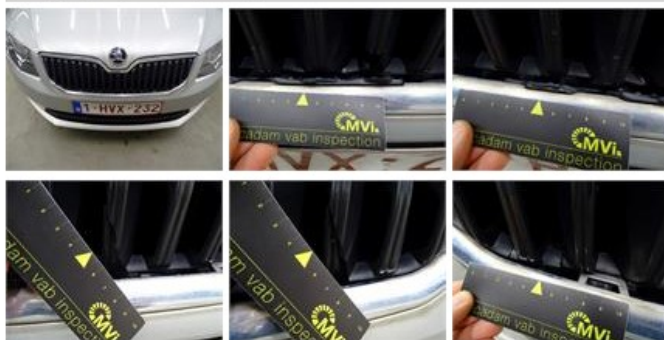
Bumper grille, Broken, E - Replace

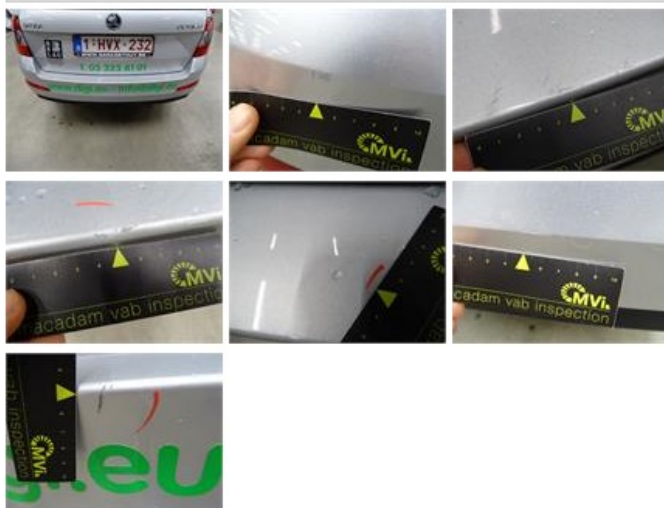
Bumper R, Scratch(es), LI - Repair and paint (complete)

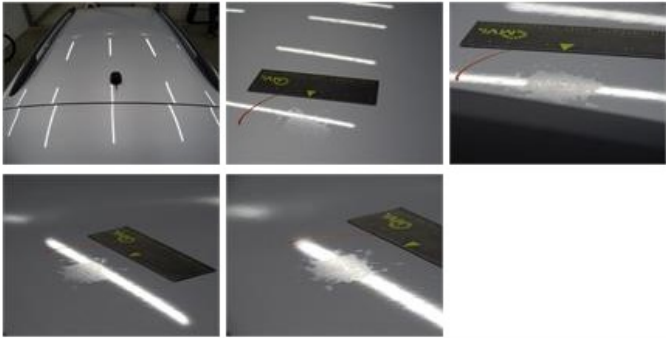
| Roof, Chemical polution, LI - Repair and paint (complete) | 481,50 |

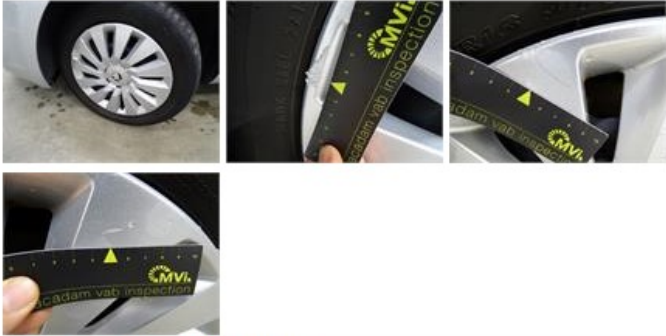
| Wheel cover F L, Scratch(es), E - Replace | 30,00 |

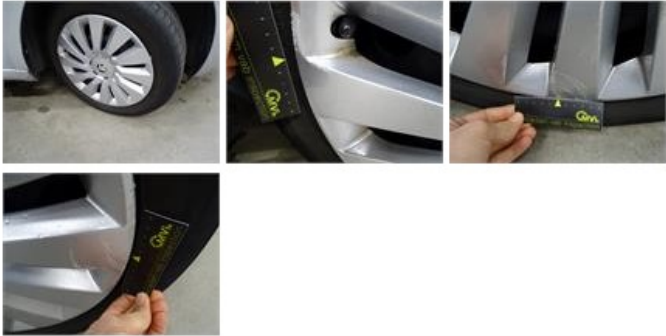
| Wheel cover F R, Scratch(es), E - Replace | 30,00 |

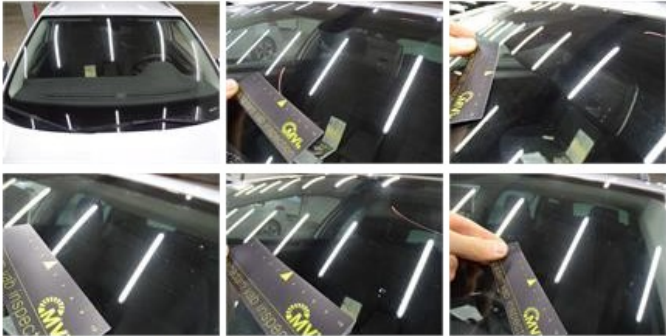
| Windscreen, Scratch(es), E - Replace | 0,00 |
