**VOLVO S90: 1SBV544**

**Limited Technical Inspection**

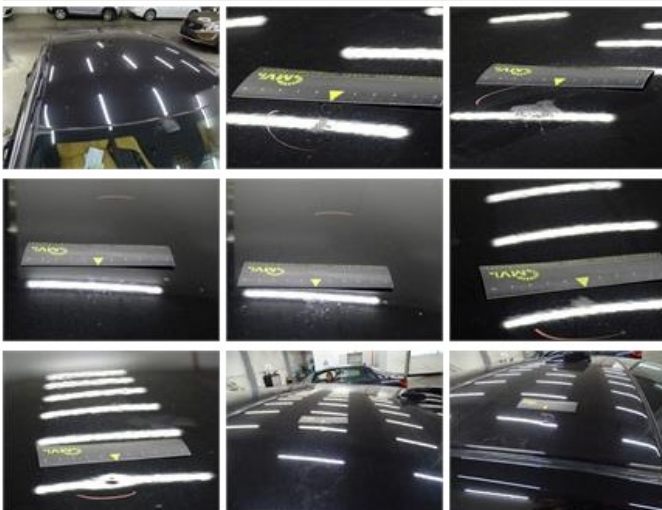
Roof, Chemical polution, LI - Repair and paint (complete) 577,80

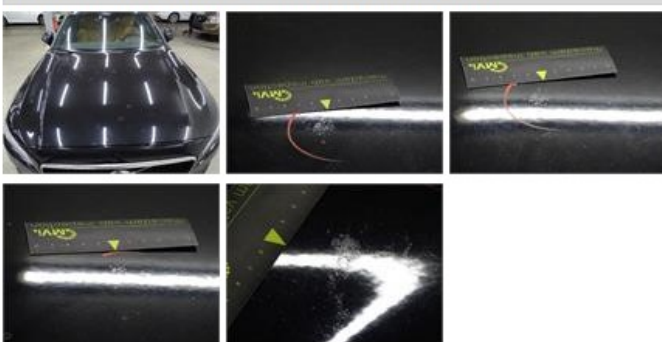
Bonnet, Chemical polution, LI - Repair and paint (complete) 348,09
