VOLKSWAGEN GOLF VII: 1LKD710

Limited Technical Inspection

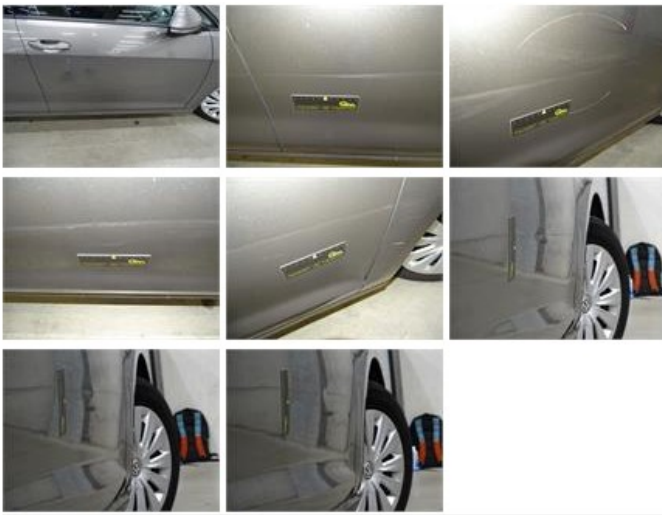
Door F R, Dent(s) and scratch(es), LI - Repair and paint (complete) 318,35

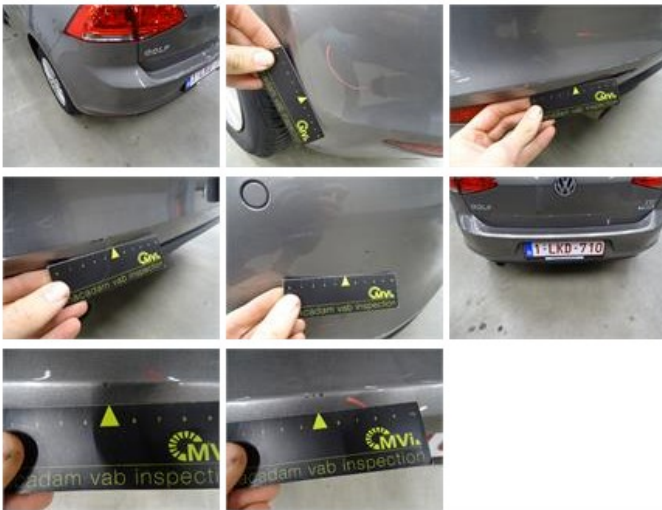
Bumper R, Scratch(es), LI - Repair and paint (complete)

211,80

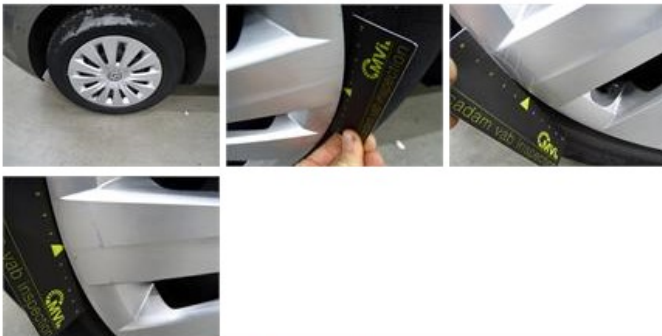
Wheel cover R R, Scratch(es), E - Replace

30,00

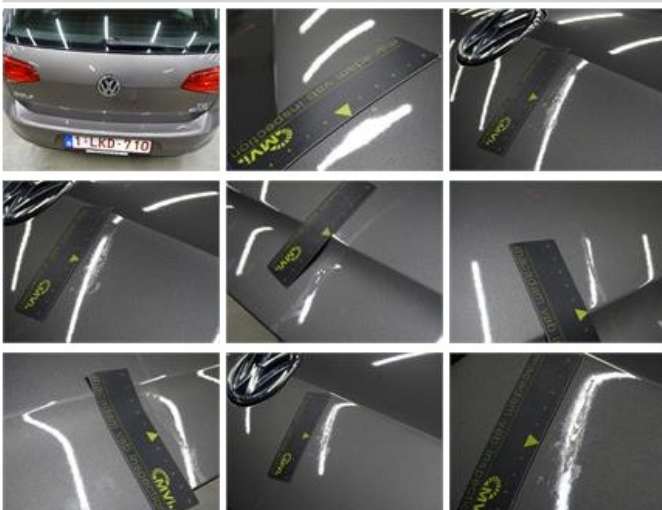
Tailgate, Chemical pollution, LI - Repair and paint (complete)

301,68

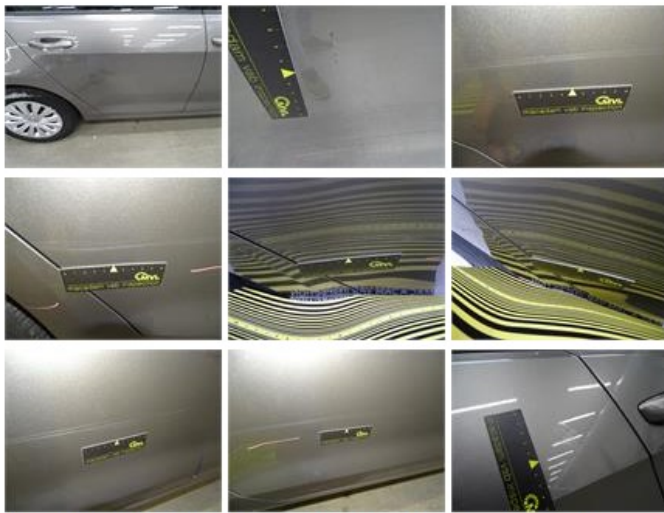
Door R R, Scratch(es), LI - Repair and paint (complete)

318,35

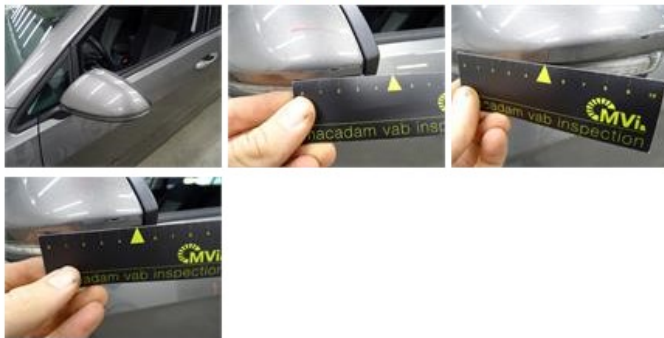
Rearview mirror housing L, Scratch(es), LI - Repair and paint (complete)

115,56

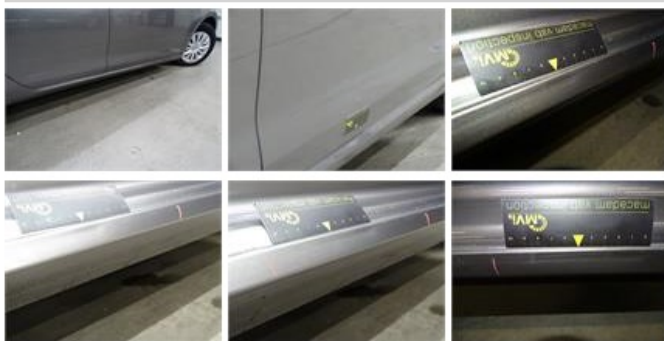
Sill outer R, Dent(s) and scratch(es), LI - Repair and paint (complete)

310,50

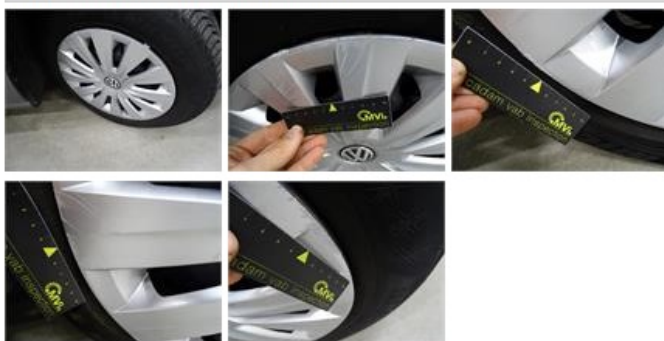
Wheel cover F R, Scratch(es), E - Replace

30,00

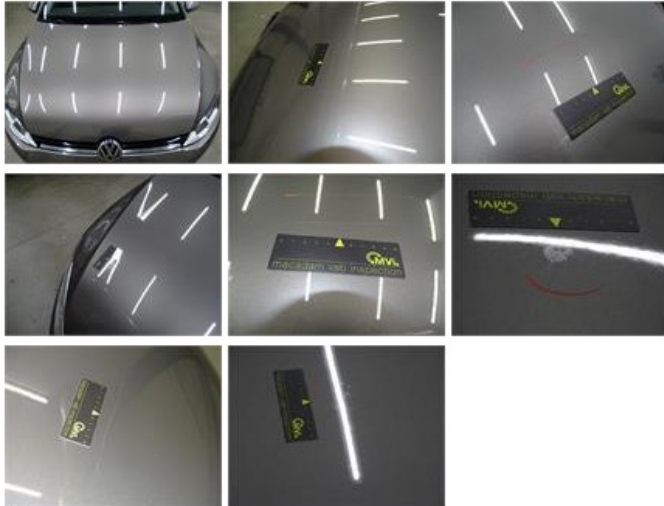
Bonnet, Dent(s) and scratch(es), LI - Repair and paint (complete) 290,08

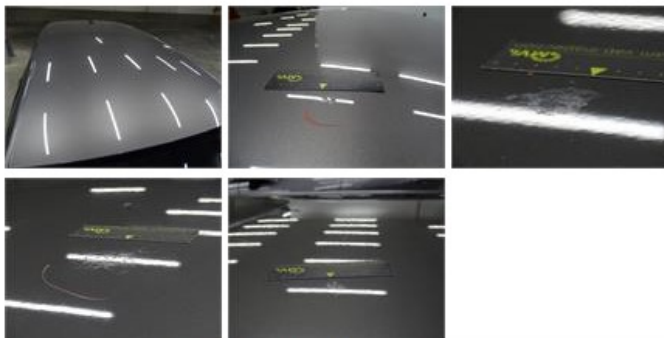
Roof, Chemical polution, LI - Repair and paint (complete) 481,50

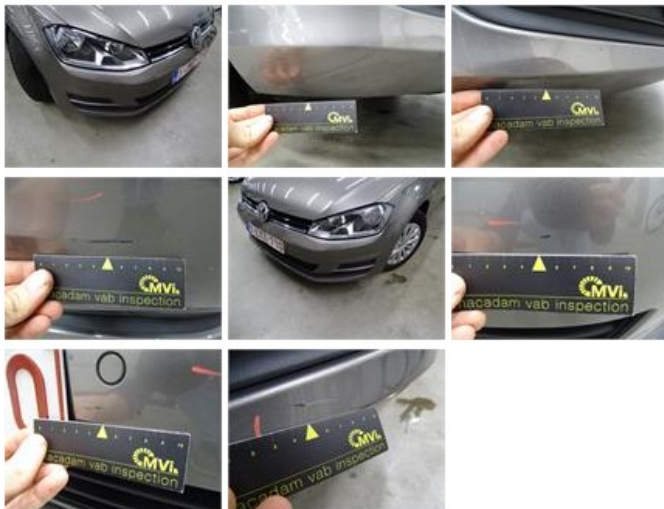
Bumper F, Dent(s) and scratch(es), LI - Repair and paint (complete) 211,80
